BRIDGE INSPECTION REPORT

PREPARED FOR: FLORIDA DEPARTMENT OF TRANSPORTATION
 BRIDGE OWNER: HARDEE COUNTY

BRIDGE NO. 060034	CONTENTS OF REPORT	INSPECTION DATE: 02/28/2018
BrM Report		U/W Inspection Report
CIDR		* Fracture Critical Data
Scour Elevation (Profile)		* Load Rating Analysis Summary
Addendum (Element Notes & Photos/Sketches)		
*This section is not included in this report.

CR-664 over Little Payne Creek

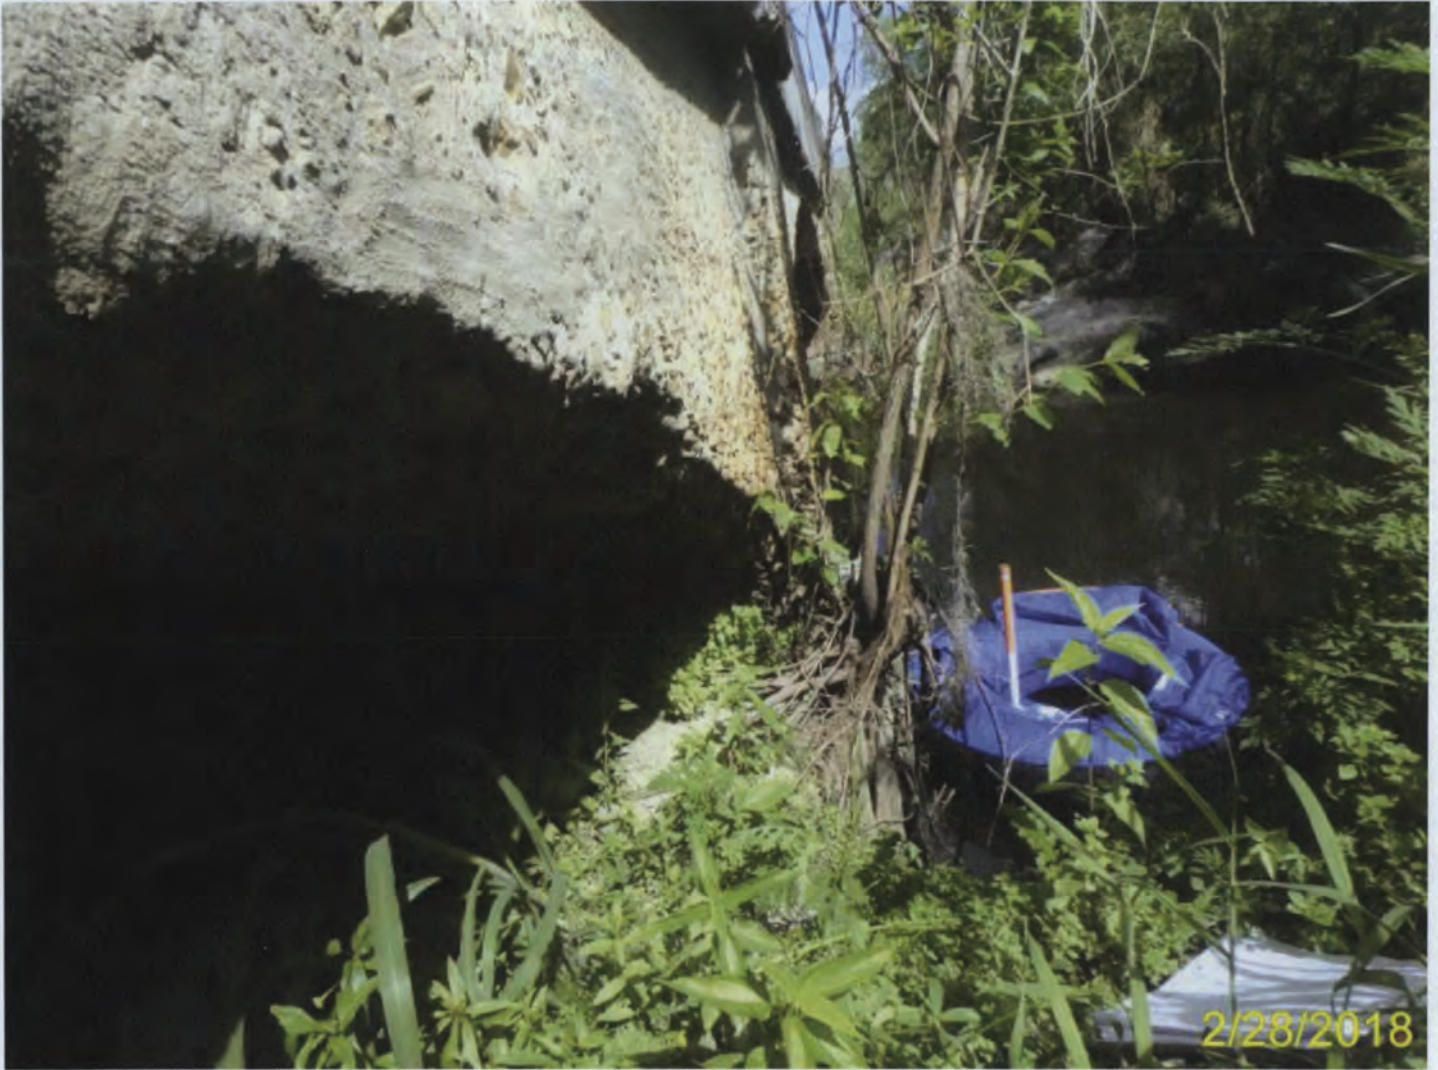
Photo 1- Element 8290 Channel

The 4.3ft. difference for the Pier 2 right channel measurement (downstream) is due to the back side of the pier/channel bank edge starting to scour - NEW. Refer to photo 1.

Difference in channel profile right at Pier 2 (downstream)

REPAIR RECOMMENDATION:
None

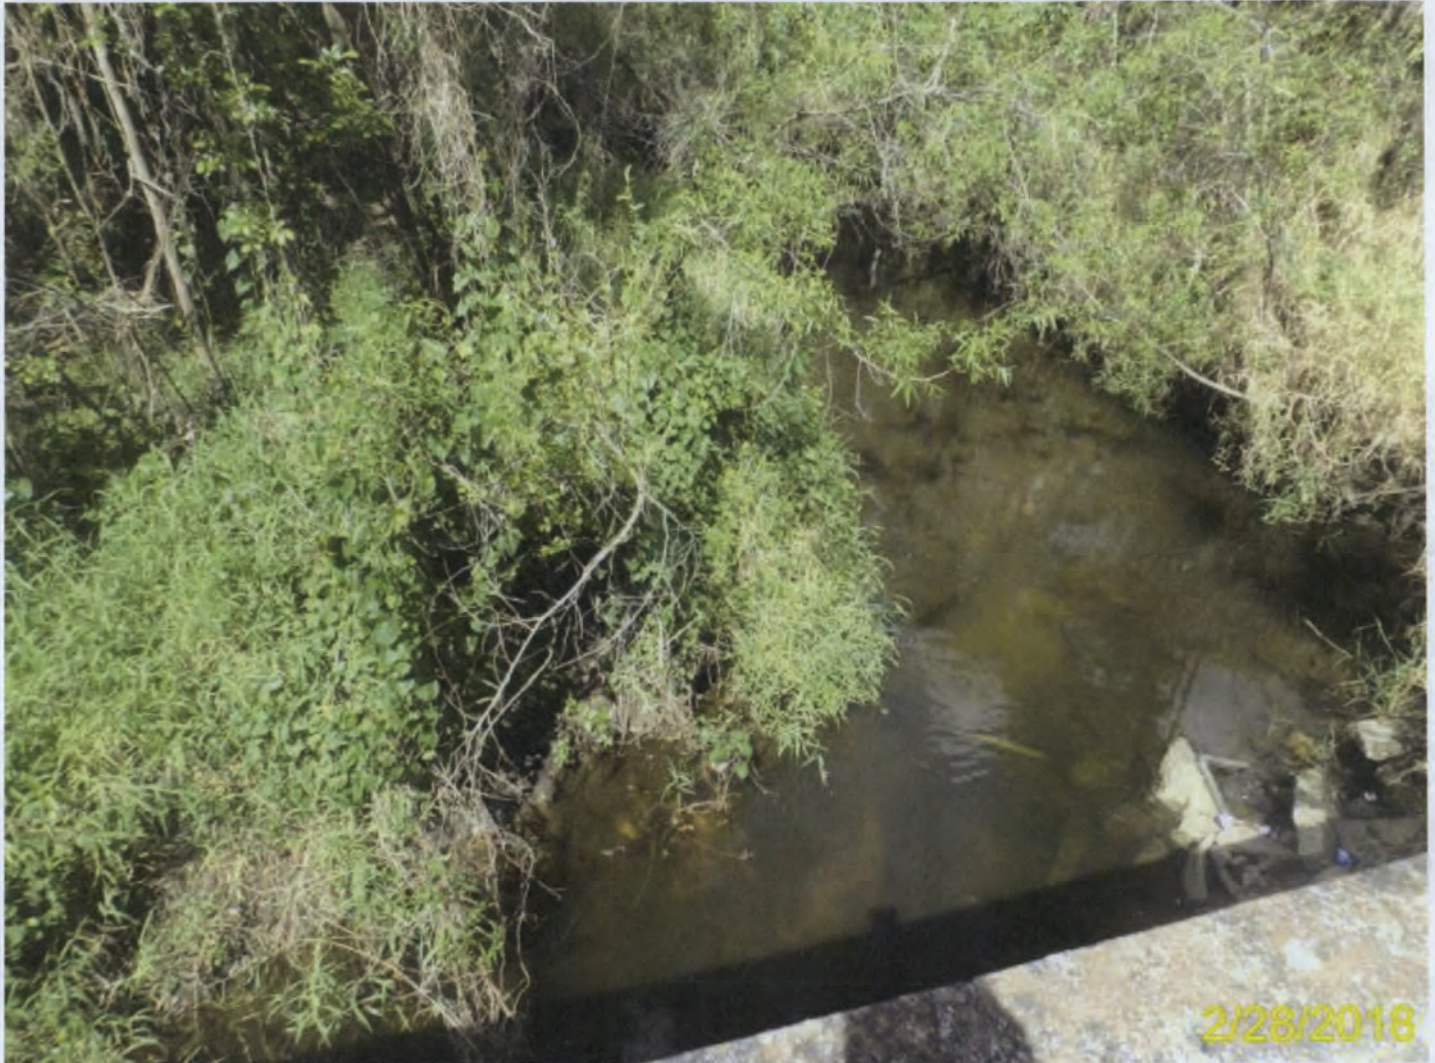
Photo 2 - Element 8290 Channel

The channel has a greater than a 30 degree angle of attack flowing into north face of Pier 3 and flows through Span 2 - NEW. Refer to photo 2. REPAIR

Channel flow of attack on the substructure grater than 30 degrees

REPAIR RECOMMENDATION:
Regrade and realign channel.

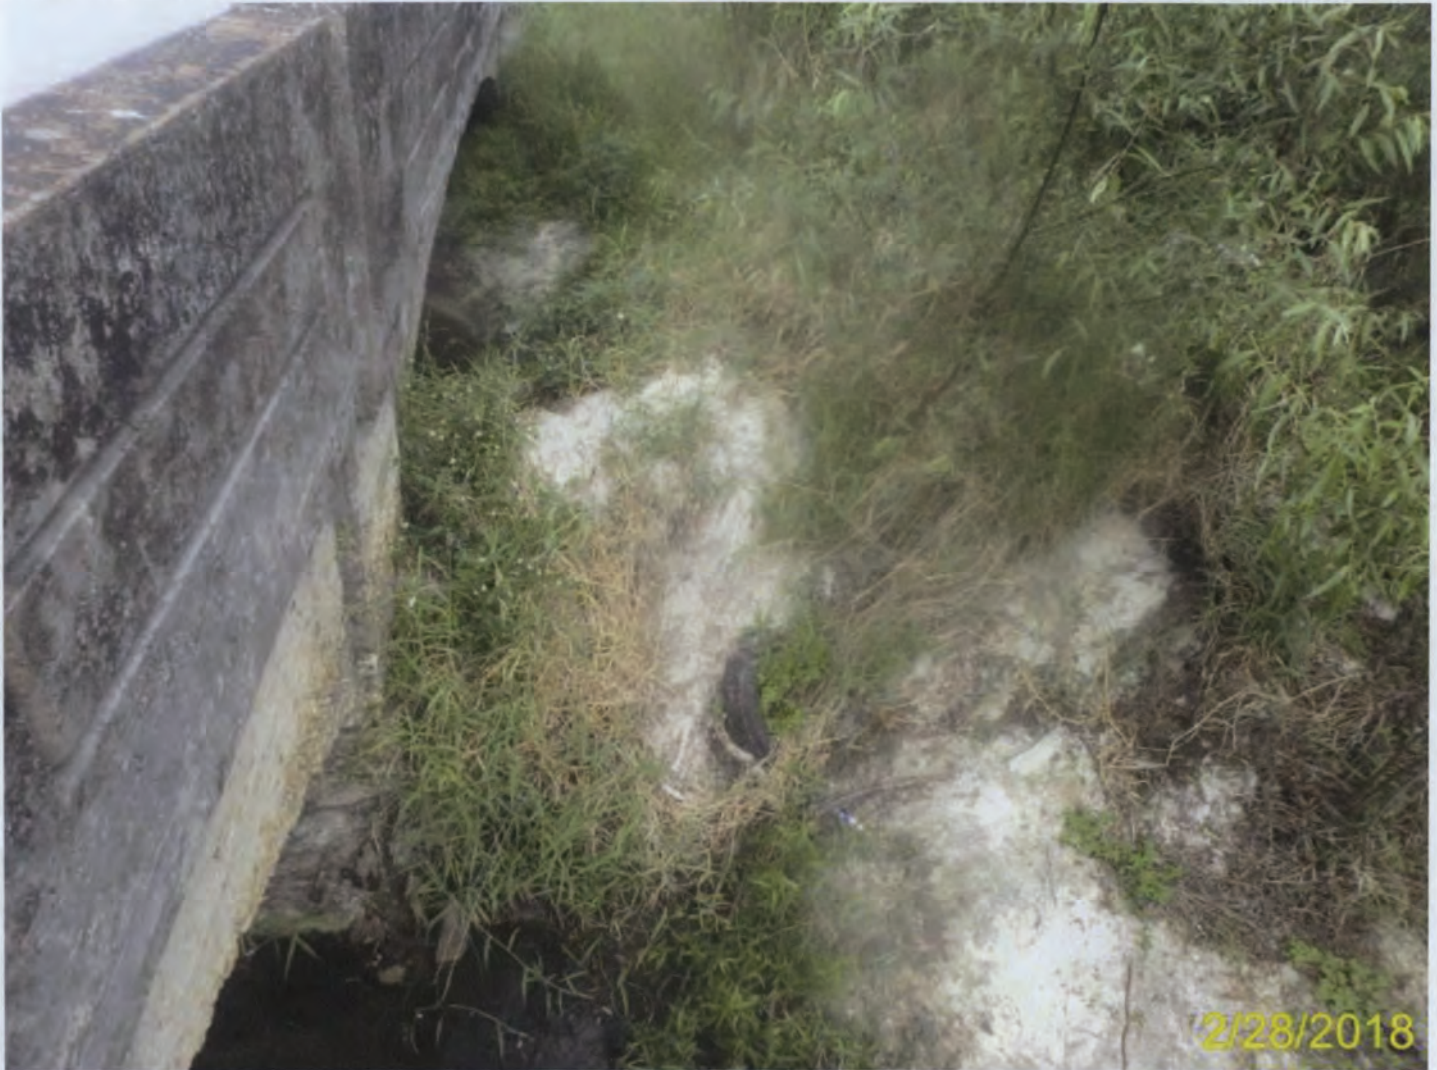
Photo 3 - Element 8290 Channel

There are vegetation islands with rooted trees along both sides of Pier 3 up to 17ft. x 8ft. x 6ft. which is affecting the flow. Refer to photo 3. REPAIR

Vegetation island in the south channel at Pier 3

REPAIR RECOMMENDATION:
Refer to photo 2.

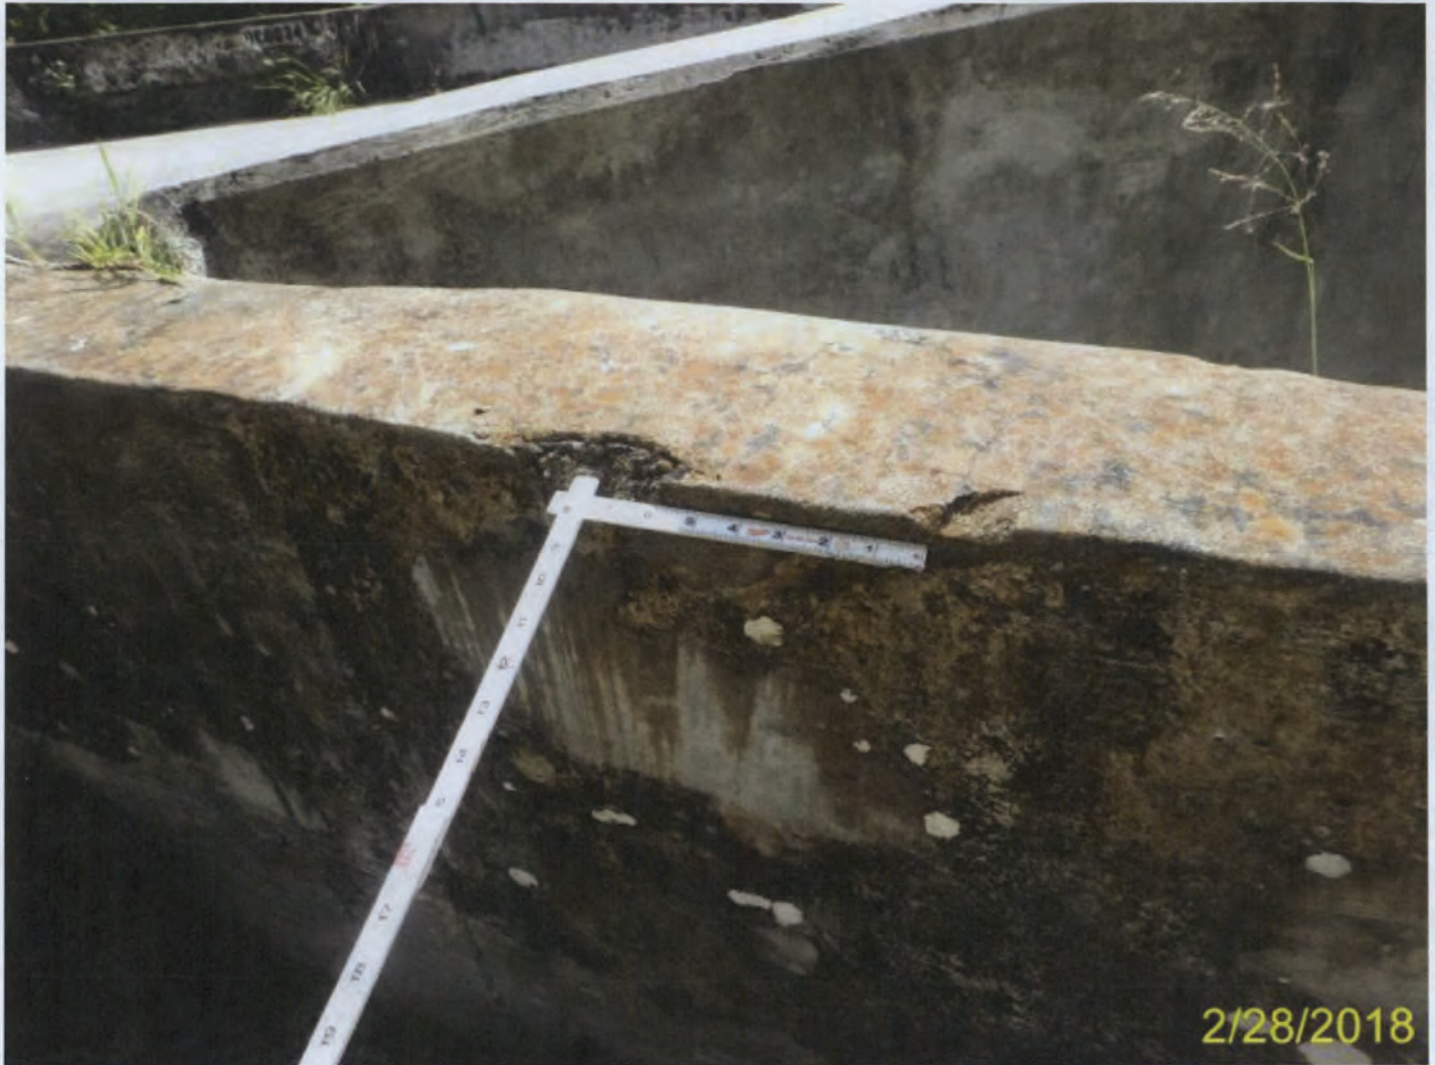
Photo 4 - Element 8475 R/Conc Walls

CS3 1080 = There are spalls up to 1ft. x 7in. x 2in. intermittently throughout. Refer to

Typical spall in the northwest wingwall

REPAIR RECOMMENDATION:
None

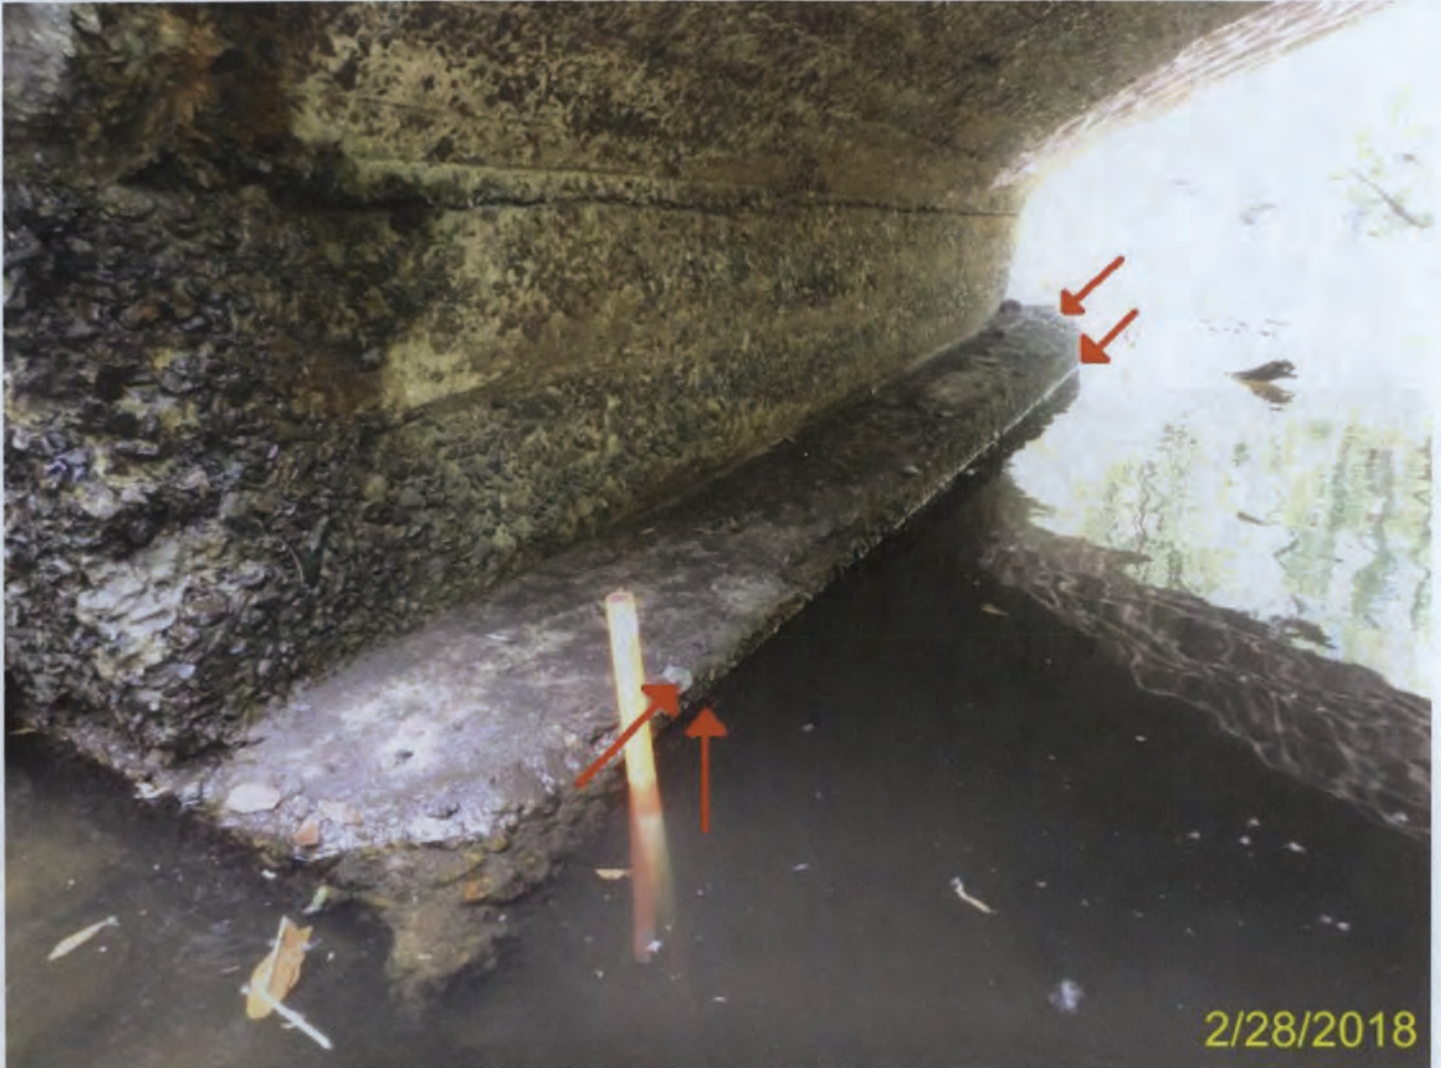
Photo 5 - Element 220 Re Conc Pile Cap/Ftg

CS4 9120 = The west face of Pier 3 footer is exposed up to 12ft. long x 4ft. high, with an area of undermining to the footer up to 7ft. long x 4in. high x 3.6ft. penetration starting from the north end, due to degradation/scour - INCREASE. Refer to Element 220 for related comments. REPAIR (1EA)

CS4 6000 = Pier 3 footer is exposed on the west face up to 12ft. long x 3.6ft. high and up to 8ft. x 2ft. on the east face. Refer to photo 5. INCREASE REPAIR (12FT)

Pier 3 footer unlevel and exposed on the west side with undermining

REPAIR RECOMMENDATION:

Install recommended scour countermeasures and establish a benchmark to monitor if settlement is increasing.

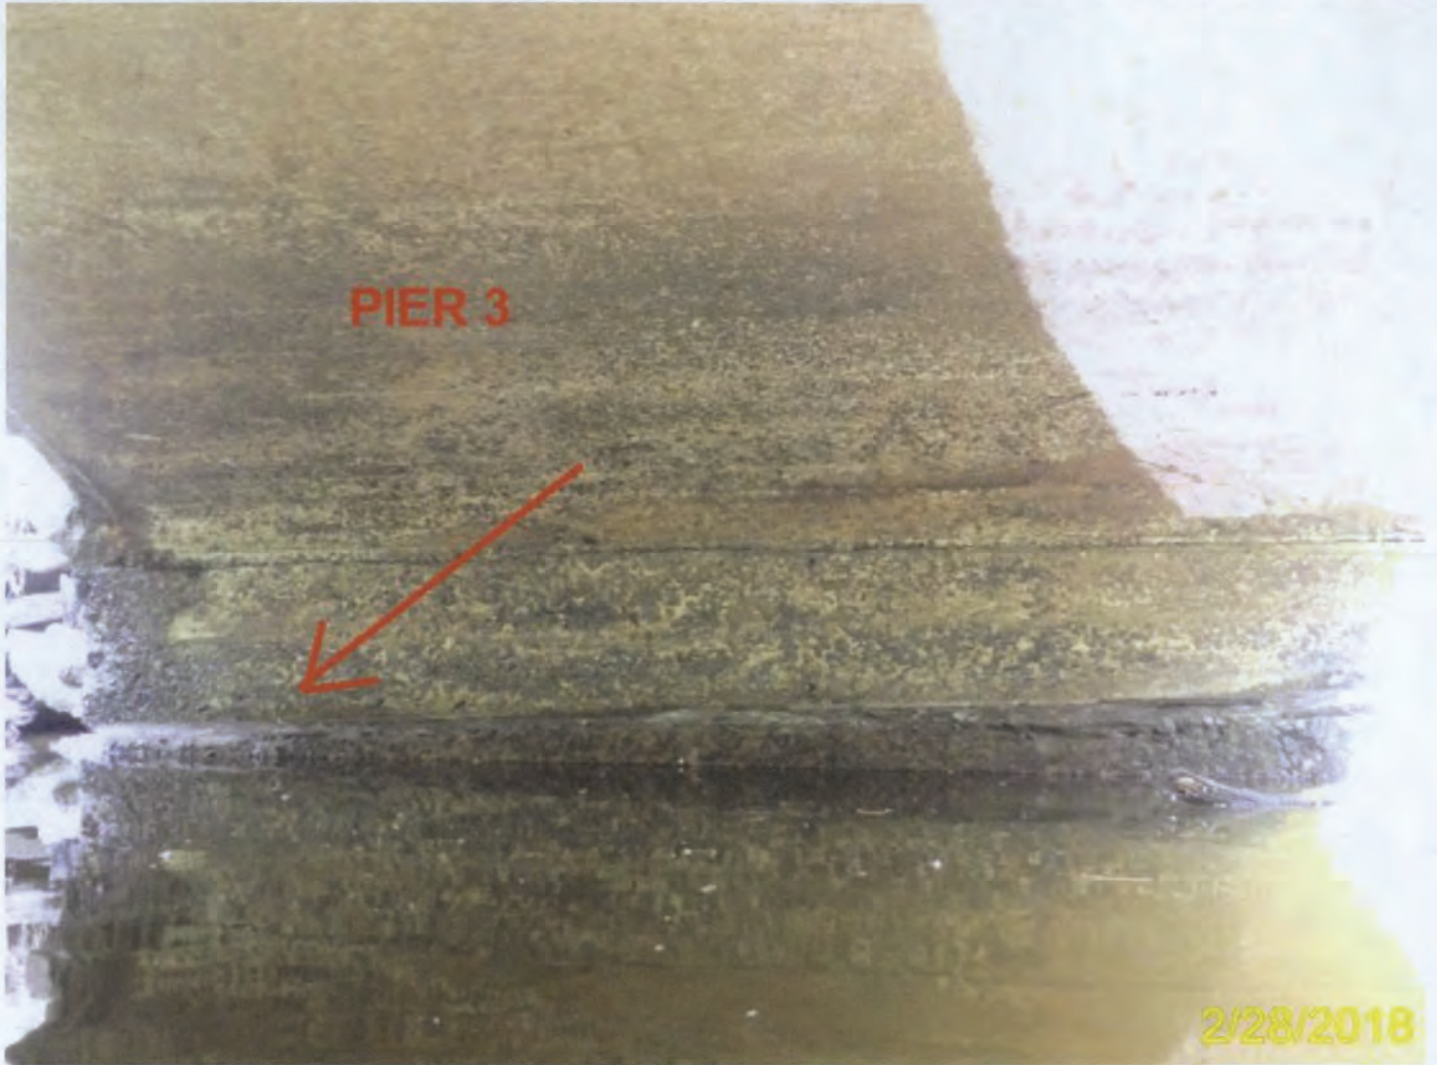
Photo 6 - Element 220 Re Conc Pile Cap/Ftg

Pier 3 appears to have settled at the north end (left side)

REPAIR RECOMMENDATION:
Refer to photo 5.

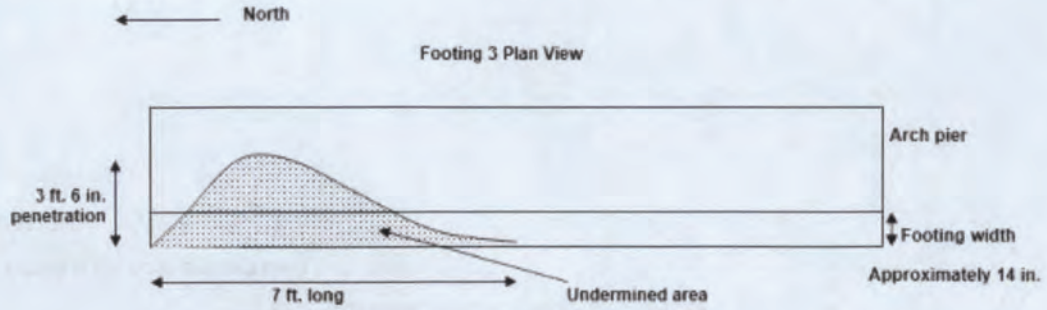
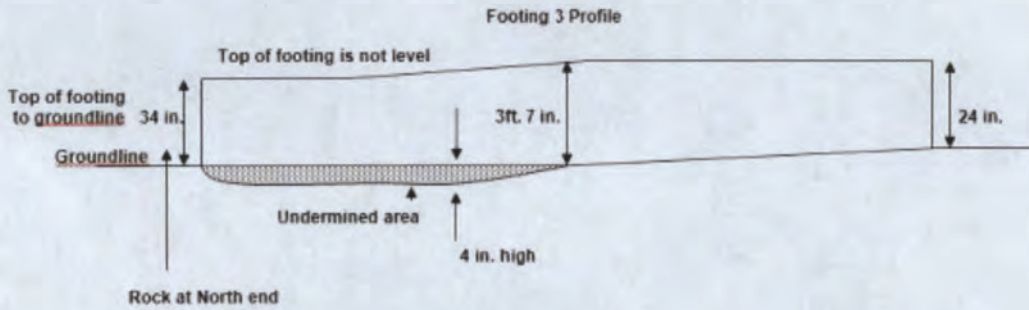
Sketch 1 - Element 220 Re Conc Pile Cap/Ftg

The following was noted by the underwater divers:
Pier 3 Footer: West side, starting at north end, undermined, 7ft. x 4in. x 3ft. 6in. of penetration - NEW. Refer to sketch 1. REPAIR (See deficiency above)

WORK ORDER RECOMMENDATION:
Refer to photo 5.

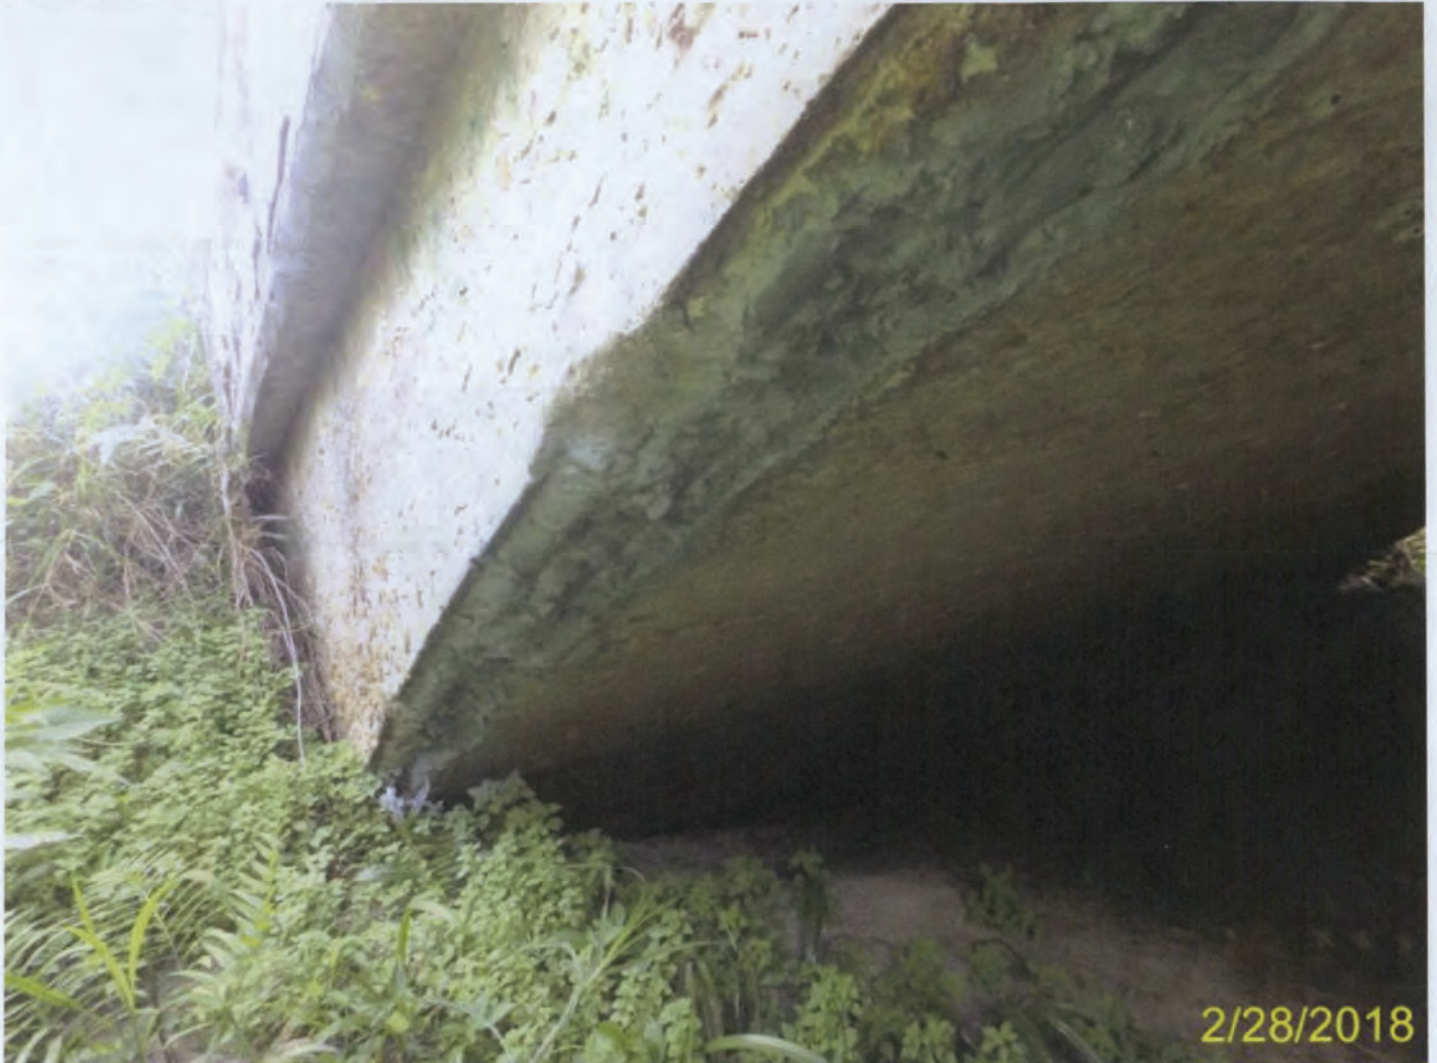
Photo 7 - Element 144 Re Conc Arch

CS3 1080 = Arch 1 right edge, underside and spandrel wall has intermittent spalls up to 10ft. 6in. x 8in. x 1-1/2in. with exposed steel with intermittent area along the outer rib with up to 100% section loss. A light grout coating has been applied; however, the steel is still exposed. The inspector coated the exposed steel with ZRC at the time of inspection. Refer to photo 7. REPAIR (11FT)

Spall with exposed steel sprayed with ZRC in the right edge of Arch 1

REPAIR RECOMMENDATION:
Repair all spalls with exposed steel in the arches.

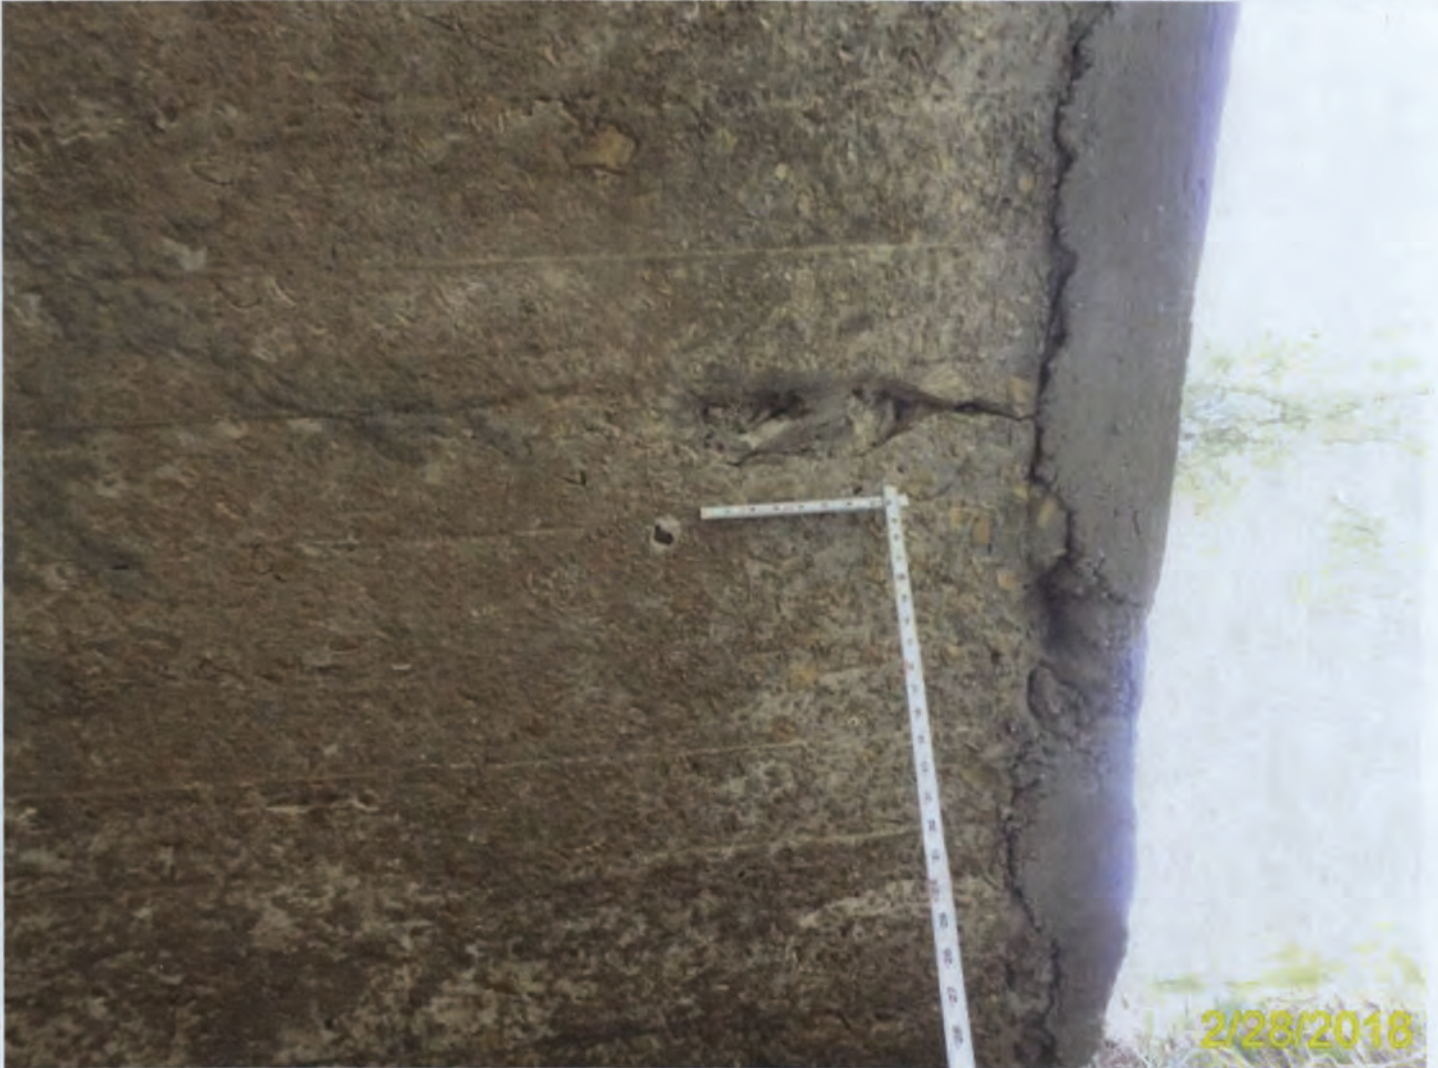
Photo 8 - Element 144 Re Conc Arch

CS3 1130 = Arch 2 left spandrel wall/underside, starting two feet from Pier 2, has a transverse crack, with spalling up to 8in. x 3in. x 2in., extending east 7ft. long x up to 1/2in. wide and an associated 1/16in. wide multi-directional crack, extending to the midpoint of the arch and back towards Pier 2. A light grout coating has been applied to these cracks - INCREASE. Refer to photo 8. REPAIR (7FT)

Spall with associated crack in Arch 2

REPAIR RECOMMENDATION:
Repair spall and crack along the left side of Arch 2.

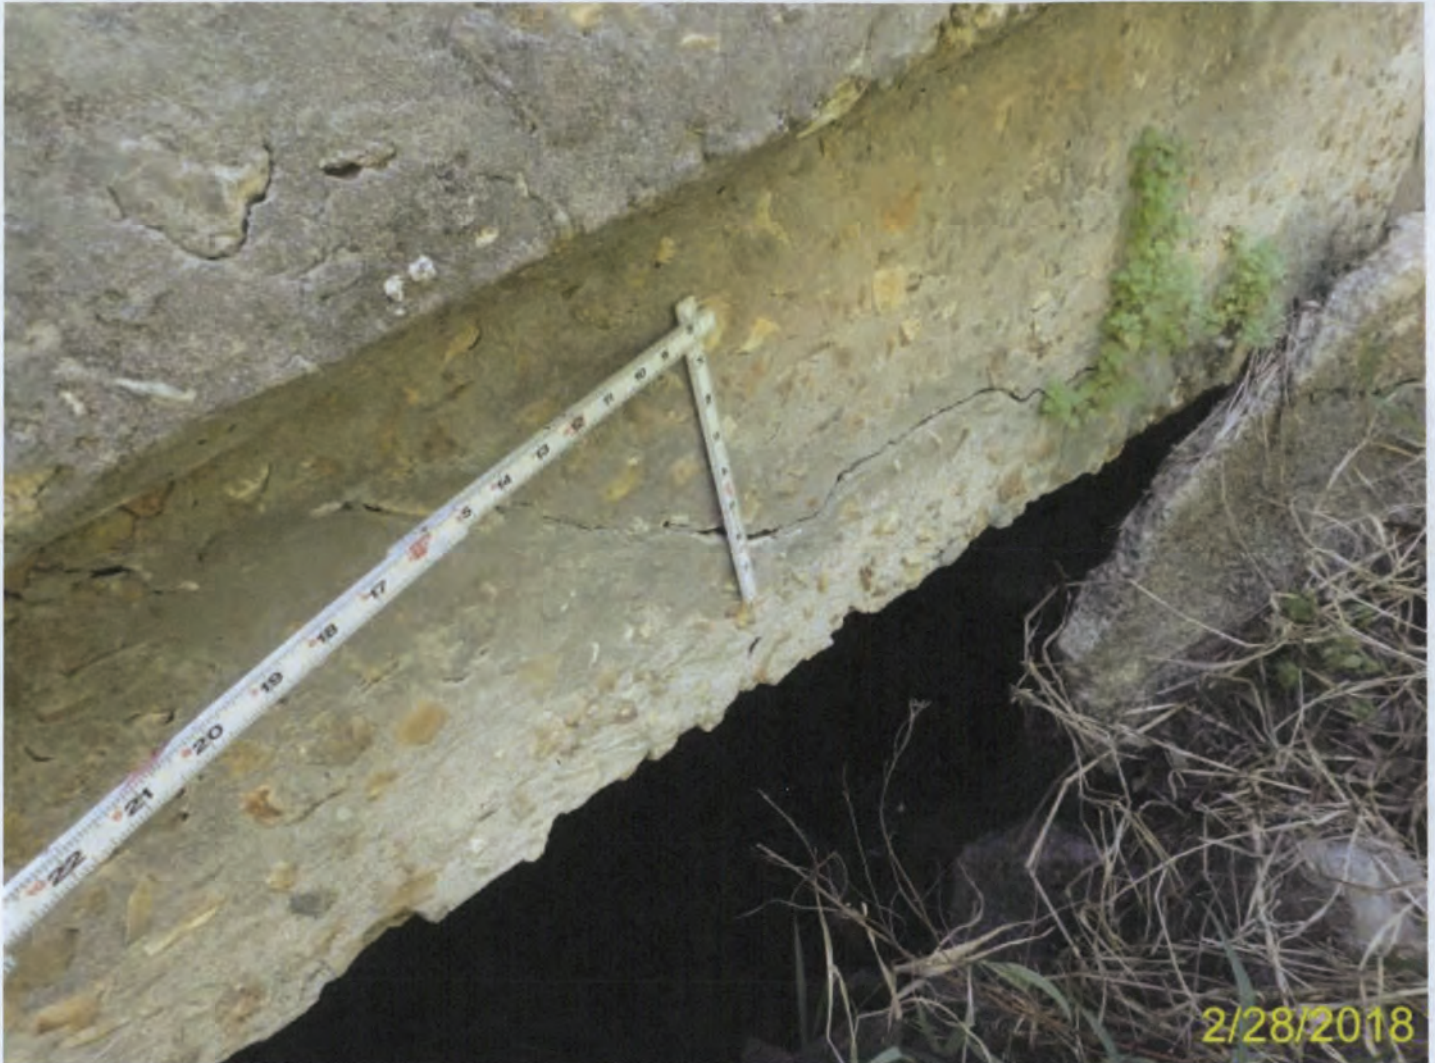
Photo 9 - Element 144 Re Conc Arch

The left arch in Span 3 has a crack up to 1/8in. wide emitting from the above noted spall and extending up to 8ft. in length - NEW. Refer to photo 9. REPAIR

Crack in the left side of Arch 3

REPAIR RECOMMENDATION:
Seal crack in the left side of Arch 3

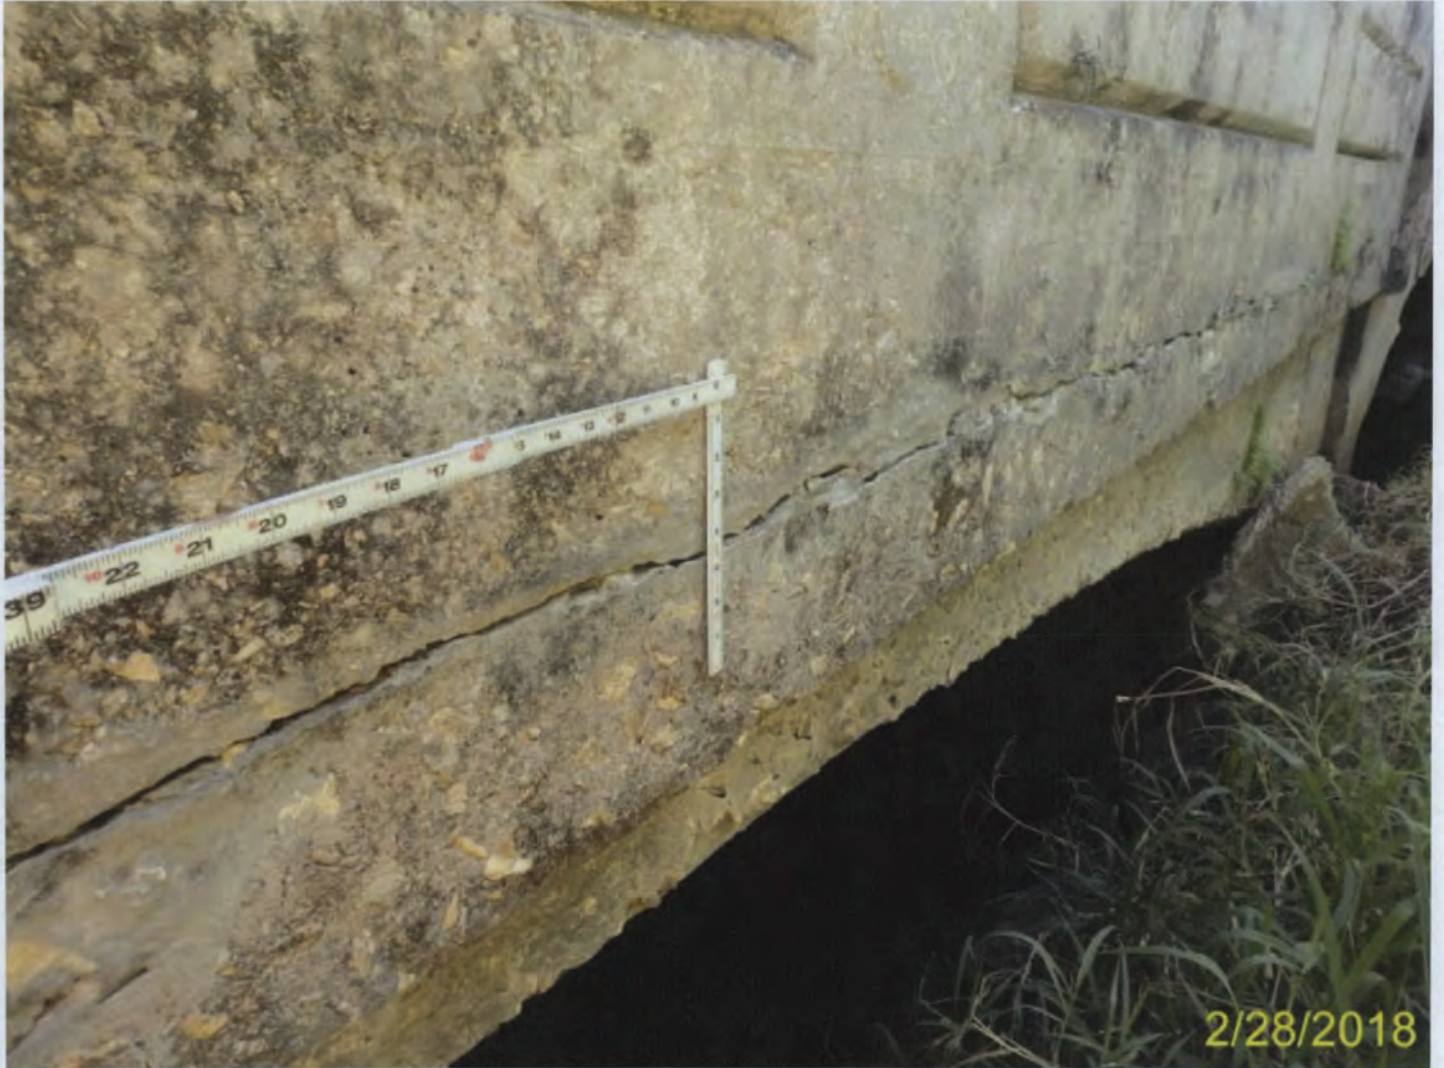
Photo 10 - Element 331 Re Conc Bridge Railing

Crack in the bottom outside left face of Span 3

REPAIR RECOMMENDATION:
Repair crack in bottom outside left face of Span 3.

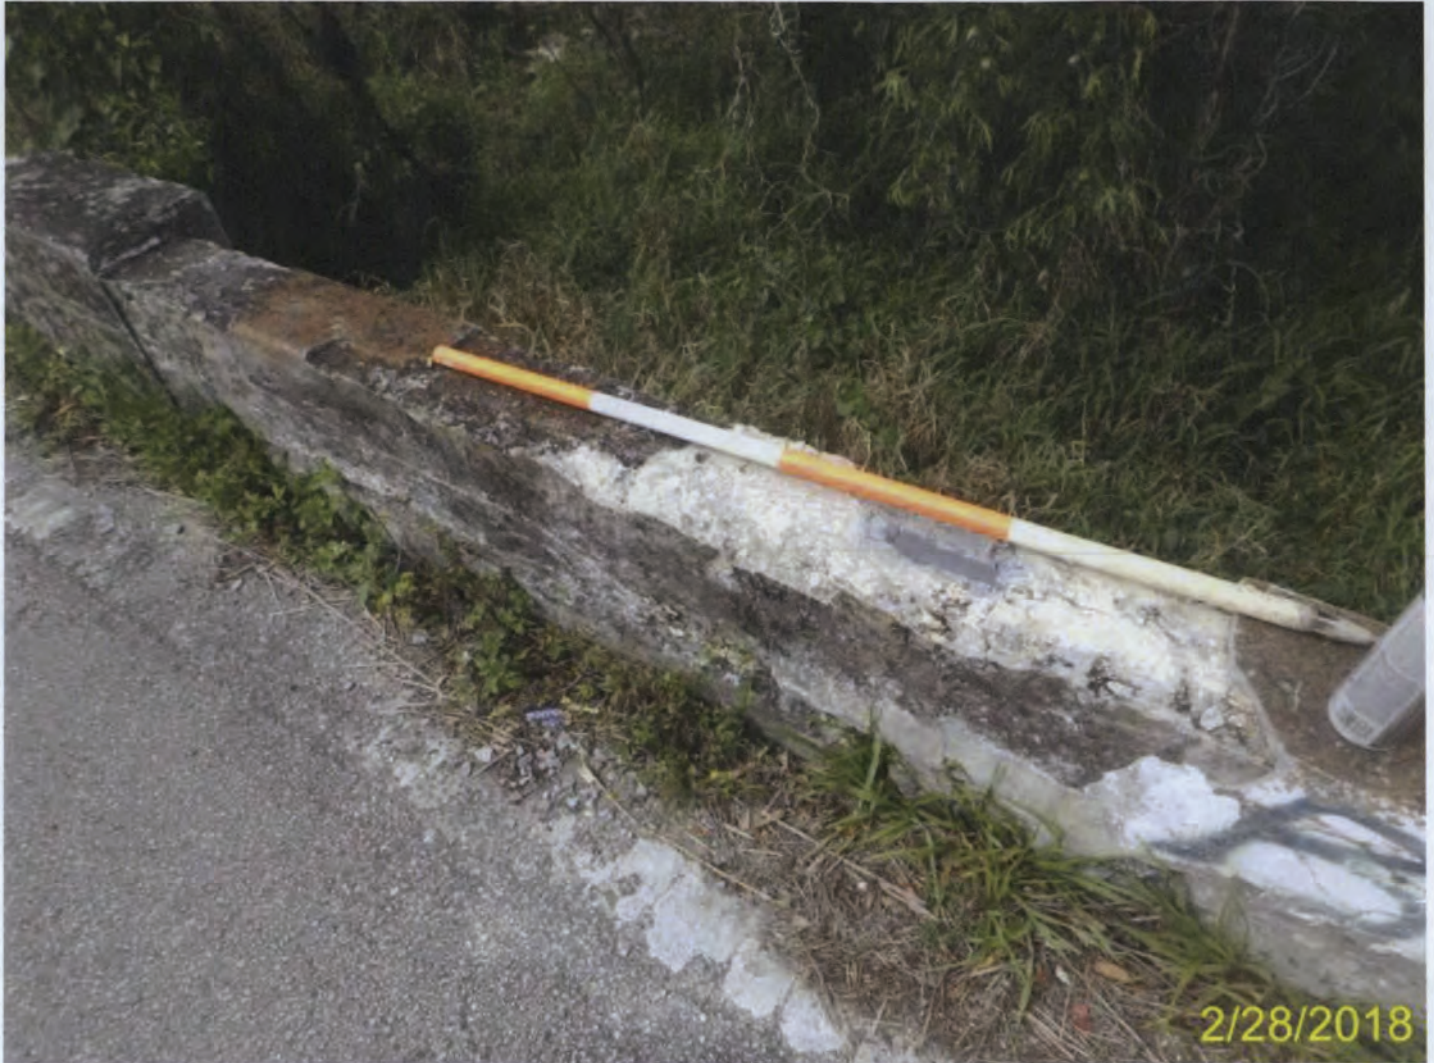
Photo 11 - Element 331 Re Conc Bridge Railing

- 331/3 CS2 1130 = The top face of both bridge rails have intermittent transverse and vertical cracks up to 1/8in. wide intermittently throughout.(50FT)
- CS3 1130 = The bottom outside left face of the arch and bridge rail in Span 3 has a crack up to 10ft. long x 1/4in. wide - NEW. Refer to photo 10. REPAIR (10FT)
- CS3 1080 = Both bridge rails have intermittent spalls/delaminations up to 10ft. x 8in. x 3/4in. with exposed rebar in the top and outside faces throughout. Refer to photo 11. (20FT)
- 1080/3 Refer to Parent Element
- 1130/3 Refer to Parent Element

Typical spall in the top of the bridge rails

REPAIR RECOMMENDATION:
None

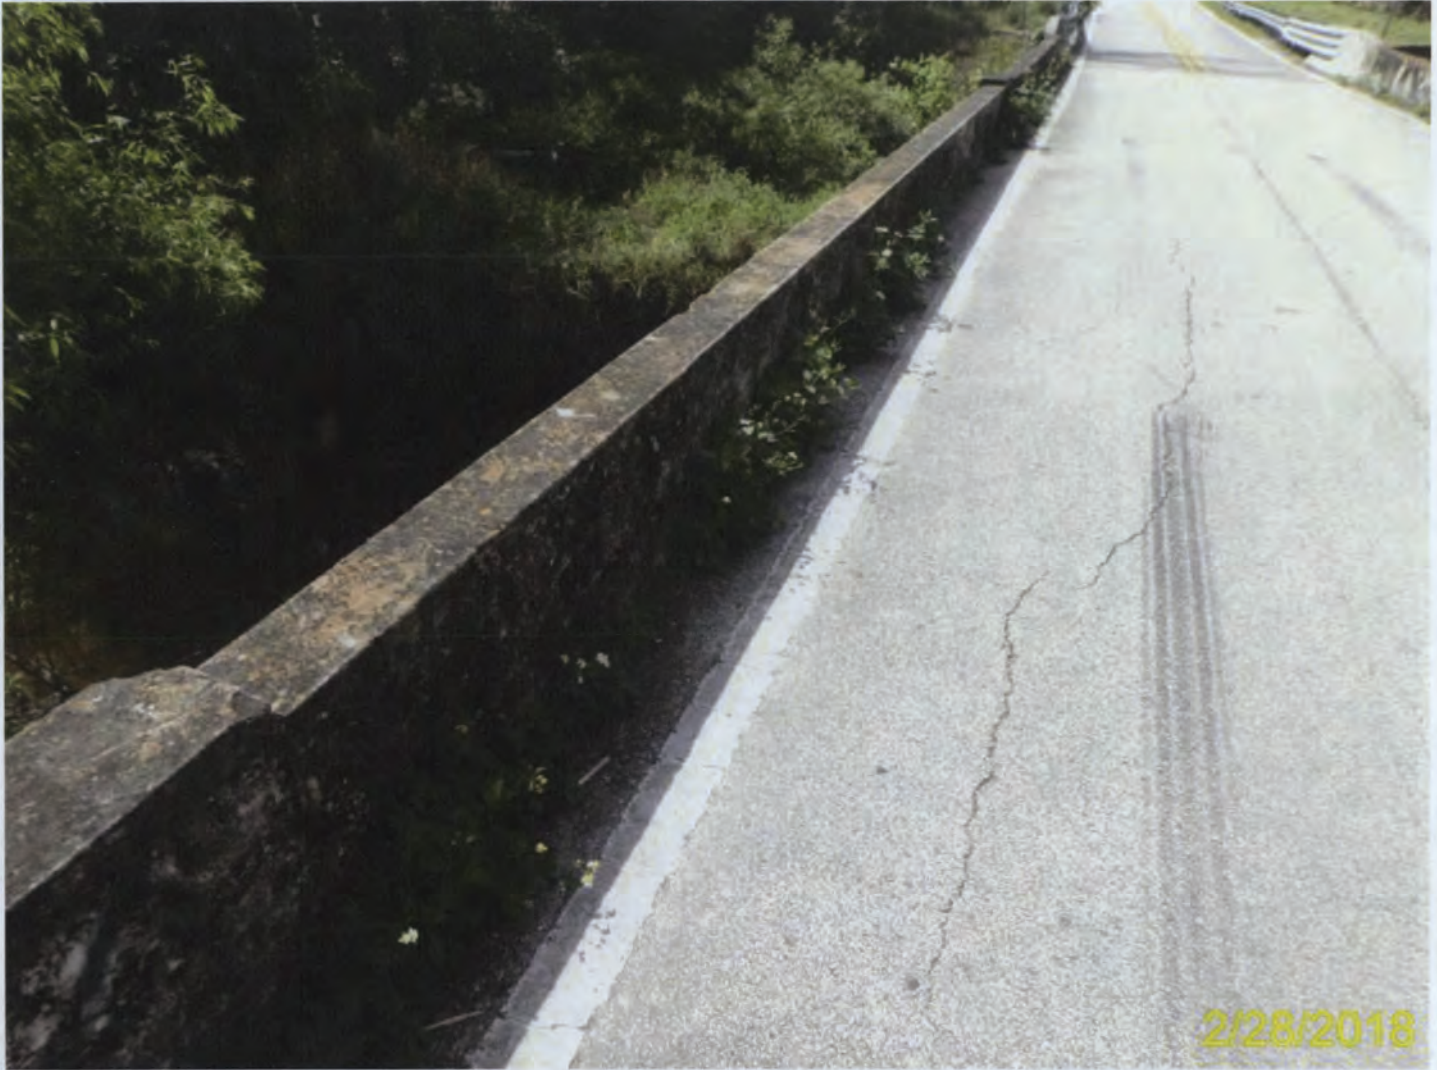
Photo 12 - Inspection Notes

Heavy vegetation on top of structure along barrier

REPAIR RECOMMENDATION:
Remove vegetation on top of structure.

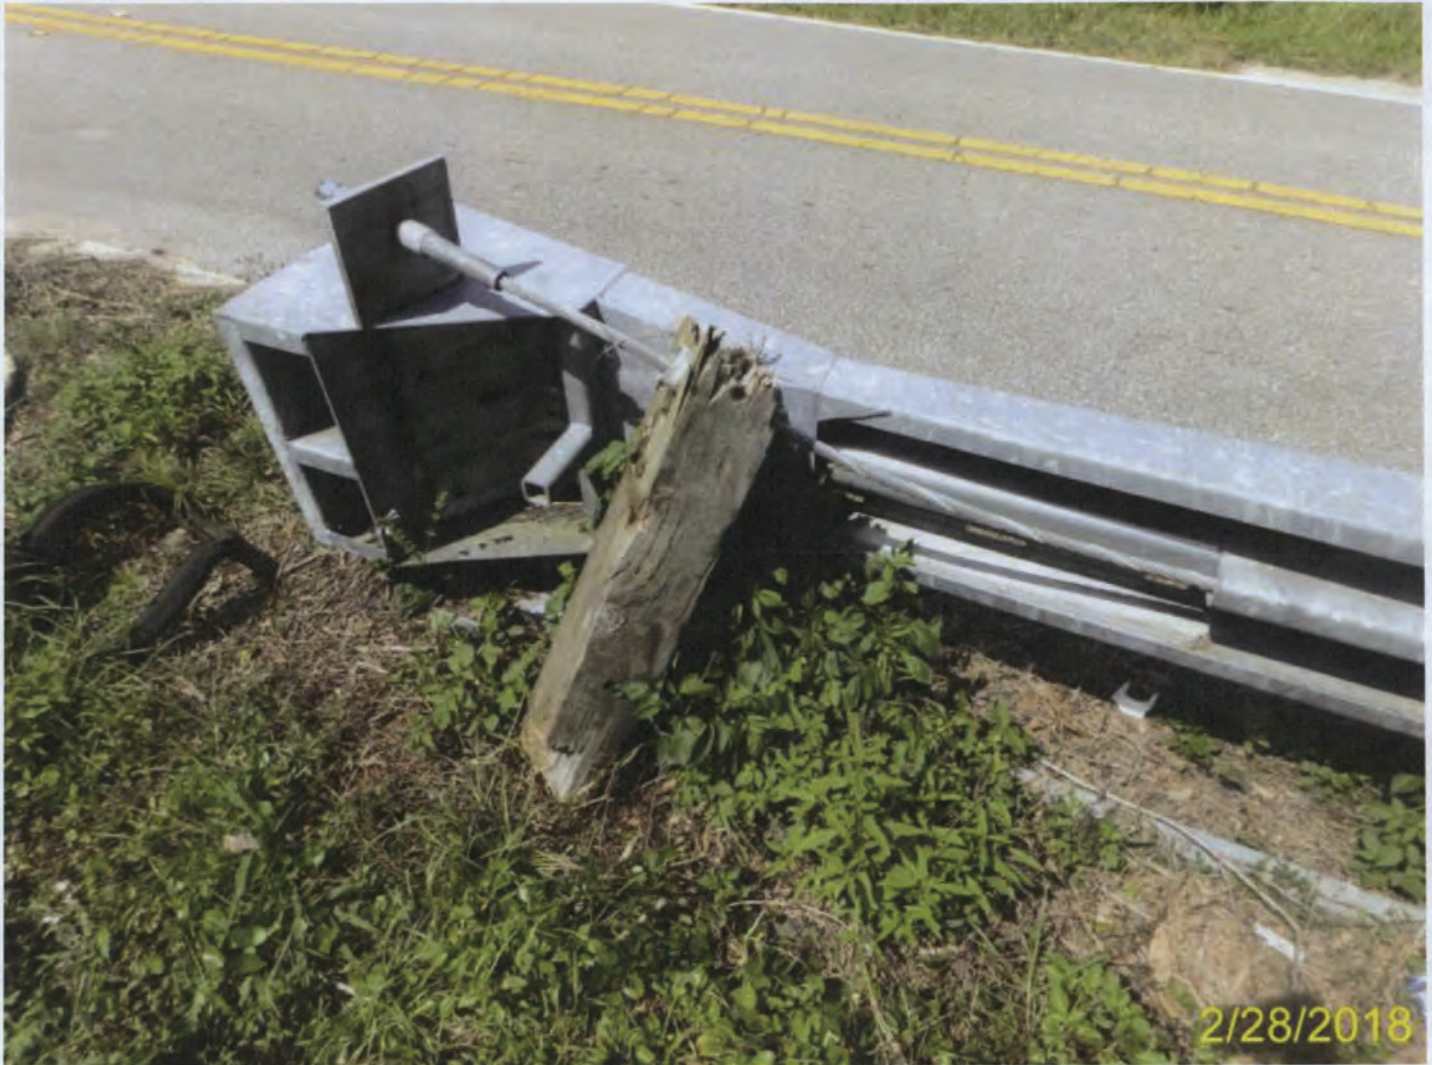
Photo 13 - Inspection Notes

The guardrail end terminal has sustained impact at the southwest corner, resulting in one broken post and damage to a 12ft. panel. Refer to photo 13. REPAIR

Southwest guardrail end terminal damage and broken post

REPAIR RECOMMENDATION:

Repair southwest guardrail end terminal, broken post and damaged 12ft. panel.
