BRIDGE INSPECTION REPORT

PREPARED FOR: FLORIDA DEPARTMENT OF TRANSPORTATION
 BRIDGE OWNER: HARDEE COUNTY

BRIDGE NO. 060034	CONTENTS OF REPORT	INSPECTION DATE: 02/28/2018
BrM Report		U/W Inspection Report
CIDR		* Fracture Critical Data
Scour Elevation (Profile)		* Load Rating Analysis Summary
Addendum (Element Notes & Photos/Sketches)		
*This section is not included in this report.

CR-664 over Little Payne Creek

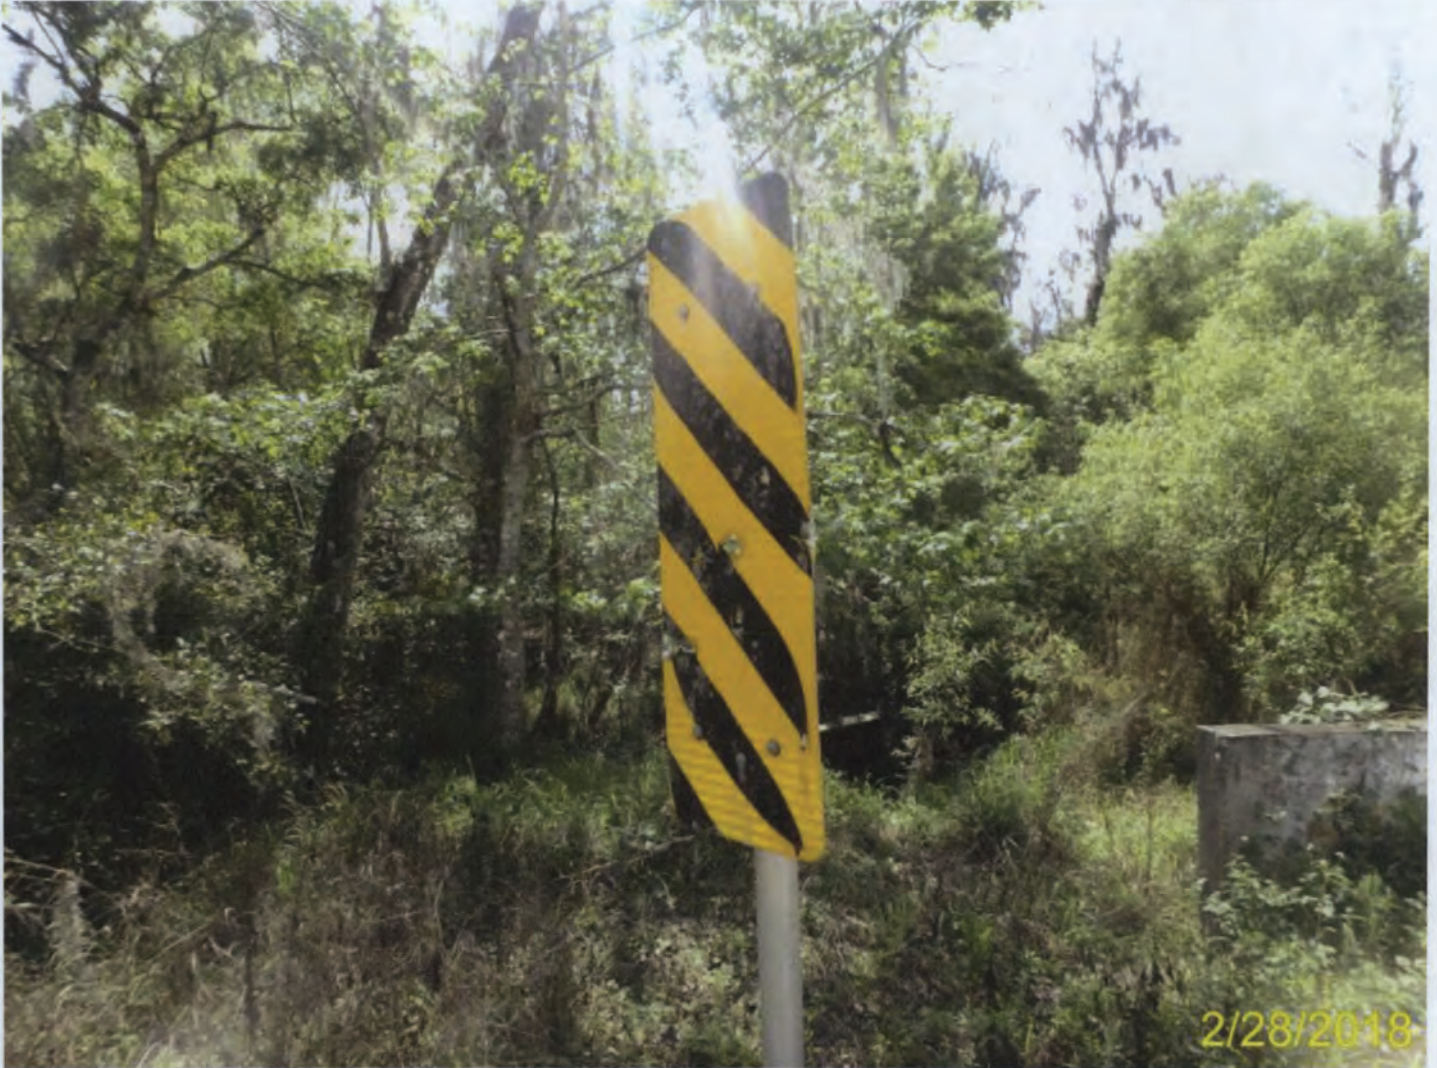
Photo 14 - Inspection Notes

The Type III marker at the northeast, southeast and southwest corners have bullet damage - NEW. Refer to photo 14. REPAIR

Typical bullet damage in object marker (southeast shown)

REPAIR RECOMMENDATION:
Repair the object markers.
