CONTAMINATION TECHNICAL MEMORANDUM FOR MAINLINE AND DRAINAGE SITES

Florida Department of Transportation

Harborview Road PD&E Re-evaluation

Limits of Project: From Melbourne Street to I-75

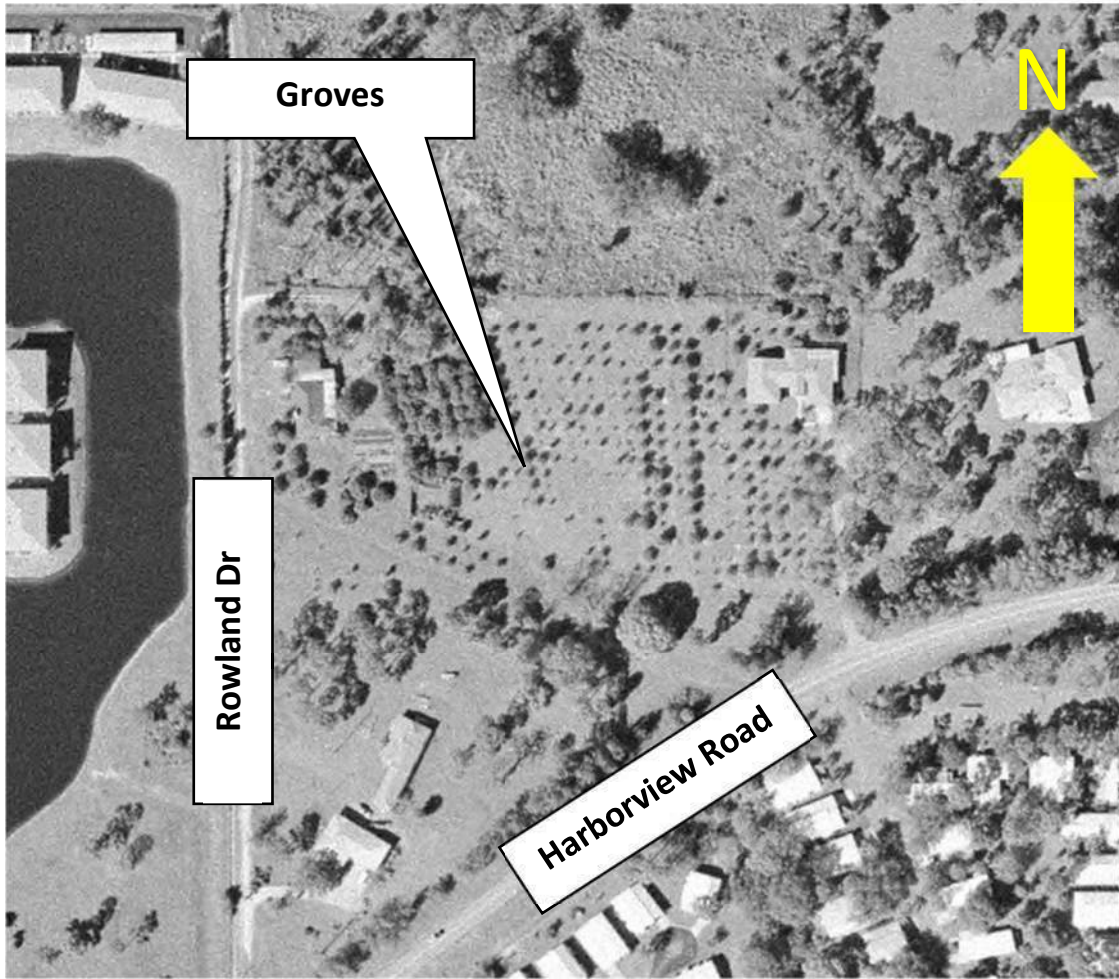
**SITE 7 – FORMER GROVES
1995 AERIAL PHOTOGRAPH**

7	Former Groves	2021 CSER 2023 Re-Evaluation Aerial photographs Site reconnaissance	Adjoining north	Herbicides Pesticides	Medium	This site was first identified in the September 2021 CSER (Ponds) and April 2023 Re-evaluation by aerial photograph review. The 2021 Drainage report assigned a risk rating of Medium due to the existence of former groves within the footprint of Pond 3C (Appendix B) (now called SMF 3). The 2023 Re-evaluation assigned a risk rating of Low due to no evidence of source areas such as structures/pole barns, ASTs, heavy machinery or irrigation pumps found within the study area. During the April 2023 and October 2023 site reconnaissance, this site was observed as a grassy undeveloped field. No regulatory reports were found. During the October 2023 site reconnaissance, this site was observed as a grassy undeveloped field. No contamination concerns were observed. Risk Rating: Given the historical land use as groves adjoining the ROW, the assigned risk rating of Low has been changed to Medium .

- One site (Map ID 7 – Former Groves) is assigned a risk rating of Medium. Level II testing is recommended given the potential for contamination impacts related to the use of pesticides and herbicides. The Former Groves appear to be adjoining north of the Harborview Road mainline and therefore Level II testing is warranted. Laboratory analysis of soil samples may include one or more of the following: arsenic by EPA Method 6010, Organochlorine Pesticides by EPA Method 8081, Organophosphorus Pesticides by EPA Method 8141, and Chlorinated Herbicides by EPA Method 8151. If impacts from this site are identified during Level II testing, Level III support activities such as source removal

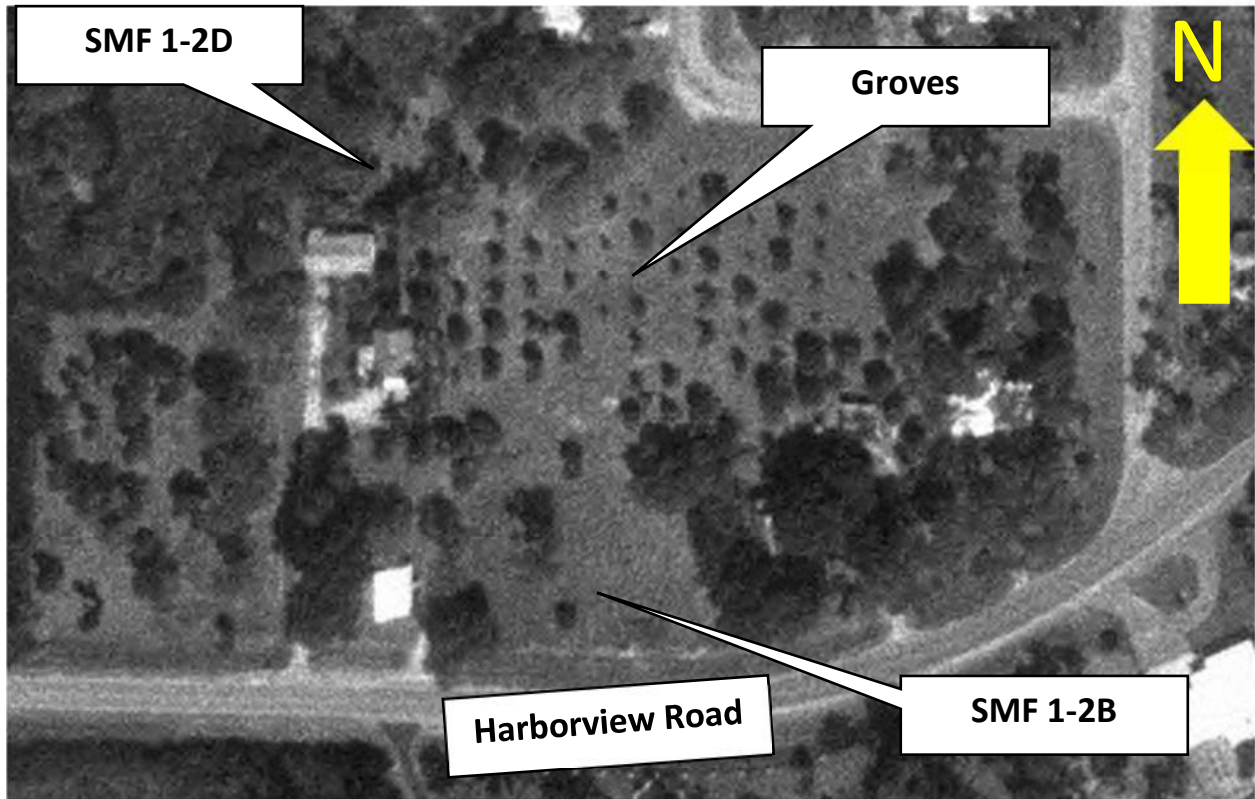
**SITE 10 – FORMER GROVES
1975 AERIAL PHOTOGRAPH**

10	Former Groves	Aerial photographs	200 feet north	Arsenic Herbicides Pesticides	No	This site was depicted 200 feet north of the Harborview Road ROW from 1975 to 1985. The groves appeared abandoned in 1985 and were redeveloped as residences between 1995 and 2005. No regulatory reports were found. Risk Rating: Given the separation distance, this site is assigned a risk rating of No.

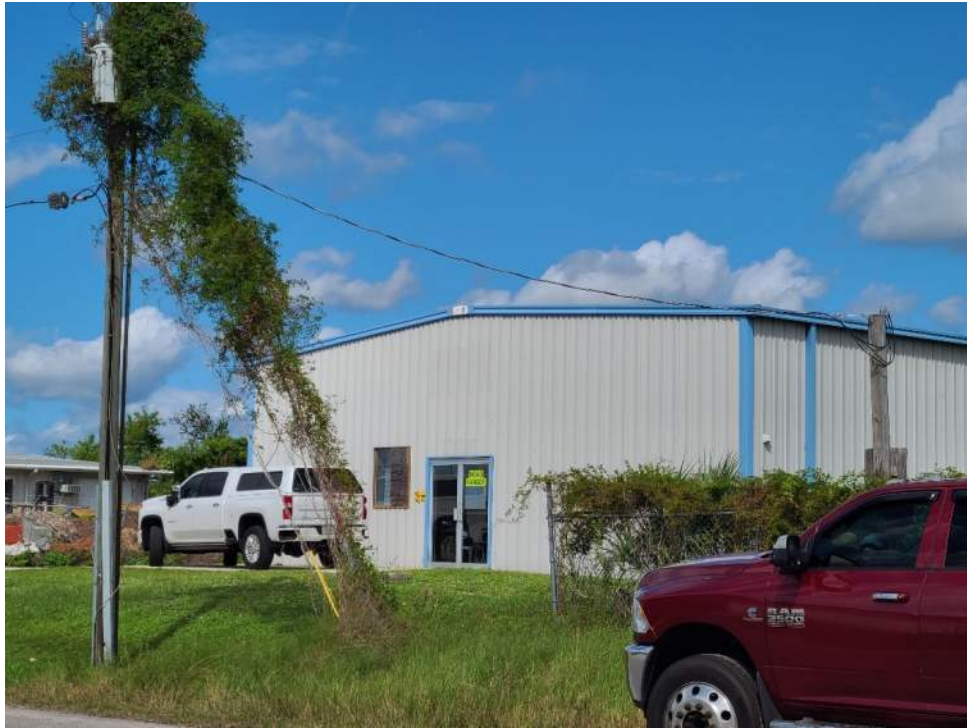
Site 1 – Marketing Arm International
Janice Avenue looking south

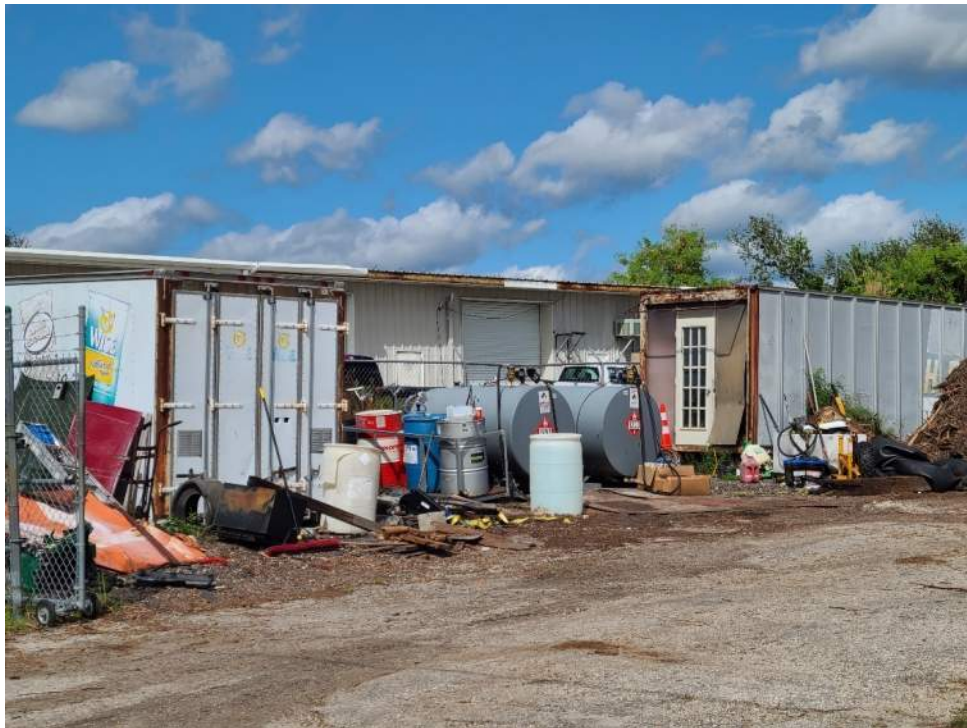
Site 2 – Former Bailey’s Towing
Janice Avenue looking northwest

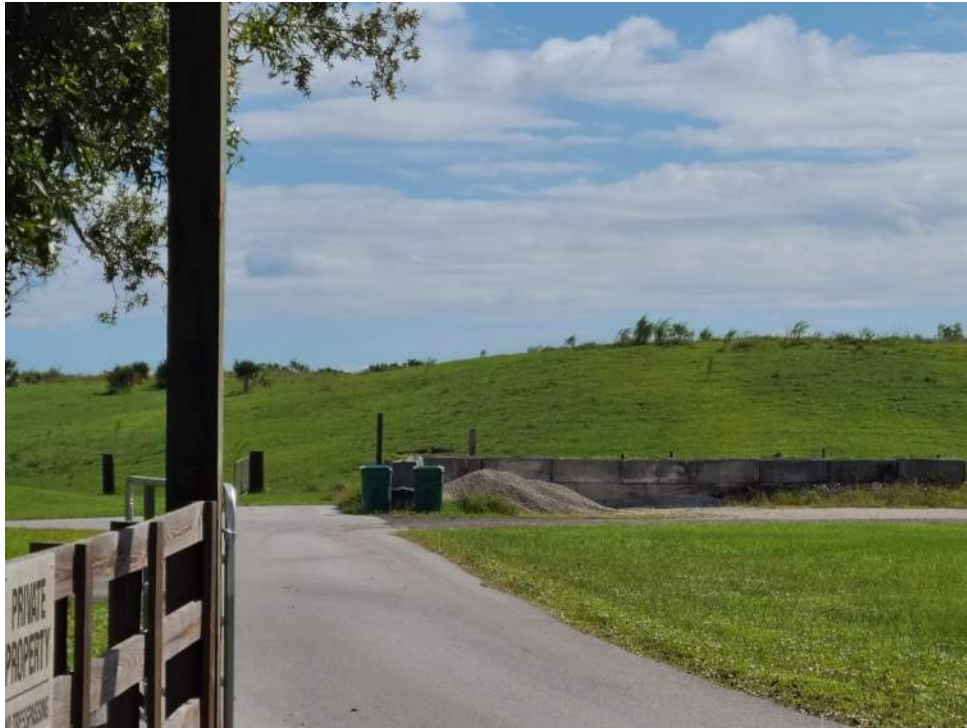
6	Former Raulerson Yard Trash Compost Site Rowland Drive Punta Gorda, FL Facility ID: 72563, 72909	2023 Re-Evaluation MapDirect Aerial photographs Site reconnaissance	570 feet north of Harborview Road ROW	Petroleum Hazardous waste	Low	This site was first identified in the April 2023 Re-evaluation and was assigned a risk rating of Low due to a lack of reported soil or groundwater contamination. This site is located 570 feet north of the Harborview Road ROW and had a petroleum ASTs removed in 1993. During the April 2023 and October 2023 site reconnaissance, this site was observed as a residential home with a few smaller structures used for storage. The area of the former Yard Trash Compost site is a series of medium sized mounds covered with grass and light vegetation approximately 570 feet north of the Harborview Road ROW. No contamination concerns were observed on-site. No subsequent regulatory files were identified since the April 2023 Re-evaluation. Risk Rating: Given a separation distance of 570 feet north, and no reports of hazardous waste or petroleum-related contamination at this facility, this site retains a risk rating of Low.

Site 6 – Former Raulerson Yard Trash Compost Site Rowland Drive looking east

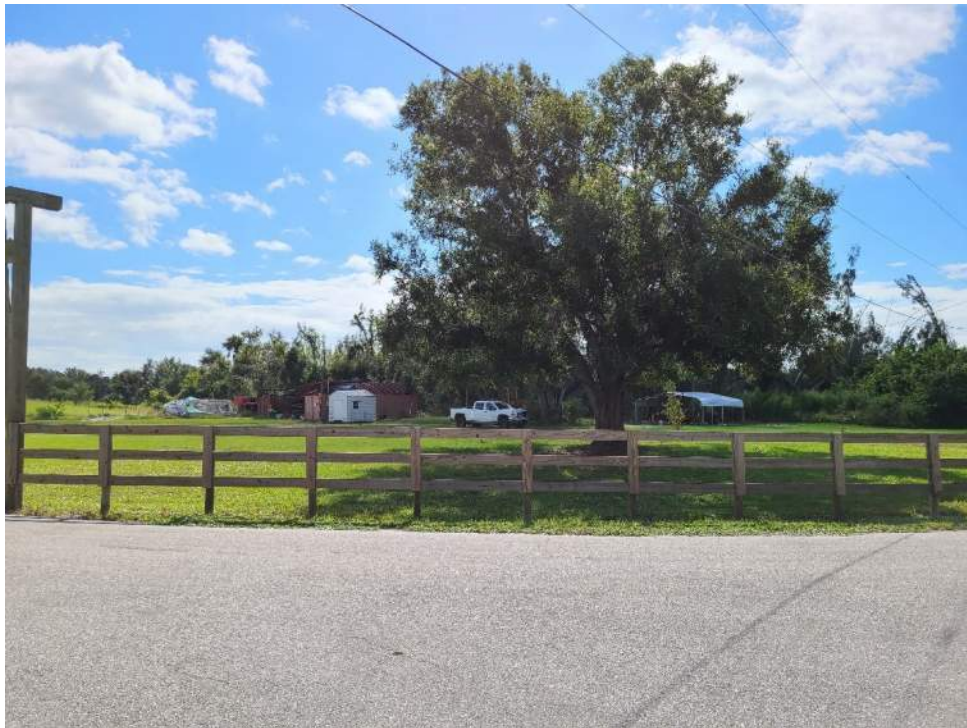
Site 6 – Former Raulerson Yard Trash Compost Site
Rowland Drive looking east

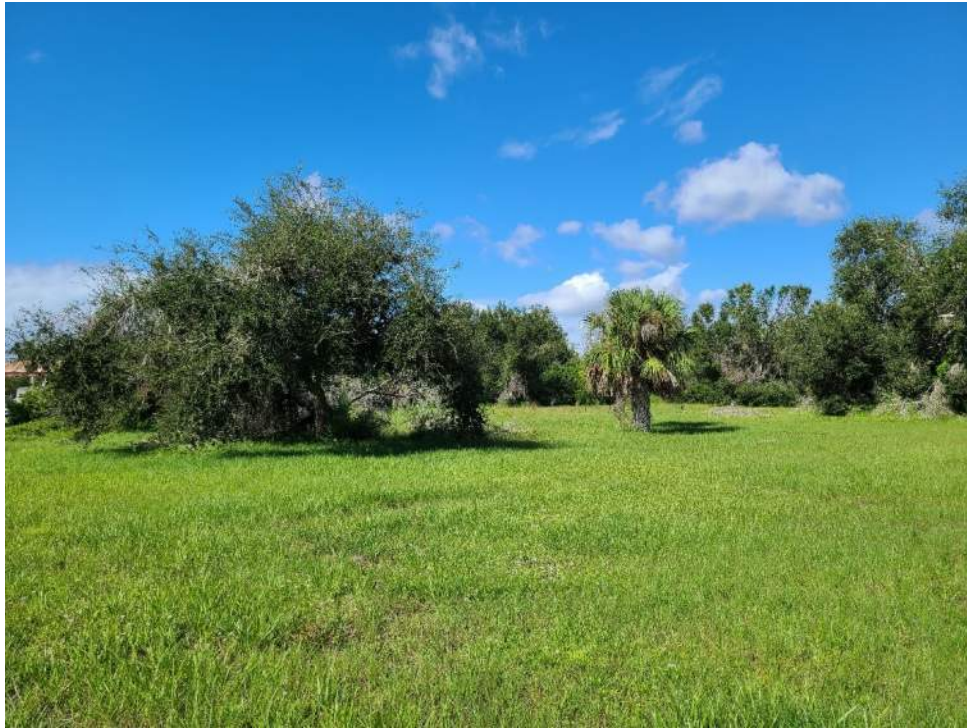
Site 6 – Former Raulerson Yard Trash Compost Site
Area of former AST looking southeast

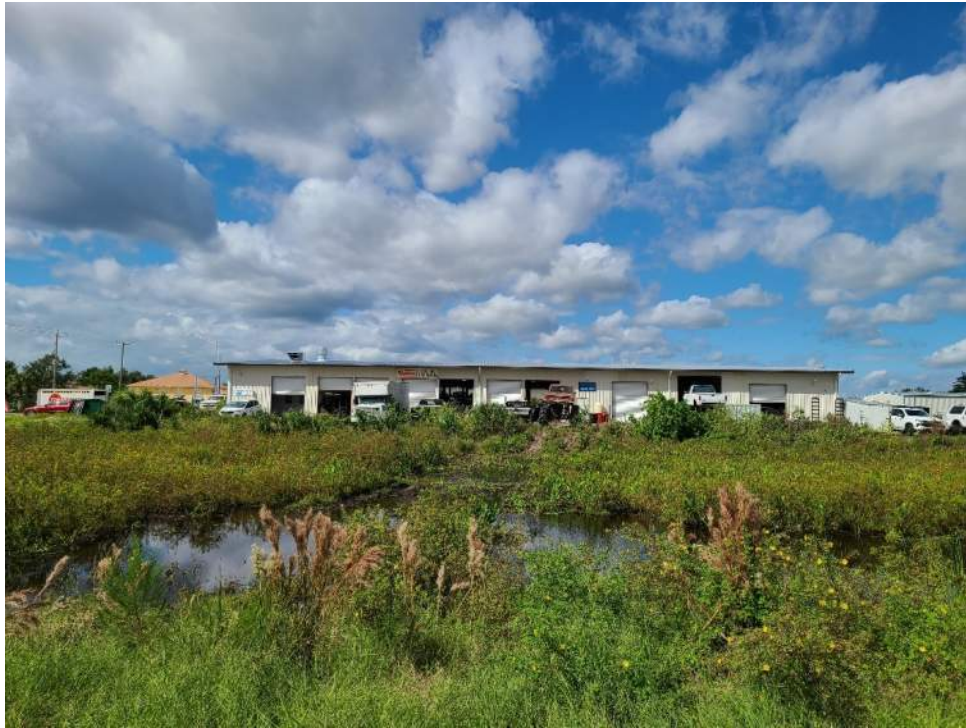
Site 7 – Former Groves
Harborview Road looking west

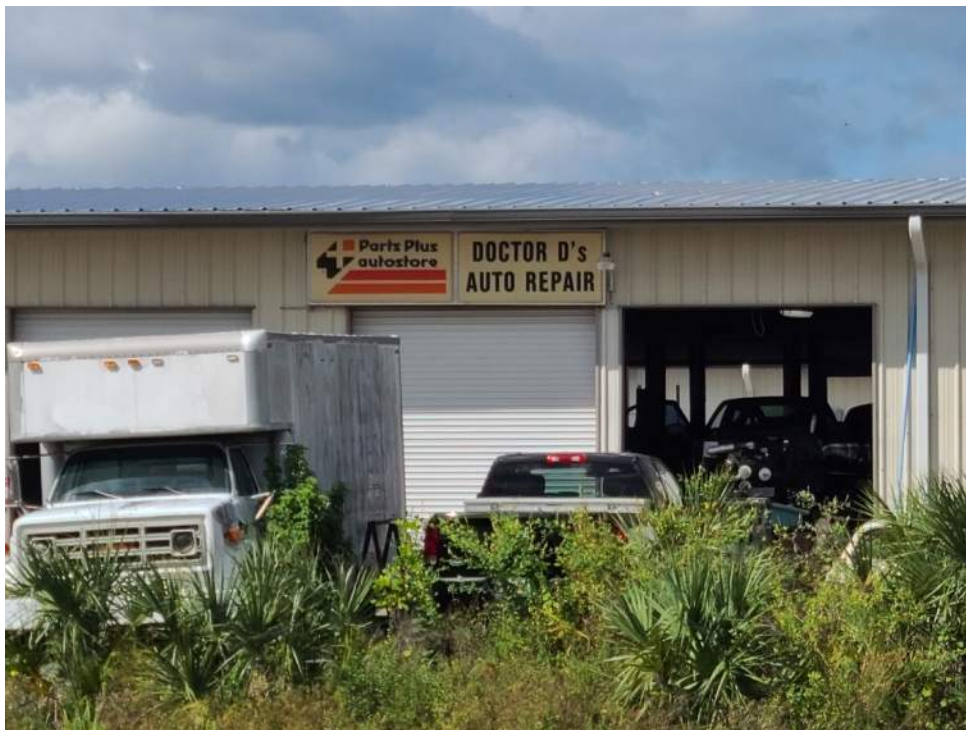
Site 7 – Former Groves
Harborview Road looking south

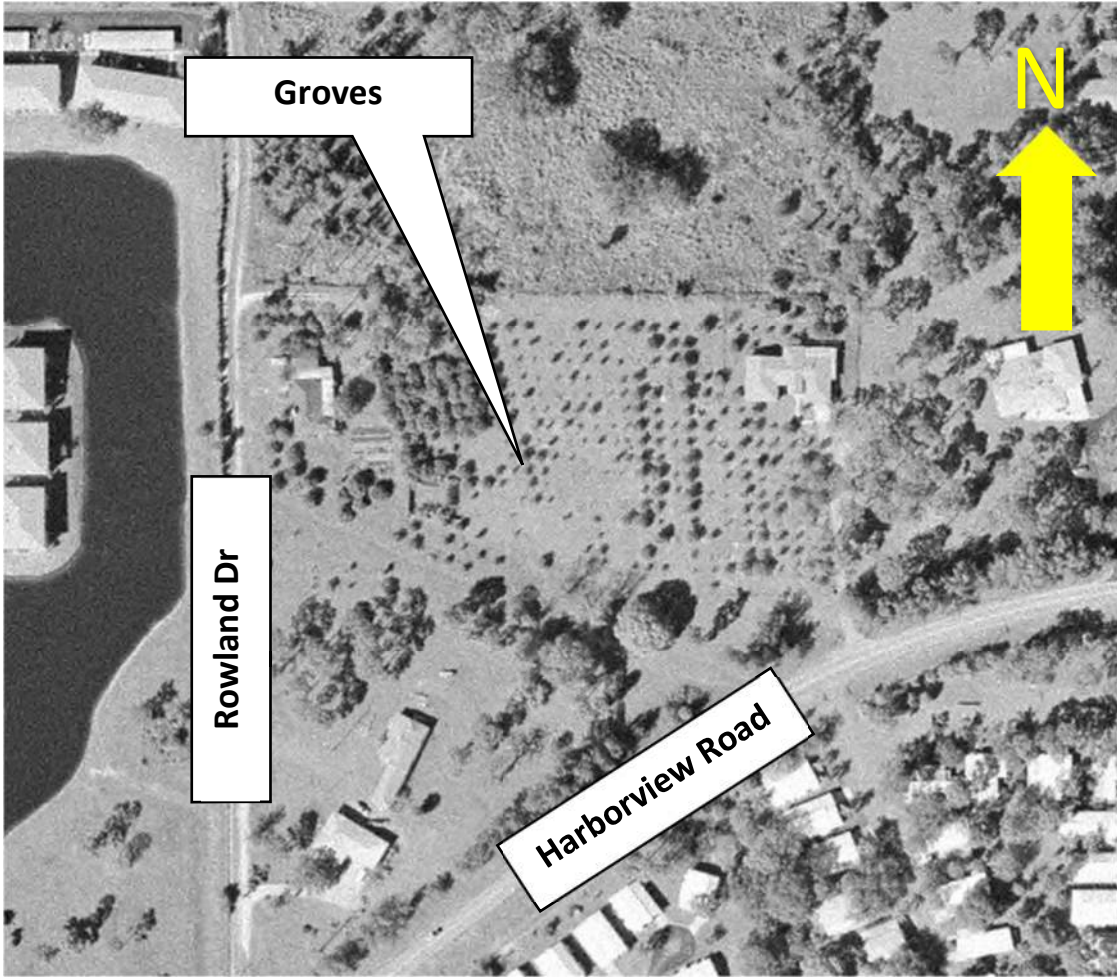
**SITE 7 – FORMER GROVES
1995 AERIAL PHOTOGRAPH**

7*	Former Groves	N/A	Low	This site was not previously identified in the PD&E CSER dated October 2018. Review of the FDOT's aerial photographs from 1975 to 1995 (Appendix D) depict groves adjoining the ROW. The location of the former groves was interpreted from the historical aerial photographs and estimated on Sheet No. 1 (Appendix A). Groves were not identified in the regulatory report since they are not regulated. Although grove cultivation in itself does not confirm the presence of contamination, many of the activities associated with grove cultivation can result in hazardous materials or petroleum product contamination of the soil and/or groundwater. These activities include vehicle/equipment maintenance and fueling, pesticide, herbicide and fertilizer formulation and application, and freeze prevention via grove heaters. The maintenance of grove vehicles including tractors, harvesting equipment, pesticide sprayers, and motors used in the groves for pumping water or powering grove blowers was commonly performed near a central barn or storage area. In times prior to the current level of environmental awareness, the maintenance of equipment commonly involved draining oil, transmission fluid, or fuel directly onto the ground. No mix/load areas, diesel powered irrigation pumps, central grove barns, or storage areas were observed on-site or during historical aerial review. During the site reconnaissance, this site was observed as a grassy field. This site was assigned a risk rating of Low.

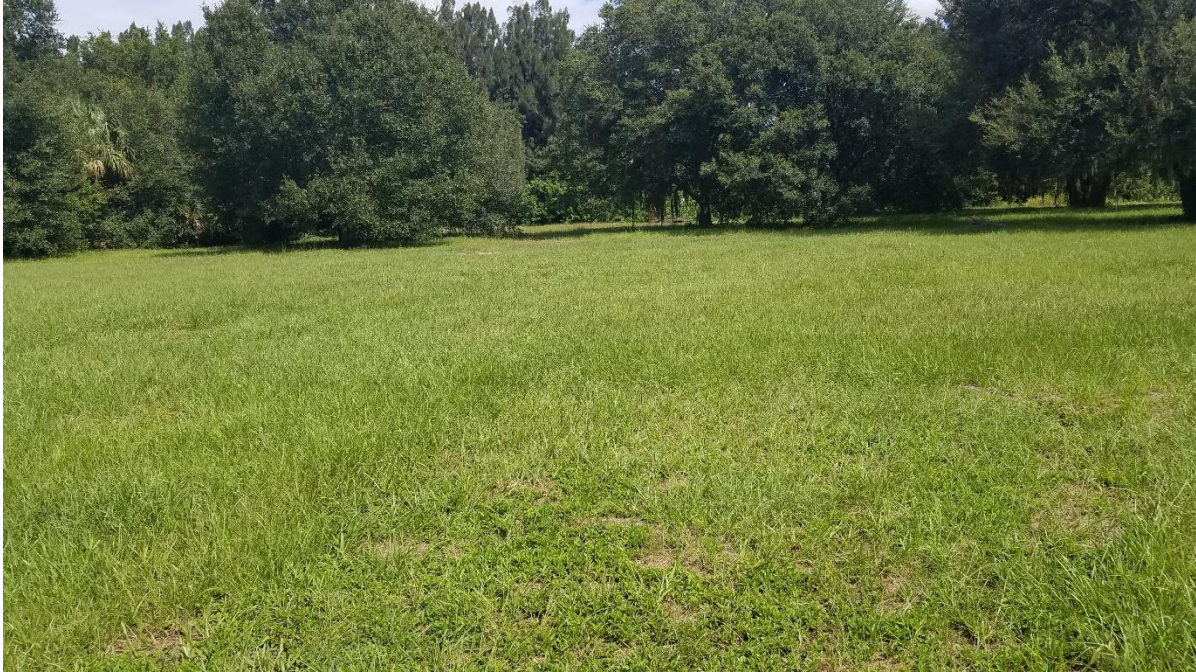
SMF 3	Herbicides Pesticides Petroleum Solid Waste	Medium	<p>This drainage site was first identified in the September 2021 CSER (Drainage) as Pond 3C and was assigned a risk rating of Medium due to the former groves located within this drainage site from 1975 to 2005. Aerial photographs (Appendix B) depict this site as an open field from 2022 to 2023. No likely sources of concentrated contamination concerns such as pole barns, irrigation pumps, or machinery were observed during aerial photograph review. During the September 2021 and October 2023 site reconnaissance, this drainage site was observed as an open field. No regulatory information was identified.</p> <p>One contamination site identified as MAP ID 7 – Former Groves is located within SMF 3. Contamination impacts regarding Map ID 7 are anticipated.</p> <p>The nearest offsite contamination concern is Map ID 6 - Former Raulerson Yard Trash Compost Site, Rowland Drive Punta Gorda (Facility ID: 72563, 72909), located 450 feet north of SMF 3. This site was first identified in the September 2021 CSER (Drainage), and the April 2023 Re-evaluation. No subsequent regulatory files were found after the April 2023 Re-evaluation. Contamination impacts are not anticipated.</p> <p>Risk Rating: Given the historic land use of groves within SMF 3, this site retains a risk rating of Medium.</p>

Pond 3C: west-central area looking north

- One drainage site identified as SMF 3 is assigned a risk rating of Medium. Level II testing is recommended given the potential for contamination impacts related to the use of pesticides and herbicides. The Former Groves appear to be within and adjoining the SMF 3 drainage site footprint and therefore Level II testing is warranted. Laboratory analysis of soil samples may include one or more of the following: arsenic by EPA Method 6010, Organochlorine Pesticides by EPA Method 8081, Organophosphorus Pesticides by EPA Method 8141, and Chlorinated Herbicides by EPA Method 8151. If impacts from this site are identified during Level II testing, Level III support activities such as source removal and/or dewatering may be required during construction. Level II testing costs are estimated at \$2,000 to \$10,000 per site.
