CULTURAL RESOURCE ASSESSMENT REVIEW

Florida Department of Transportation

Harborview Road PD&E Re-evaluation

Limits of Project: From Melbourne Street to I-75

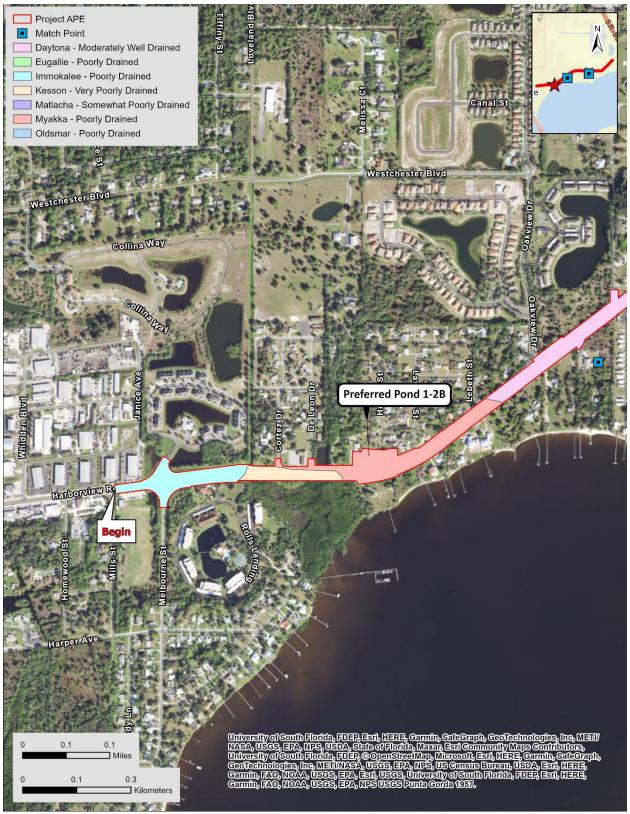
Figure 2. Soil types within the Harborview Road (CR 776) corridor and preferred pond site(s).

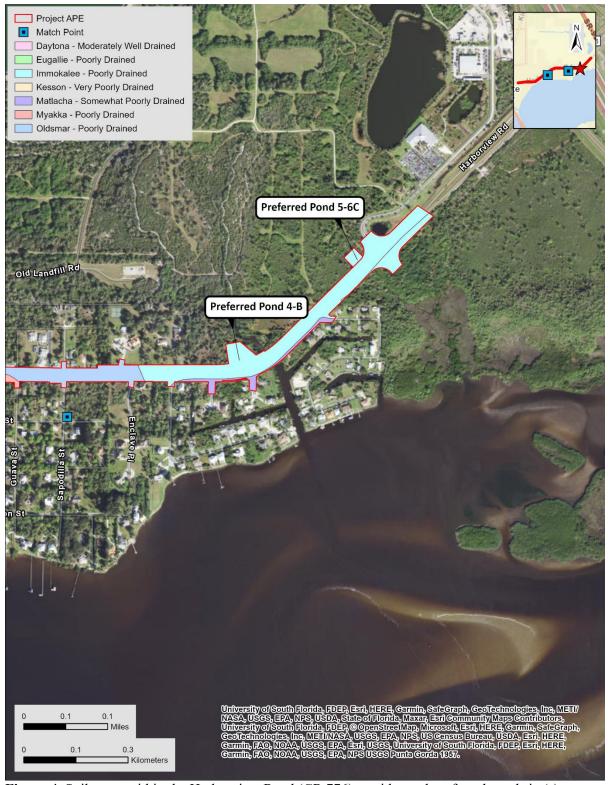
Figure 4. Soil types within the Harborview Road (CR 776) corridor and preferred pond site(s).

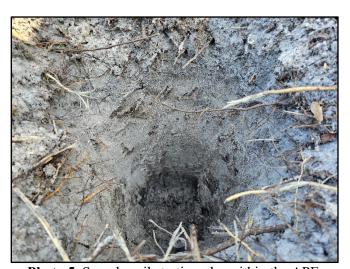
Photo 5. Sample soil stratigraphy within the APE.

Archaeological: Field survey resulted in a visual reconnaissance and the excavation of a total 97 shovel tests; this includes 58 from the 2017 survey and 12 from the 2022 survey. The distribution of the shovel test pits is shown on Figures 10 - 12. The 30 current shovel tests were placed judgmentally, and most were dug to 100 cm unless impeded by fill. All soil removed from each t was screened through a 6.4 mm mesh hardware cloth to maximize the recovery of artifacts. The locations of all shovel tests were recorded with Trimble Juno 5D Series/Terrasync mobile mapping application and following the recording of relevant data such as stratigraphic profile, all shovel tests were refilled. A reasonable and good faith effort was made per the regulations laid out in 36 CFR § 800.4(b)(1) (Advisory Council on Historic Preservation n.d.) to survey all areas of the project APE. General soil stratigraphy consisted of 0-20 cm below surface (bs) of gray sand; 20-80 cmbs of light gray sand; and 80-100 cmbs of dark brown sand (Photo 5).

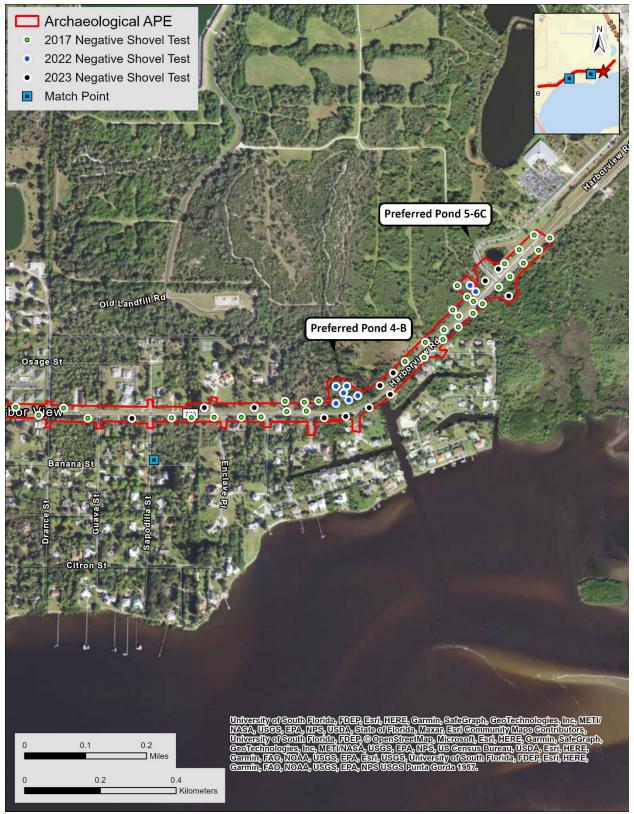
Figure 12. Location of shovel tests within the Archaeological APE.

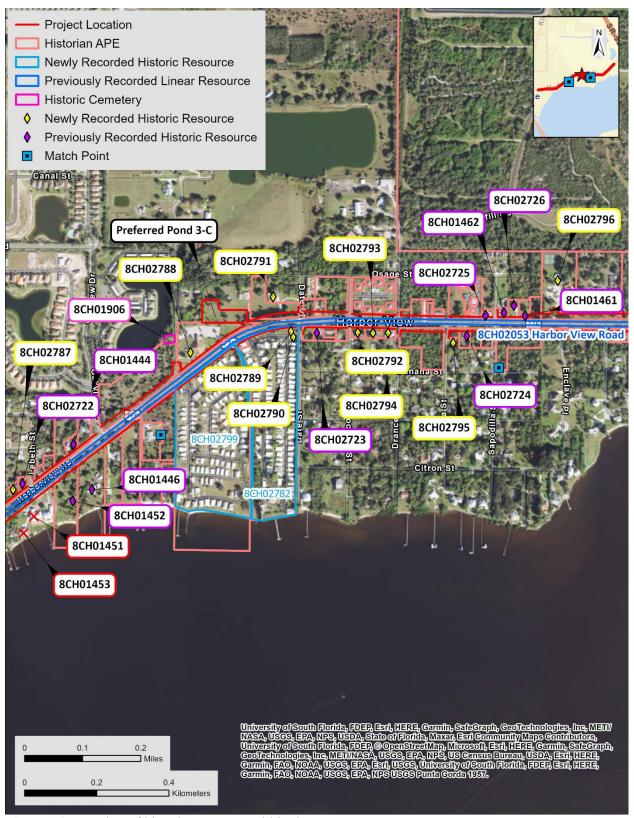
Figure 14. Location of historic resources within the APE.

8CH02782: The Mary Lu Mobile Home Park is a building complex resource group located at 24437 Harborview Road in Section 30 of Township 40 South, Range 23 East (USGS 1957). The Mary Lu Mobile Home Park is a post-World War II era trailer park that was established in ca. 1971 (Figure 14). Within the boundaries of the resource group, as contained within the APE, there are two contributing resources. These include two representative mobile homes constructed in ca. 1971 (8CH02789 and 8CH02790). There are approximately 105 additional non-contributing resources within the mobile home park. It was beyond the scope of work for this CRAS to identify all resources within the entire resource group, and only representative mobile homes or permanent structures within the APE visible from the rightof-way were evaluated. The Mary Lu Mobile Home Park is comprised of two main north-south streets which meet to the south and one east-west street to the north. The resource group is bounded roughly by Harborview Road to the north, Date Street to the east, an unnamed creek to the west, and the Peace River to the south and located within Charlotte County parcel # 402330281001 (Polk 2023). The mobile homes are predominantly oriented east-west with the shortest end of the mobile home facing the street. Most appear to have an attached carport with a concrete driveway. An analysis of historic aerial imagery reveals that the Mary Lu Mobile Home Park, which was opened in ca. 1971, was well established and had reached its current configuration by ca. 1974 (USDA 1974).

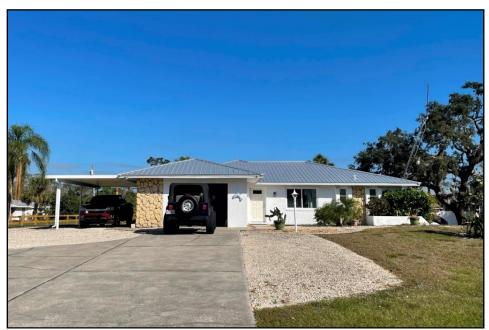
Photo 6. Masonry Vernacular style building (8CH02784) located at 24108 Harborview Road, looking north.

Masonry Vernacular: A total of 18 historic resources (8CH01444, 8CH01454, 8CH01455, 8CH01462, 8CH02741, 8CH02742, 8CH02783, 8CH02784, 8CH02785, 8CH02788, 8CH02791 – 8CH02798) within the APE are of the Masonry Vernacular style (Photos 6 and 7). All of these resources were constructed as single-family residences and have construction dates that range from ca. 1950 to ca. 1976. Three of the former residences have been converted to other uses including a parsonage for an adjacent church (8CH02788), a retirement home (8CH02791), and community/classroom building for an adjacent mosque (8CH02796). Masonry Vernacular style buildings reflect the local customs, environment, and building materials, and do not rely on academic architectural vocabulary for their design and ornament. Within the APE, the resources generally have a continuous concrete block foundation and concrete block walls that have been painted or covered in stucco. The windows are typically metal or vinyl single-hung sash or sliding units. Roof types commonly consist of hip or gable roofs, and most are clad with composition shingles. Most display replacement windows and roofs, fenestration changes, and additions.

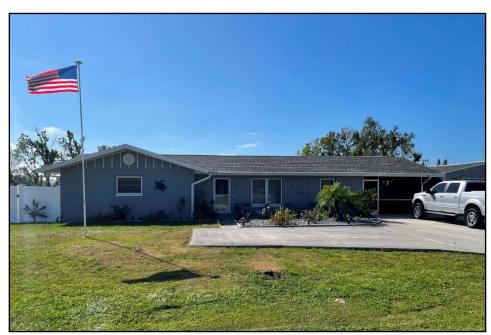
Photo 7. Masonry Vernacular style building (8CH02793) located at 24541 Harborview Road, looking south.

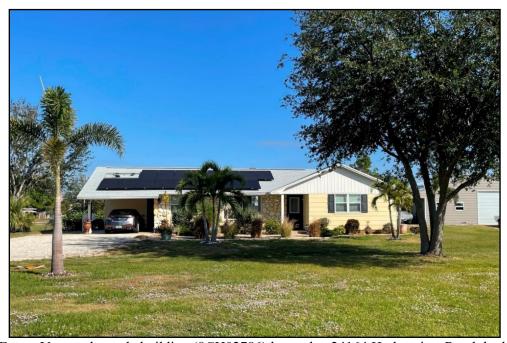
Photo 8. Frame Vernacular style building (8CH02786) located at 24164 Harborview Road, looking north.

Frame Vernacular: Six historic resources (8CH01338, 8CH01446, 8CH01452, 8CH01456, 8CH02786 and 8CH02787) within the APE are of the Frame Vernacular style (**Photo 8**) and were constructed between ca. 1930 and 1973. Frame Vernacular style buildings are simple structures built with available local materials and boasting little ornamentation (McAlester 2013). They are often built by developers, contractors, master carpenters, or the building's occupants. These buildings are decidedly practical structures. Within the APE, this building type has continuous concrete block and concrete slab foundations with wood frame structural systems. Roof types include an intersecting gable with a shed roof with composition shingles and a hip roof with a gable roof and hip roof extension additions. The exteriors of the buildings are clad in various siding, including stucco, cement mineral fiber boards, vinyl, stone, and artificial masonry veneer. The windows include vinyl single-hung sash and fixed units. Exterior ornamentation is minimal and includes shutters, stone accents, and exposed beams. The resources display alterations and additions, such as replacement roofing, siding, and windows, as well as large additions (8CH02787).

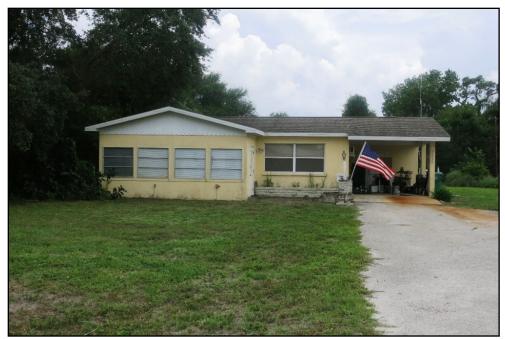
Photo 9. Ranch style building (8CH02724) located at 25059 Harborview Road, looking south.

Ranch: Five historic resources (8CH02722, 8CH02723, 8CH02724, 8CH02725, and 8CH02727) within the APE are of the Ranch style (**Photo 9**) and were constructed between ca. 1958 and 1961. These are all residential buildings. The style, which gained popularity after World War II, features low-slung buildings and a low-pitched roof with large windows (McAlester and McAlester 2013). Within the APE, this building type has concrete slab foundations with gable or cross-gabled roofs clad with composition shingles. The majority of these buildings are clad in stucco. Fenestration typically includes awning and single-hung sash windows. Exterior ornamentation is minimal, and typically consists of gable vents and extended eaves with boxed rafters. Most display alterations or additions, such as replacement roofs and windows and living-space additions. In 2018, these five resources were determined ineligible for listing in the NRHP.

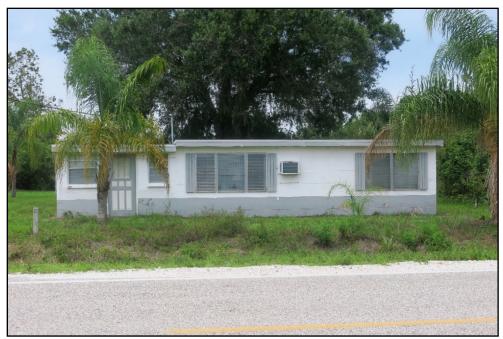
Photo 10. Contemporary style building (8CH01461) located at 25118 Harborview Road, looking north.

Contemporary: Two historic resources (8CH01461 and 8CH02726) within the APE are of the Contemporary style (**Photo 10**) and were constructed in ca. 1956 and 1961. The style, which gained popularity in the 1950s, features flat roofs with wide overhanging eaves or low-pitched roofs, and the building is often clad with contrasting materials and textures (McAlester 2013). Within the APE, this building type has a continuous slab foundation and flat or cross-gabled roofs. The exteriors are clad in concrete block or brick. Window units include jalousie, single-hung sash, and metal awning. The example displays alterations, such as replacement roofing. In 2018, both of these resources were determined ineligible for listing in the NRHP.

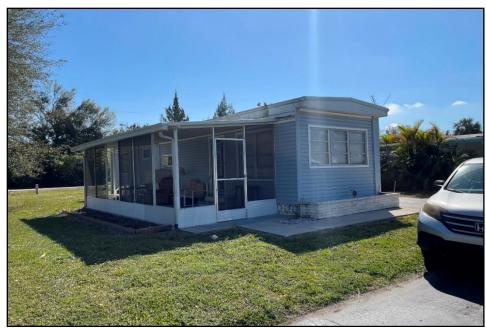
Photo 11. Mobile home with no style (8CH02789) located at 24437 Harborview Road #1, looking southeast.

No Style: Two historic resources within the project APE are mobile homes with no style (8CH02789 and 8CH02790) and were constructed in ca. 1971 (**Photos 11 and 12**). The representative mobile homes within the APE are single-wide with porches and carports and all display alterations. This building type rests on a pier foundation that is surrounded with decorative concrete blocks. Metal single-hung sash and awning windows are most common, and exterior ornamentation is minimal. These manufactured buildings have no style and are simply built in a factory with a steel chassis to allow for the

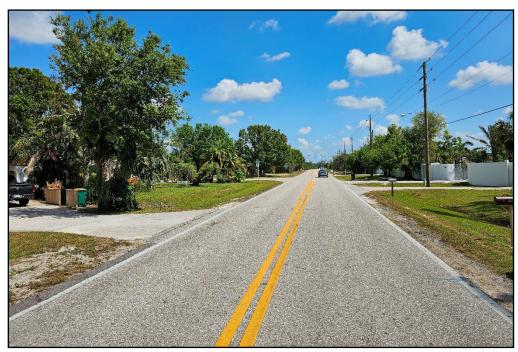
Photo 13. Harborview Road (CR 776) (8CH02053), looking northeast from LeBeth Street.

The segment of Harborview Road (CR 776) (**Photo 13**) was constructed c. 1935 and connects Charlotte Harbor to the community of Harborview. It is a two-lane road paved with asphalt, and it has sporadic dedicated turn lanes and no shoulder. Within the project area, Harborview Road extends from its intersection with Melbourne Street to the southwest to its intersection with I-75 to the northeast. The road

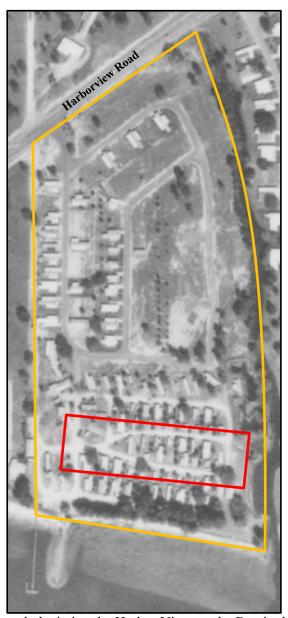
Photo 2. 1974 aerial photograph depicting the Harbor View on the Bay in the early stages of expansion (USDA 1974). Orange line denotes approximate resource group boundary. Red box indicates location of original cul-de-sac which is now Snook Avenue.

An analysis of historic aerial imagery reveals that the Harbor View on the Bay MHP – known as Harbor View Park until ca. 2021 – was originally located along the shore of Charlotte Harbor/the Peace River (USDA 1952) (Photo 1). The mobile home park was comprised of a large cul-de-sac with multiple buildings located along the shoreline and was accessed by a north-south roadway connecting to Harborview Road to the north. A fishing pier was present at this time. An additional road was constructed to the north of the cul-de-sac by ca. 1970 (USDA 1970). The mobile home park was significantly expanded in ca. 1974 with the opening of additional lots to the north of the original southern portion (USDA 1974) (Photo 2). By ca. 1985, the northern portion of the resource group had been fully developed and the original southern portion of the property was reconfigured to the current design with Snook Avenue taking the place of the original cul-de-sac (FDOT 1985). Today, the Harbor View on the Bay Mobile Home Park is comprised of a main road named Manatee Loop with two east-west cross streets - Tarpon Street and Snook Avenue and an inner north-south street, Redfish Way. Two small cul-de-sacs, named Sawfish Way and Sea Trout Way, are located along the eastern side of Manatee Loop. The resource group is bounded roughly by Harborview Road to the north, an unnamed creek to the east, single-family residential properties to the west, and the Peace River to the south and located within Charlotte County parcel # 402330251008 (Polk 2023). The mobile homes are predominantly oriented east-west or north-south with the shortest end of the mobile home facing the street. The mobile homes located on cul-de-sacs are slightly angled toward the road. Most appear to have an attached carport with a concrete driveway. Following the completion of the park's expansion, alterations appear to be limited to the development of the remaining vacant lots. Several mobile homes along Redfish Way were demolished and/or removed between ca. 2004 and ca. 2018 (Google Earth 2023). Community amenities are limited to an activities clubhouse containing an arts and crafts area, library, and game room, a shuffleboard court adjacent to the clubhouse, and a fishing pier projecting into the Peace River (Harbor View on the Bay n.d.). These are not accessible from the public right-of-way.

The Harbor View on the Bay MHP has been significantly altered over the years through large-scale expansion and redesign of the original plan. The building complex resource group is limited to a basic layout with few community amenities and a clubhouse. The Harbor View on the Bay Mobile Home Park is a common mobile home park found throughout Florida and it is not a significant embodiment of a type, period, or method of construction, and background research did not reveal any historic associations with significant persons and/or events. As a result, 8CH02799 does not appear eligible for listing in the NRHP, either individually or as part of a historic district.

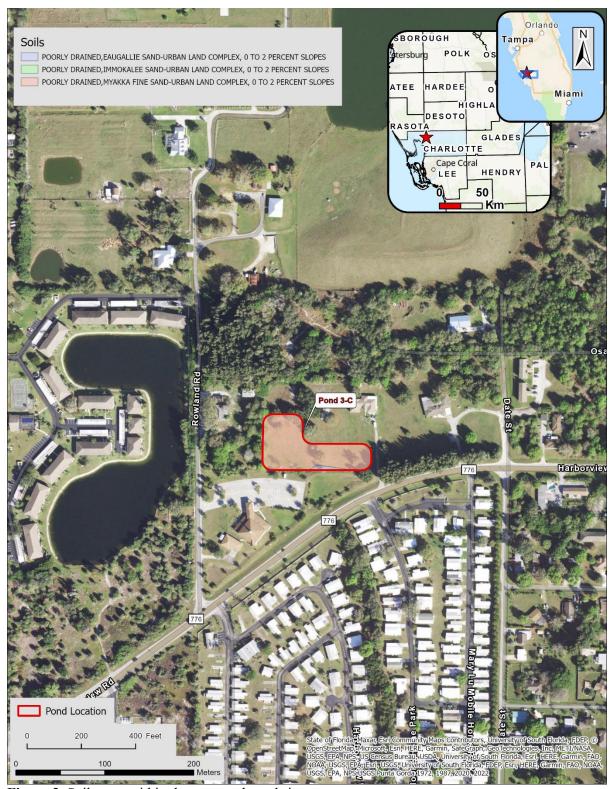
Figure 3. Soil types within the proposed pond site.

Soils within the project corridor are part of the Oldsmar-Myakka soil association. This association includes nearly level and poorly drained soils found on flatwoods vegetated in South Florida slash pine, sawpalmetto, and pineland threeawn (USDA 1984). These flatwoods soils typically consist of one to three feet of organic stained sand. The specific soil types within the APE are shown on Figures 2 - 4.

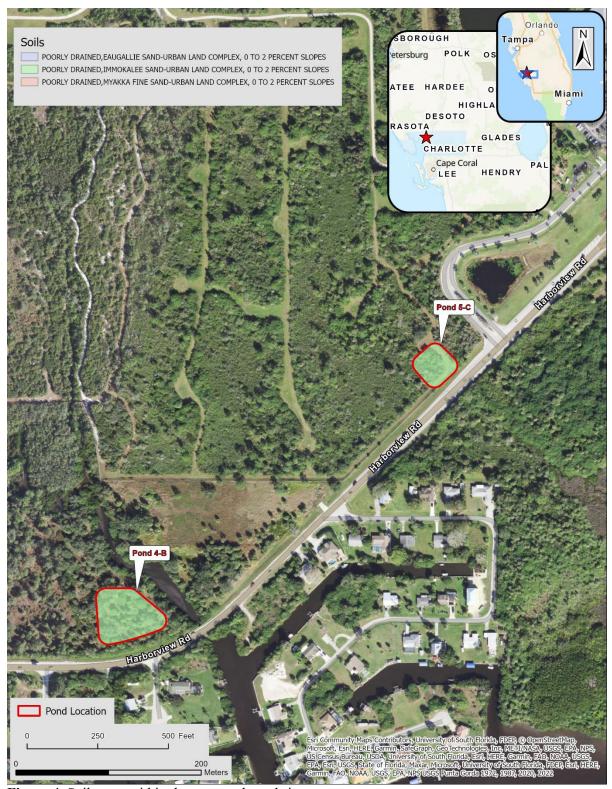
Figure 4. Soil types within the proposed pond site.

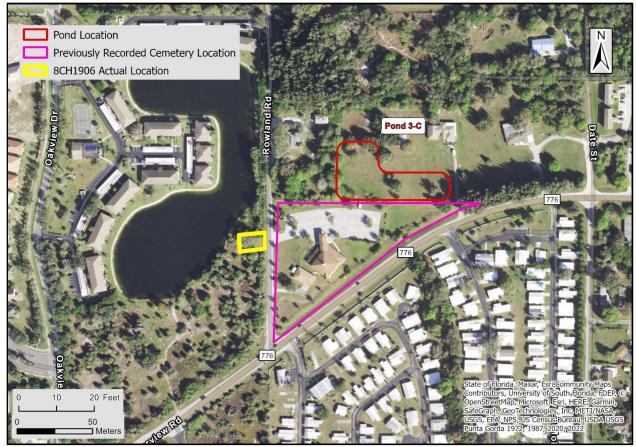
Figure 8. Correct location of the Hickory Bluff Cemetery (8CH01906) in relation to the inaccurate previously recorded GIS data.

In addition, the previously recorded Hickory Bluff Cemetery (8CH01906) appears on Figure 7 as being within the APE, adjacent to proposed Pond 3C; however, during the background research, it was determined that the boundary for the Hickory Bluff Cemetery (8CH01906) was not accurately plotted within the FMSF geographic information system (GIS) data. The boundaries to the Hickory Bluff Cemetery are clearly depicted by the map and GPS coordinates presented in Scot Shively's report, *Hickory Bluff Cemetery: A Charlotte County Pioneer African American Cemetery* (Shively 2016). Furthermore, a historic marker is located on the west side of Rowland Drive marking the area of the cemetery, which is approximately 300-feet southwest of the proposed pond site. **Figure 8** depicts the inaccurate GIS plotting of the cemetery in relation to the correct location. The cemetery was first recorded in 2008 during the *Phase II of the Charlotte County Resource Survey* and has not been evaluated by the SHPO.

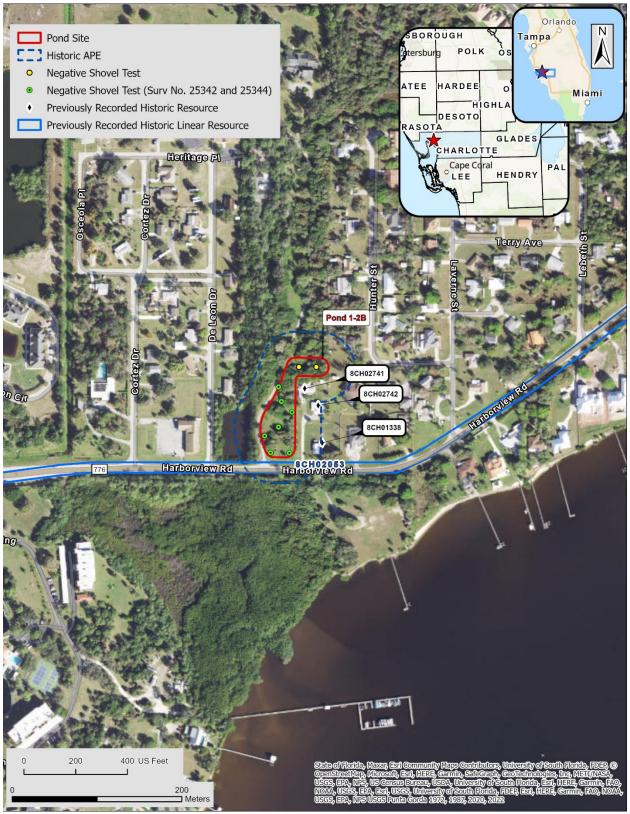
Figure 9. Location of shovel tests and historic resources within the APE.

Historical: As a result of the historical survey, no historic resources were identified within any of the proposed pond sites; however, four previously recorded historic resources (8CH01338, 8CH02053, 8CH02741, and 8CH02742) had been previously recorded adjacent to the four proposed pond sites within the APE (**Figures 9 – 11**). This includes three buildings (8CH01338, 8CH02741, and 8CH02742) located adjacent to proposed Pond site 1-2B and the historic linear resource, Harborview Road (8CH02053), located adjacent to proposed pond sites 1-2B, 3C, 4B and 5C. These four resources were recorded/updated in 2018, at which time they were determined ineligible for listing in the NRHP by the SHPO. Therefore, the resources were not updated as part of this survey as no significant changes were observed. As a result of the field reconnaissance survey, no new historic resources were identified within the APE.

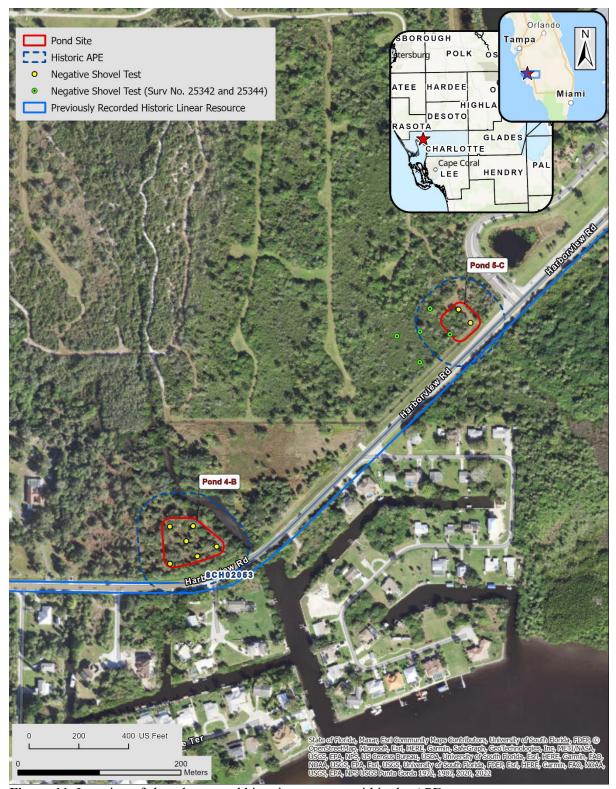
Figure 11. Location of shovel tests and historic resources within the APE.
