#### CULTURAL RESOURCE ASSESSMENT SURVEY TECHNICAL MEMORANDUM

# STATE ROAD (SR) 31 STATE ENVIRONMENTAL IMPACT REPORT (SEIR) FROM COUNTY ROAD (CR) 78 TO NORTH OF COOK BROWN ROAD LEE AND CHARLOTTE COUNTIES, FLORIDA

Financial Project ID No.: 428917-2-21-01 ETDM: 9651

December 2020

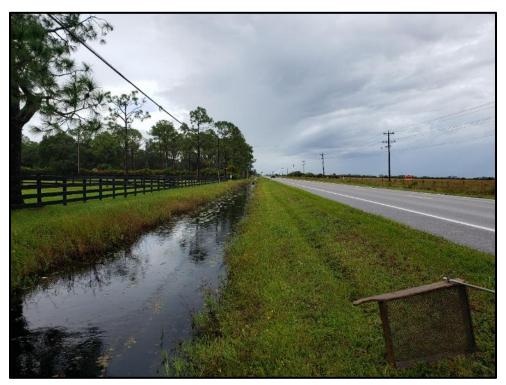
**Photo 1.** Looking north, along the west side of SR 31 towards Busbee Lane.

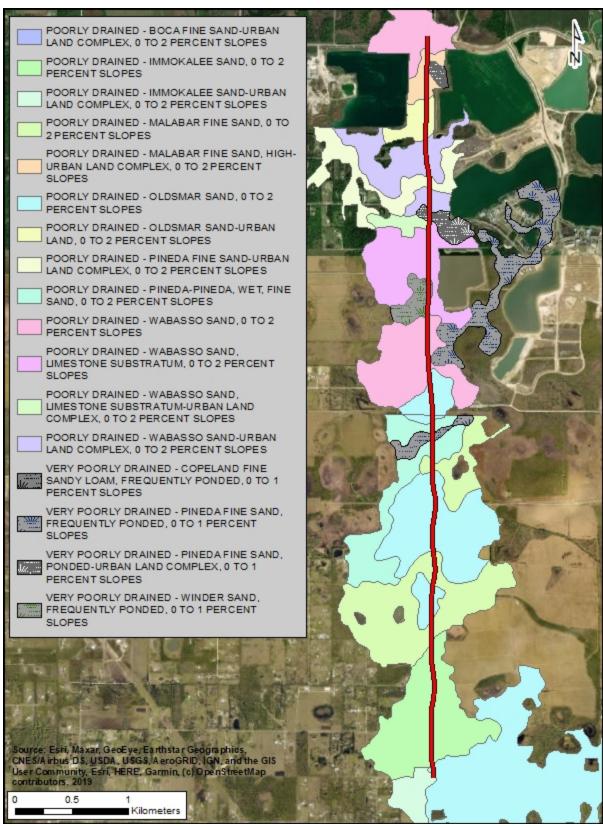
**Figure 2.** Soil type distribution within the APE.

The APE is located in Sections 1, 6, 7, 12, 26, 30, 31, and 36 on the boundary line between Ranges 25 and 26 East, of Township 42 and 43 South in Lee and Charlotte County, Florida (United States Geological Survey [USGS] 1957, 1958). The APE is situated on three soil associations. The Wabasso-Pineda-Bocca association includes nearly level, poorly drained soils of the flatwoods and sloughs; the Oldsmar-Malabar-Immokalee association soils which are characteristic of flatwoods and sloughs and are in areas that are nearly level and poorly drained; and the Isles-Boca-Pompano is a nearly level, poorly drained soil found in swamps and depressions (USDA 1984a, 1984b). The soils specific to the project area are detailed in **Figure 2.**

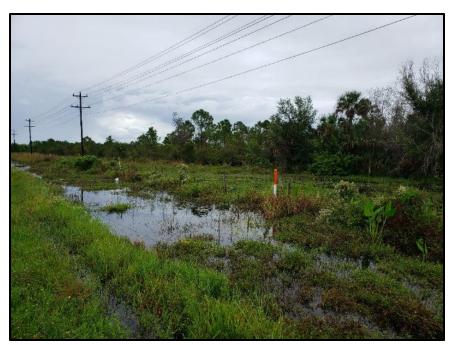
Photo 2. Northeast view along the east side of SR 31.

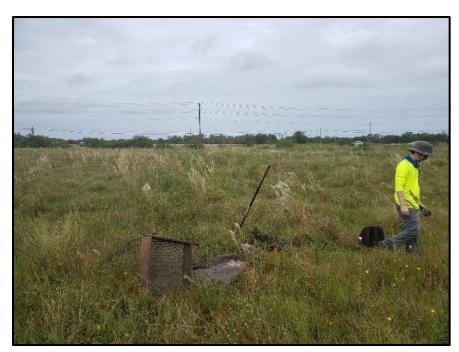
**Photo 3.** Vacant area along the west side of SR 31, south of Babcock.

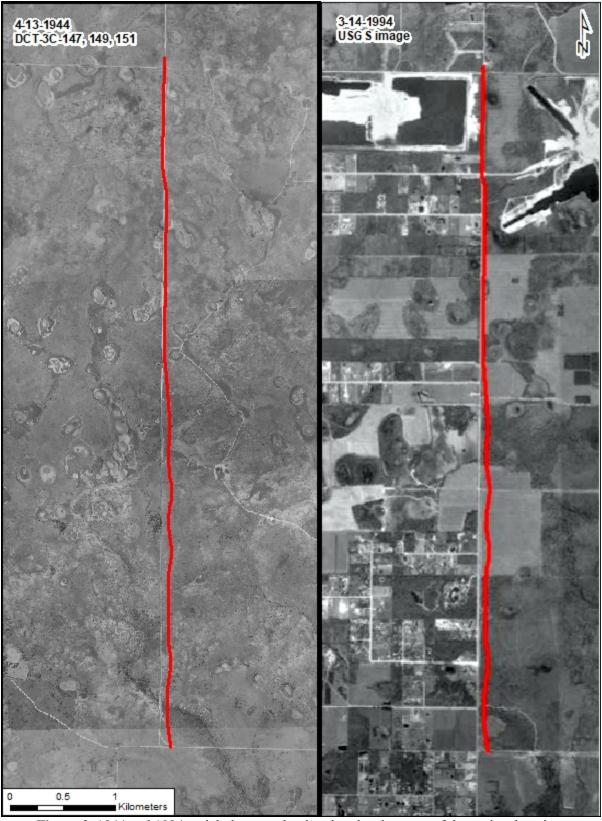
Figure 3. 1944 and 1994 aerial photographs showing development of the project location.

Despite the increase in development following World War II, eastern Charlotte and Lee Counties remained largely rural (**Figure 3**). Large sections of timber land associated with Crescent B. Ranch were utilized as a working cattle ranch; however, beginning in the early 1940s, this land was managed under a public/private partnership. An early participant in the timber industry of the region was E.V. Babcock. Babcock organized the Babcock Carrier Florida Company and began acquiring large stands of timber in eastern Charlotte County and northeastern Lee County in 1919. The land owned by the company would later be known as the Babcock Crescent B Ranch (Johnson Engineering, Inc. 2005). In addition, approximately 50,000 acres of Babcock land was conveyed to the State of Florida during the early 1940s and is now the Babcock-Webb Management Area (Johnson Engineering, Inc. 2005). The Babcock Ranch Preserve was purchased by the State of Florida in 2006 in order to sustain the land as "a working ranch and timbering and eco-tourism operation" while protecting regional water sources, habitats, and cultural resources in southwest Florida (FWC n.d.). A portion of the Crescent B Ranch land also became Babcock Ranch – an 18,000-acre planned residential community with commercial spaces considered to be "the nation's first solar-powered town" (Zeitlin 2019).

In addition to timber and ranching, land south of Cook Brown Road was purchased by Charlotte Rock Industries in 1982 for use as a lime rock quarry (Williams 1982) (**Figure 3**). Lime rock excavated from the quarry was utilized for building materials and the quarry remains in use today despite issues regarding rock blasting with the ca. 1970s residences to the south on Little Farm Road and Horseshoe Road.

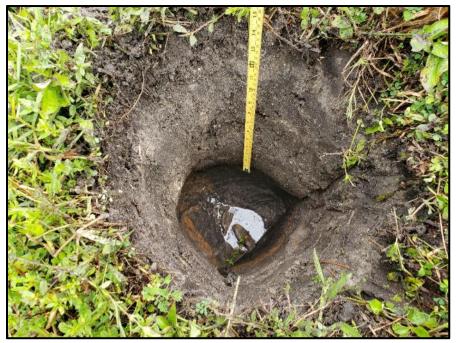
The soil stratigraphy consisted of 0-25 cm of dark grey mottled sand; 25-50 cm of wet, grey/brown sand; and 50-100 cm of light brown sand with water (**Photo 4**). Water was encountered at shallow depths in several test pits.

**Photo 4.** Typical test pit stratigraphy.

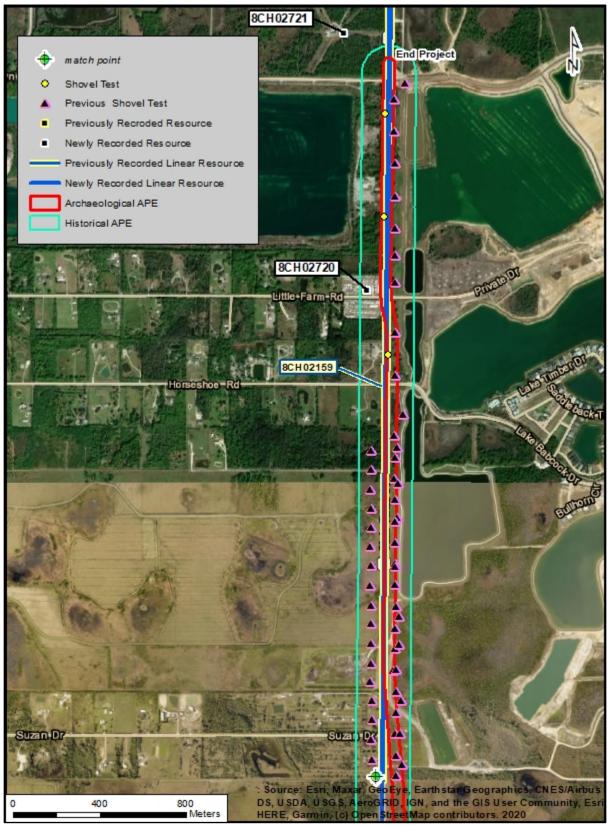
Figure 5. Location of shovel tests and historic resources within the APE.

Archaeological field survey consisted of a surface reconnaissance and judgmental subsurface testing. A total of 22 shovel tests was excavated within the APE during this most recent survey; previous surveys resulted in an additional 79 shovel tests (ACI 2004: Survey No. 10179, 2006: Survey No. 14057, 2019: Survey No. 26038 (Figures 5 & 6) within and adjacent to the APE. No cultural materials were recovered from the shovel tests or noted on the surface during any of the surveys. A reasonable and good faith effort was made per the regulations laid out in 36 CFR § 800.4(b)(1) (Advisory Council on Historic Preservation n.d.) to survey all areas of the project APE. The results are in keeping with the research considerations which noted disturbances within the archaeological APE and a general lack of remaining natural environment.

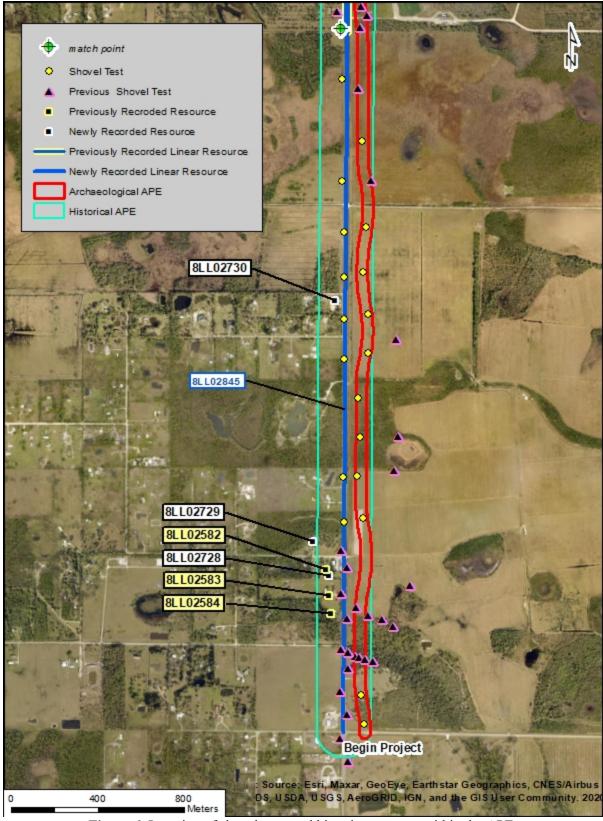
Figure 6. Location of shovel tests and historic resources within the APE.

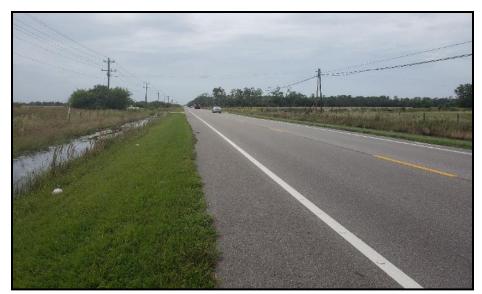
Photo 5. Photograph of SR 31 in Lee County looking south (Typ).

8LL02845 & 8CH02159: Within the APE, SR 31 runs north-south through Lee and Charlotte Counties. The Lee County segment is approximately 2-miles long and is located in Sections 1 and 12 of Township 43 South, Range 25 East; Sections 6 and 7 of Township 43 South, Range 26 East (USGS Tuckers Corner 1957). The Charlotte County segment is approximately 2.2-miles long and is located in Sections 25 and 36 of Township 42 South, Range 25 East; Sections 30 and 31 of Township 42 South, Range 26 East (USGS Tuckers Corner 1957). Both the Lee and Charlotte County segments are comprised of two 12-ft wide travel lanes that have been paved with asphalt and are each two miles long (**Photo 5**). SR 31 – originally known SR 2 – was established by the State Road Department in ca. 1917 as a route connecting the Georgia state line, Orlando, and Fort Myers (State Road Department 1917). By 1923, the route was under construction through eastern Charlotte County in order to connect the existing terminus in Arcadia with Fort Myers to the south (News-Press 1923). Alterations to both segments include grading, widening, and resurfacing. The segments of SR 31 within the APE in Lee and Charlotte Counties are of common design for the state, have undergone alterations in the form of road improvements, and are not of unique design or methods of engineering. In addition, background research did not reveal any historic associations with significant persons and/or events. Therefore, these segments of SR 31 (8LL02845 & 8CH02159) do not appear eligible for listing in the NRHP.

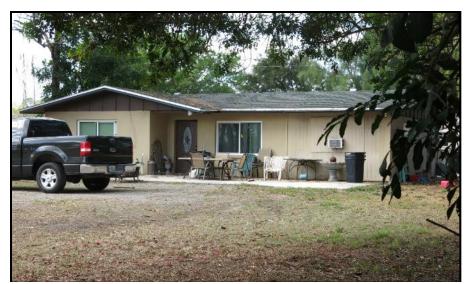
Photo 6. 19411 SR 31 (8LL02728), looking southwest.

**8LL02728:** The Masonry Vernacular style building at 19411 SR 31 was constructed ca. 1968 (**Photo 6**). The one-story, irregular plan building rests on a slab foundation of concrete and has concrete walls partially sheathed in stucco, plywood, and vertical plank. The side-gable roof over the principal mass is covered in composition shingles. The main entrance is on the east elevation through a single panel door with an oval window within a partial-width open front porch beneath portion of a low-pitched gable roof. Windows include independent, aluminum, 1/1 SHS, and slider units. There is a 1974 shed located on the west elevation. The building appears to have been reroofed and has new windows and doors. Distinguishing features include wooden gable ends, corner boards, plywood siding. The building is in fair condition and retains some of its original exterior fabric. Overall, it is a typical example of a Masonry Vernacular style residence with alterations and found throughout Lee County and research revealed no significant historical associations. As a result, 8LL02728 does not appear eligible for listing in the NRHP, either individually or as part of a historic district.

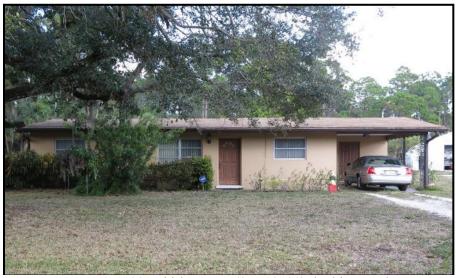
Photo 7. 11901 Shirley Lane (8LL02729), looking north.

**8LL02729:** The Masonry Vernacular style building at 11901 Shirley Lane was constructed ca. 1962 (**Photo** 7). The one-story, irregular plan building rests on a slab foundation of concrete and has concrete walls

sheathed in stucco. The low-pitched side gable roof over the principal mass is covered in composition shingles. The main entrance is on the south elevation through a single panel door with a center fanlight beneath an extended eave of the gable roof. There is a partial-width open and enclosed porch beneath a shed roof on the north elevation. Windows include independent, aluminum, 1/1 SHS; paired 3-stacked, aluminum, awning; independent, 5-stacked, aluminum, jalousie; and paired 10-stacked, aluminum, jalousie units. The building appears to have been reroofed in 2005 and additions include an open and enclosed porch to the north elevation. There are several property alterations and additions that include a 2012 detached metal garage, 1992 pool and patio, 1987 gazebo, and 1985 detached garage. Distinguishing features include wooden gable ends, low-pitched gable roof. The building is in good condition and retains most of its original exterior fabric. Overall, it is a typical example of a Masonry Vernacular style residence with alterations and found throughout Lee County and research revealed no significant historical associations. As a result, 8LL02729 does not appear eligible for listing in the NRHP, either individually or as part of a historic district.

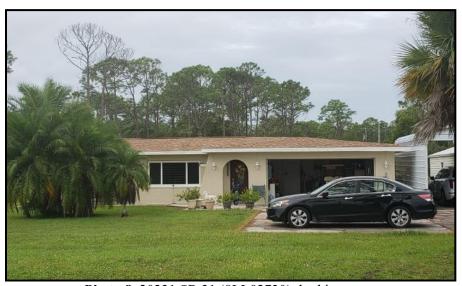
Photo 8. 20231 SR 31 (8LL02730), looking west.

**8LL02730:** The Masonry Vernacular style building at 20231 SR 31 was constructed ca. 1972 (**Photo 8**). The one-story, irregular plan building rests on a slab foundation of concrete and has concrete walls sheathed in stucco. The side-gable roof and hip roof over the principal mass is covered in composition shingles. The main entrance is on the east elevation through a single wooden, panel door with an oval window within a recessed open porch with an arched entryway beneath portion of a hip roof. There is a partial-width open and enclosed porch beneath a flat roof on the west elevation. Windows include independent, 1/1 SHS, and picture units. The building alterations include a new roof and windows, and additions include partial-width open and enclosed porches on the north elevation. Distinguishing features include arched entryway, fixed shutters, and slanted entry wall. The building is in good condition and retains most of its original exterior fabric. Overall, it is a typical example of a Masonry Vernacular style residence with alterations and found throughout Lee County and research revealed no significant historical associations. As a result, 8LL02730 does not appear eligible for listing in the NRHP, either individually or as part of a historic district.

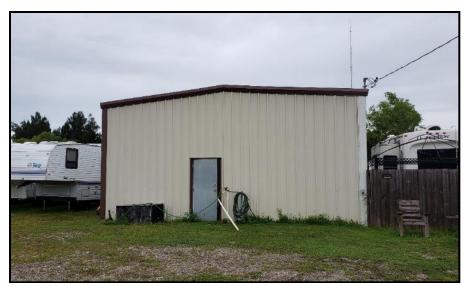
Photo 9. 41900 Little Farm Road (8CH02720), looking north.

**8CH02720:** The Industrial Vernacular style building at 41900 Little Farm Road was constructed ca. 1972 (**Photo 9**). The one-story, rectangular plan warehouse rests on a slab foundation of concrete and has metal frame walls. The low-pitched front-gable roof over the principal mass is covered in standing seam sheet metal. The main entrance is on the south elevation through a single metal door. The building does not have any visible windows. Building alterations include new metal siding applied on the east elevation. Distinguishing features include low-pitched gable roof. The building is in fair condition and retains some of its original exterior fabric. Overall, it is a typical example of a basic warehouse with alterations and found throughout Charlotte County and research revealed no significant historical associations. As a result, 8CH02720 does not appear eligible for listing in the NRHP, either individually or as part of a historic district.

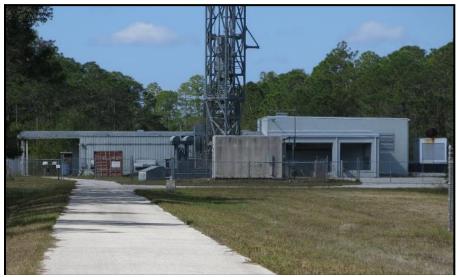
Photo 10. 12931 SR 31 (8CH02721), looking west.

**8CH02721:** The Wink TV tower, with no style, at 12931 SR 31 was constructed ca. 1966 (**Photo 10**). The one-story, irregular plan building rests on a slab foundation of concrete and has metal frame walls. The gable roof over the principal mass is covered in standing seam sheet metal. The main entrance is unknown

because the property was not accessible due to a security gate. The building does not have any visible windows. Building alterations are unknown; there was a masonry equipment/storage building added in 2006 on the north elevation. Distinguishing features include a carport on the south elevation and a massive TV tower on the east elevation. The building is in good condition and retains most of its original exterior fabric. Overall, it is a typical example of a basic TV station with alterations and found throughout Charlotte County and research revealed no significant historical associations. As a result, 8CH02721 does not appear eligible for listing in the NRHP, either individually or as part of a historic district.
