BRIDGE INSPECTION REPORT

PREPARED FOR: FLORIDA DEPARTMENT OF TRANSPORTATION
 BRIDGE OWNER: HARDEE COUNTY

BRIDGE NO. 060034	CONTENTS OF REPORT	INSPECTION DATE: 02/28/2018
BrM Report		U/W Inspection Report
CIDR		* Fracture Critical Data
Scour Elevation (Profile)		* Load Rating Analysis Summary
Addendum (Element Notes & Photos/Sketches)		
*This section is not included in this report.

CR-664 over Little Payne Creek

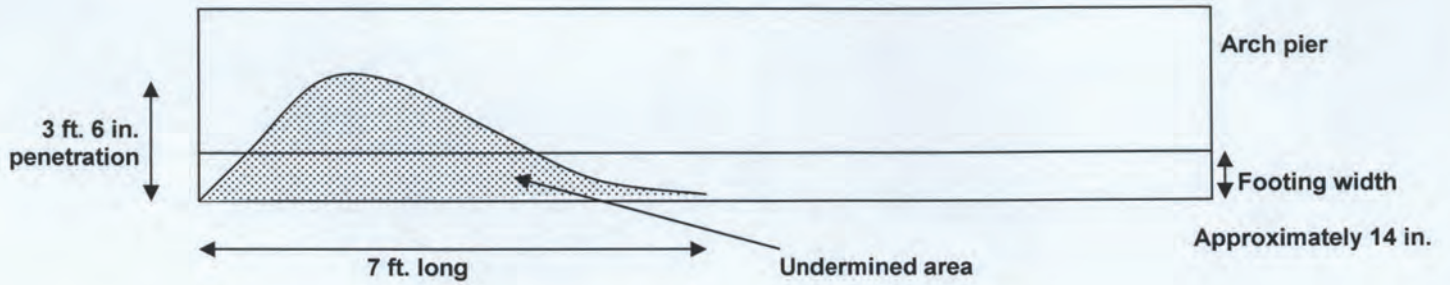
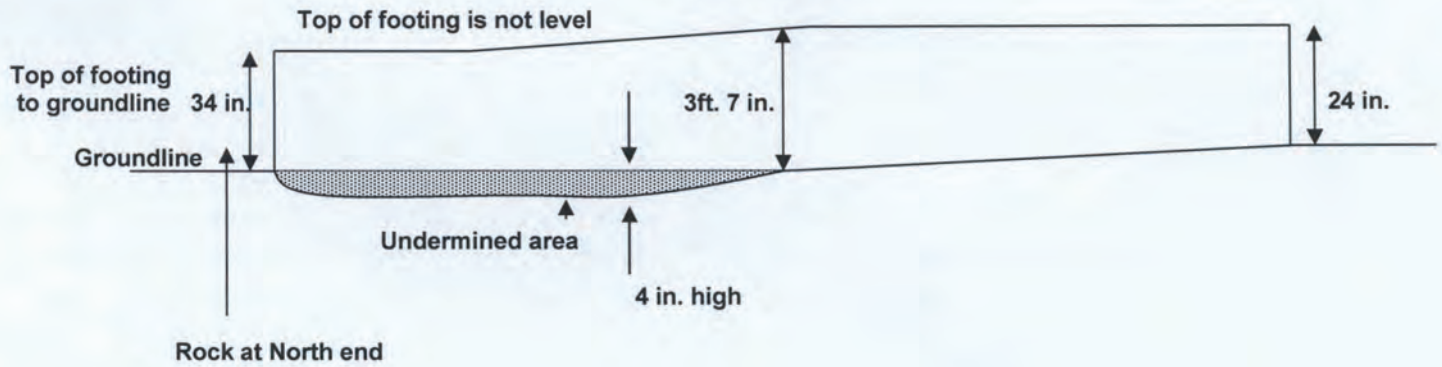
Footing 3 Plan View

CS4 9120 = The west face of Pier 3 footer is exposed up to 12ft. long x 4ft. high, with an area of undermining to the footer up to 7ft. long x 4in. high x 3.6ft. penetration starting from the north end, due to degradation/scour - INCREASE. Refer to Element 220 for related comments. REPAIR (1EA)

The following was noted by the underwater divers:
Pier 3 Footer: West side, starting at north end, undermined, 7ft. x 4in. x 3ft. 6in. of penetration - NEW. Refer to sketch 1. REPAIR (See deficiency above)
