CONTAMINATION TECHNICAL MEMORANDUM FOR MAINLINE AND DRAINAGE SITES

Florida Department of Transportation

Harborview Road PD&E Re-evaluation

Limits of Project: From Melbourne Street to I-75

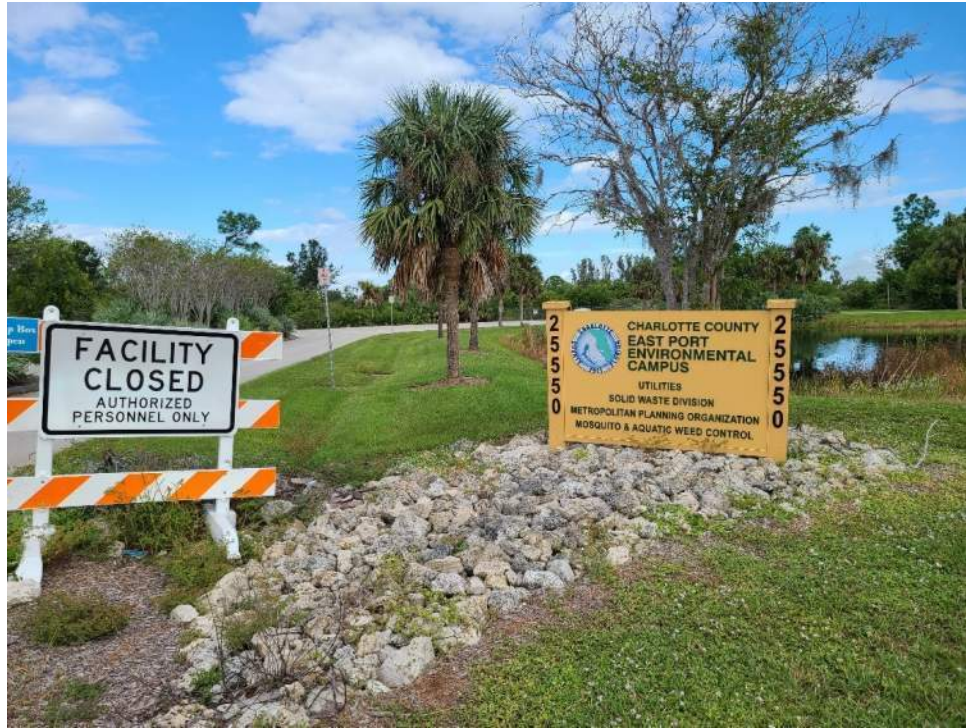
Site 5 – Charlotte County East Port Environmental Campus/Charlotte County Pest Management Harborview road looking northwest

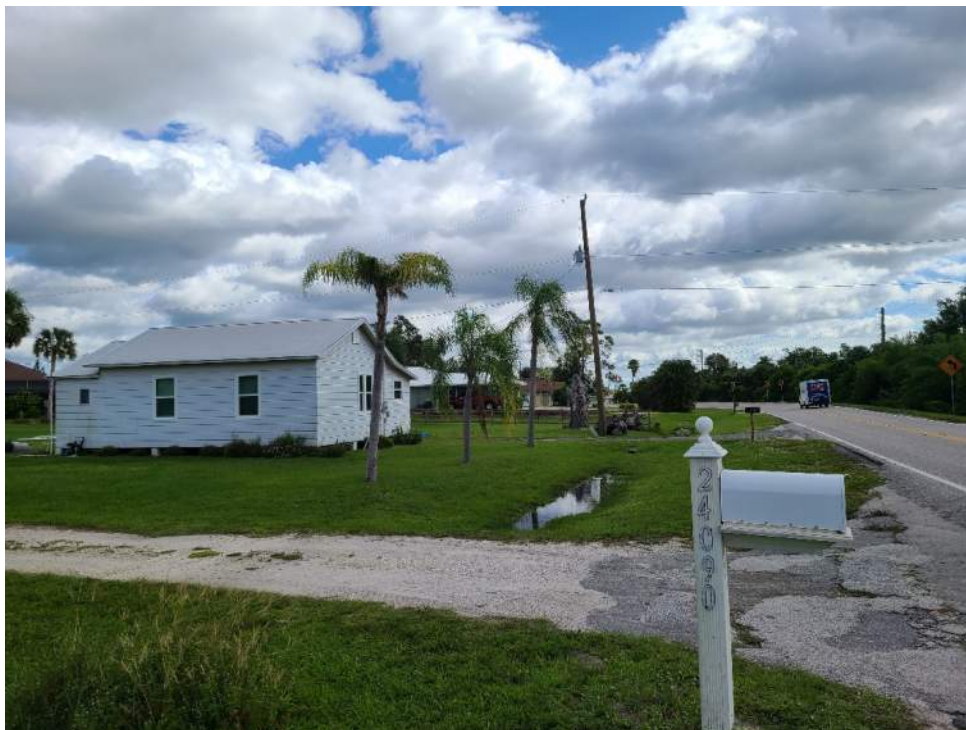
SMF 1-2B
Looking east

*	SMF 1-2	N/A	No	SMF 1-2 was not previously identified in the PD&E CSER dated October 2018. No regulatory information was identified for SMF 1-2. During the site reconnaissance, SMF 1-2 was observed as three residential homes. No contamination concerns were observed. Given a lack of contamination concerns associated with SMF 1-2, it was assigned a risk rating of No.

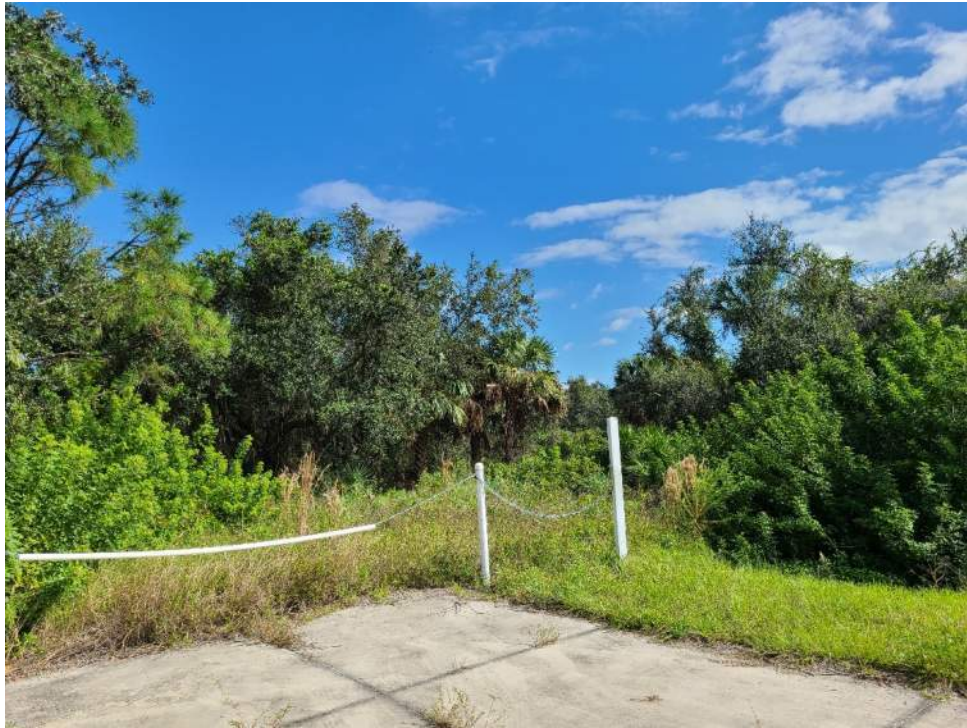
SMF 4
Looking northeast

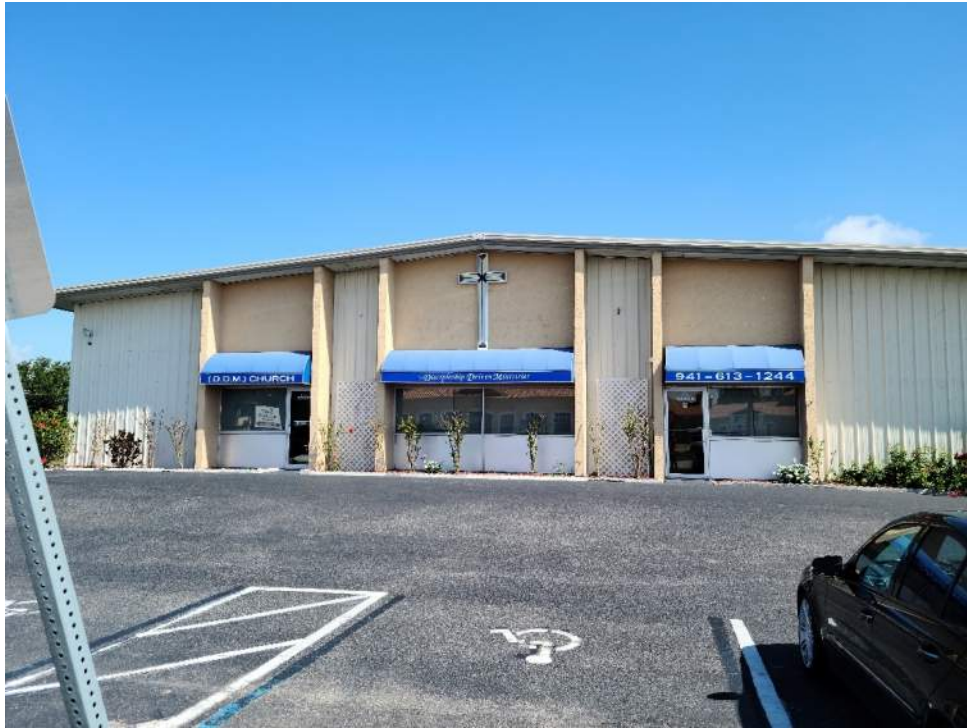
Site 1 – Former Marketing Arm International
Harborview Road looking north

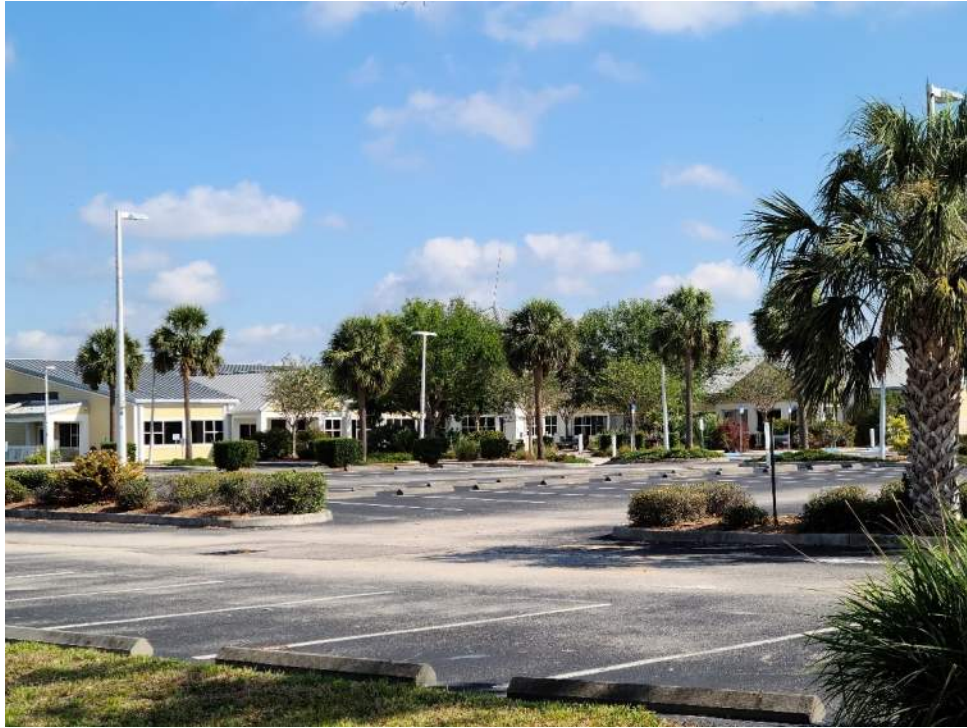
Site 5 – Charlotte County Pest-Management
Harborview road near eastern project boundary, looking northeast

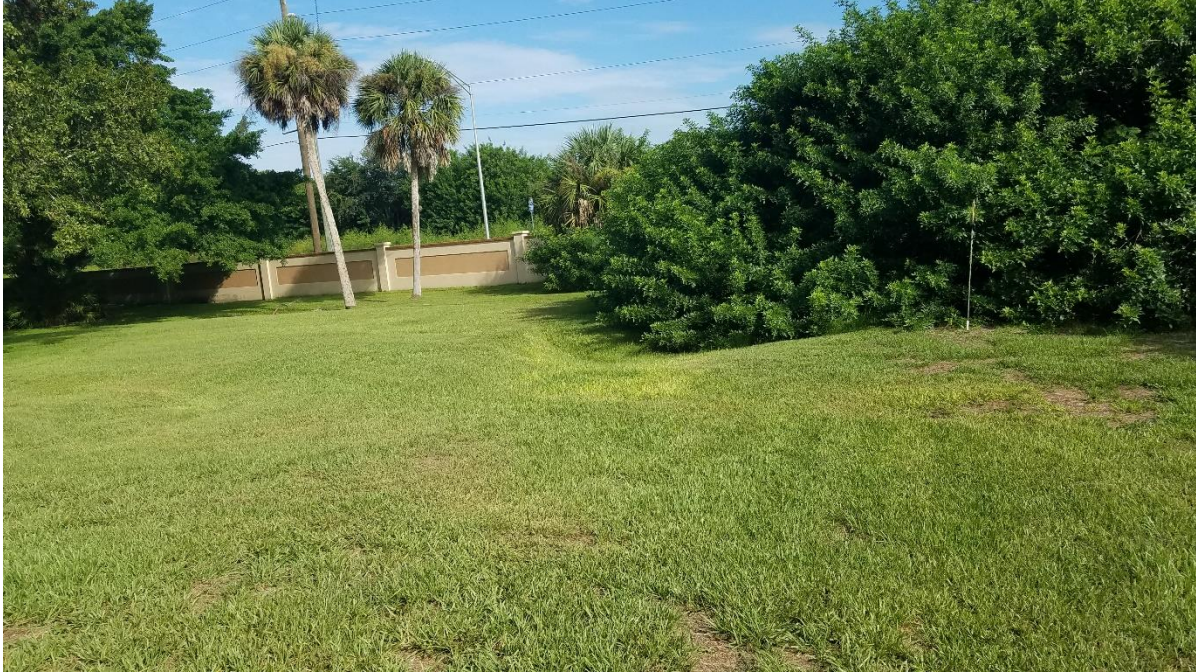
Pond 1C: central area looking north

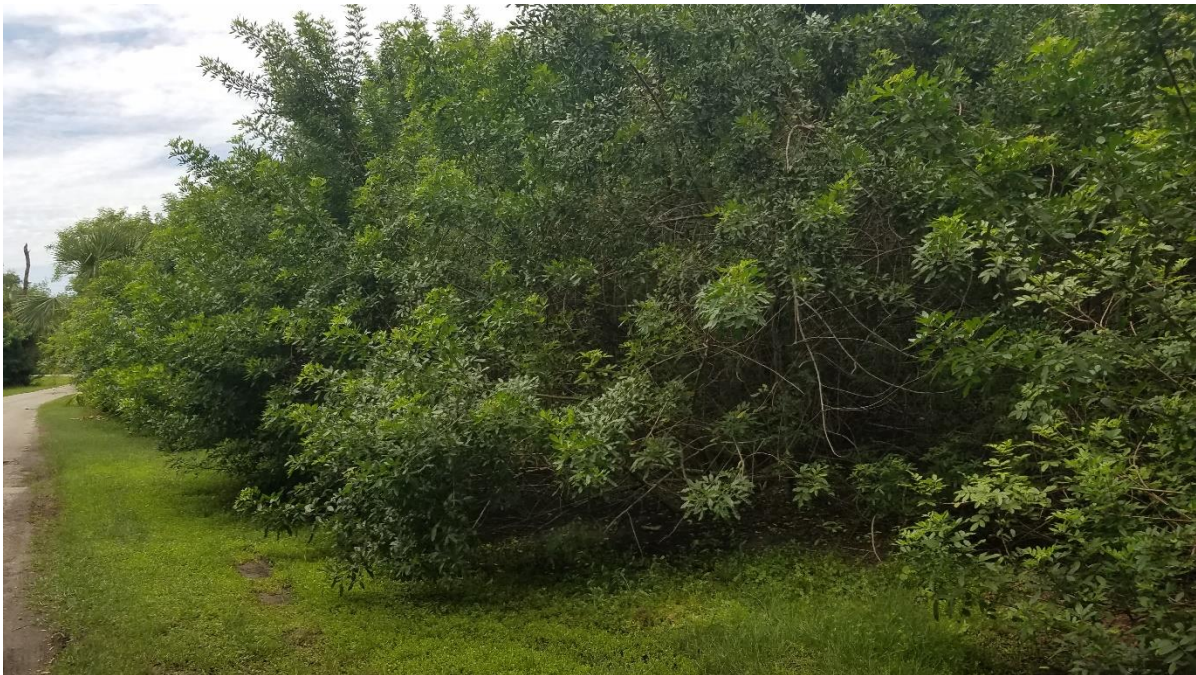
Pond 2A: northeast edge looking southwest

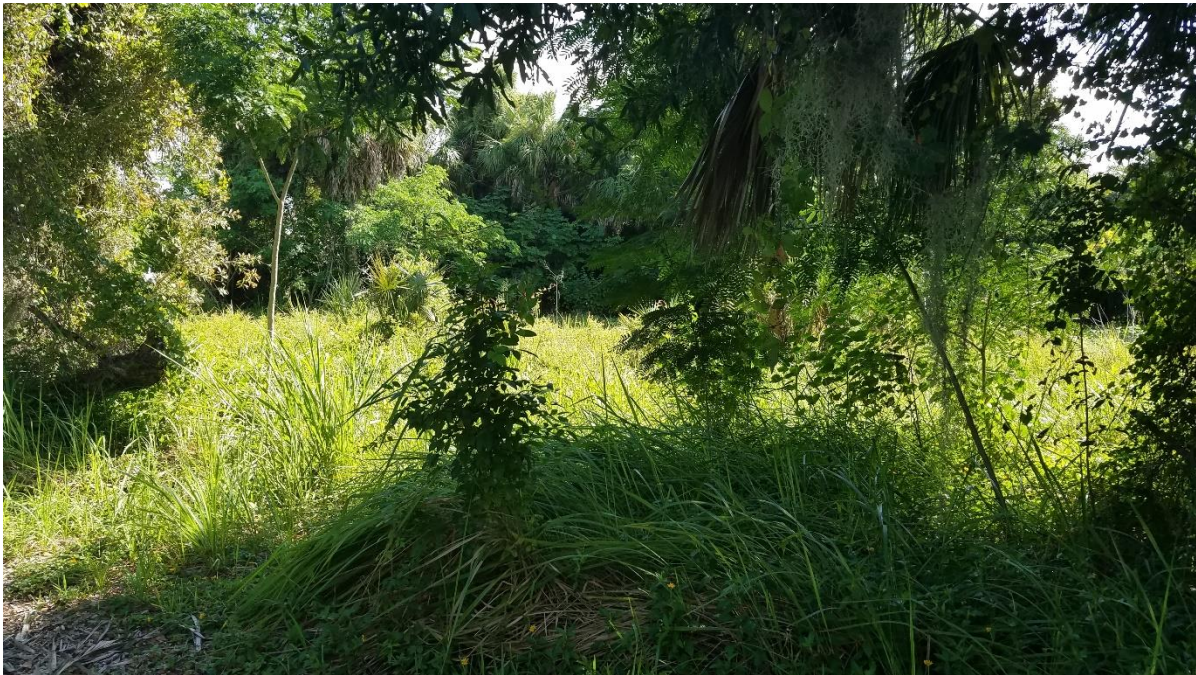
Pond 2C: central area looking north

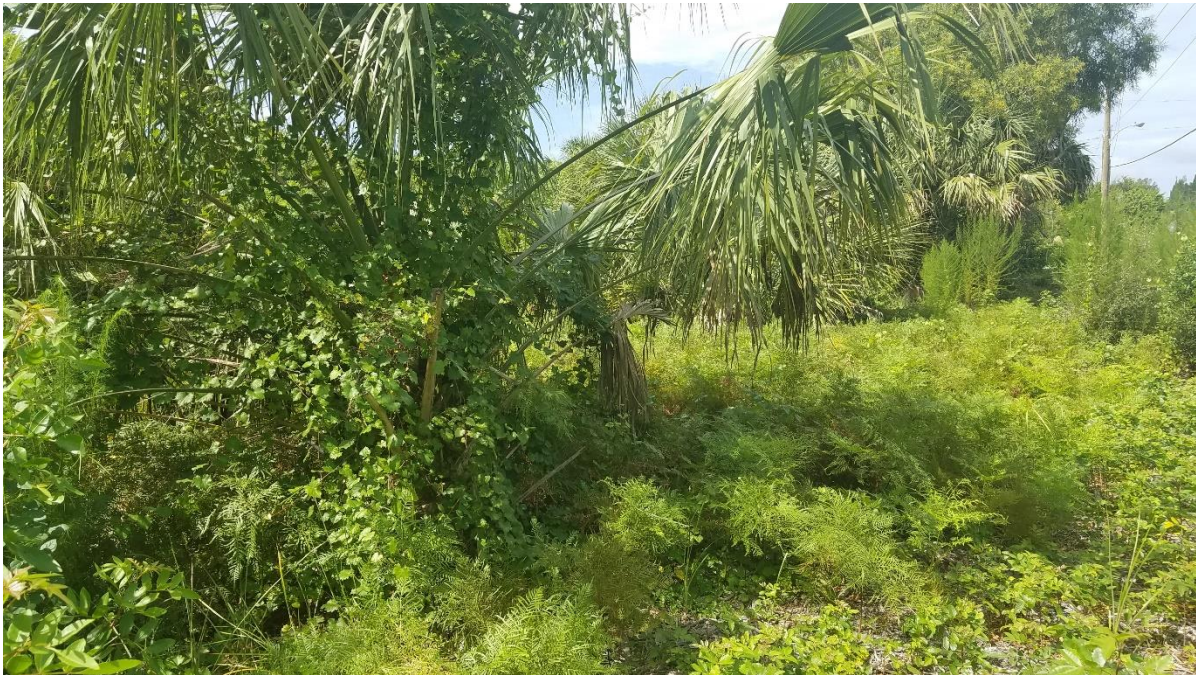
Pond 4A: north-central area looking south

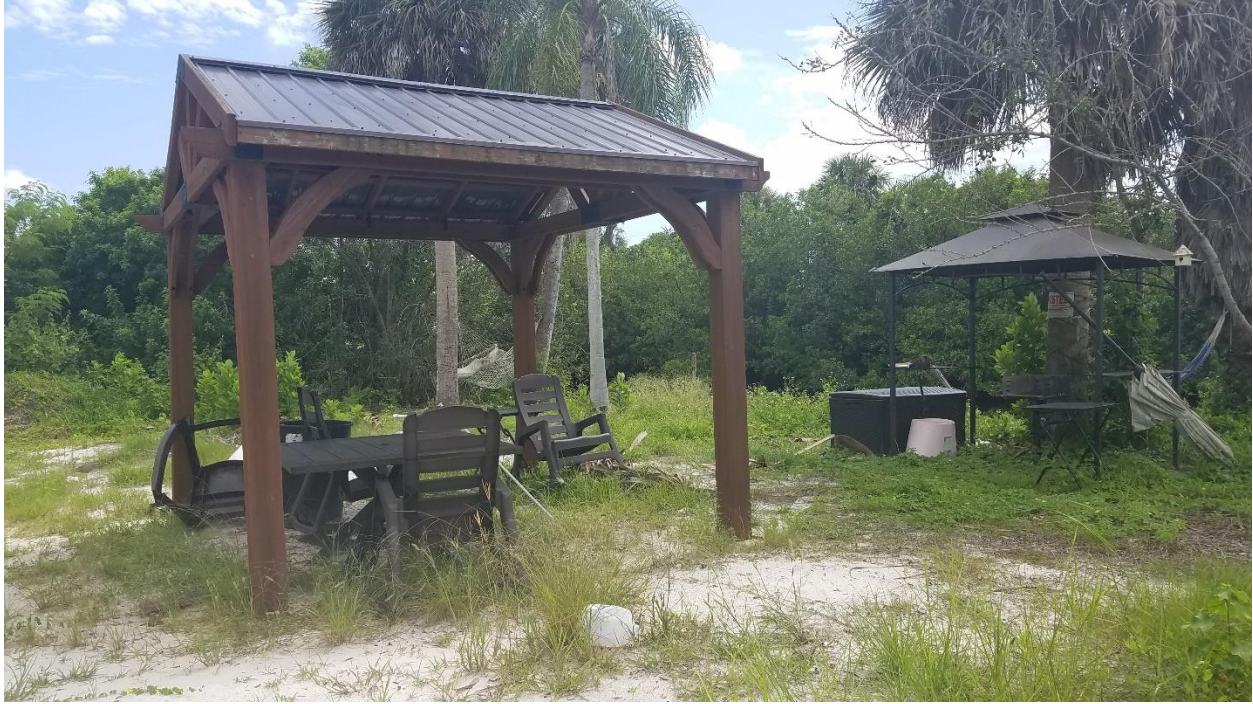
Pond 5B: southwest area looking west

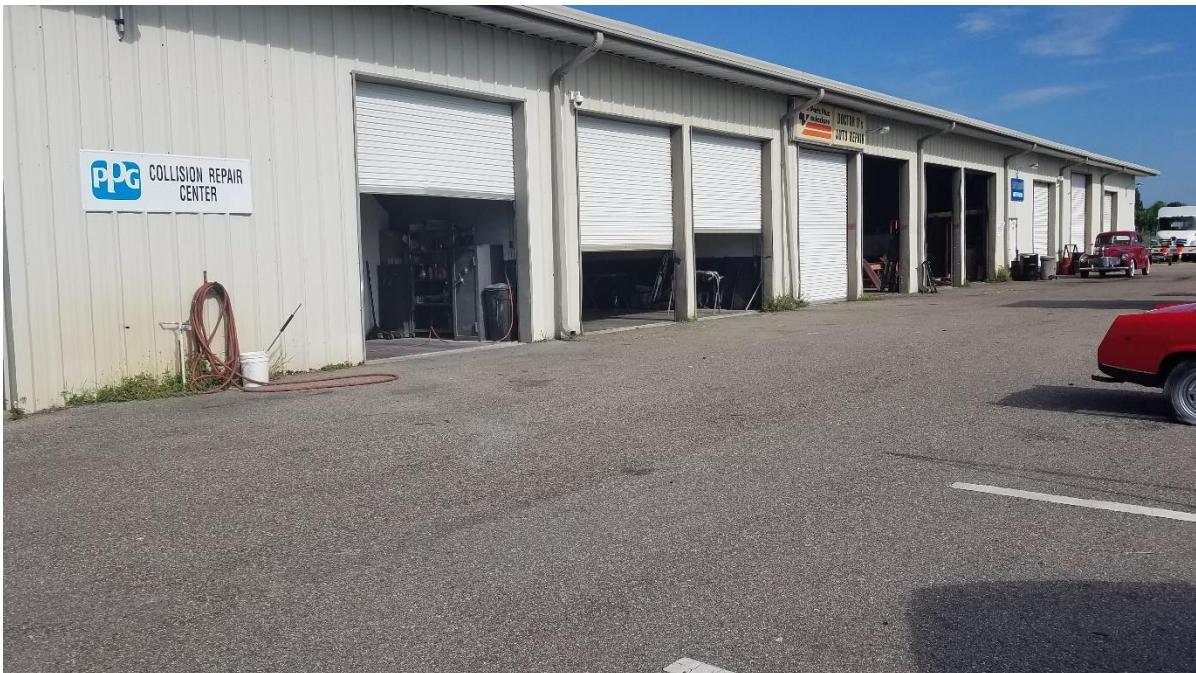
Site 2: Dr. D's Auto & Marine Repair Inc./Clune's Body Shop Inc. – southeast portion of site looking northwest
