CONTAMINATION TECHNICAL MEMORANDUM FOR MAINLINE AND DRAINAGE SITES

Florida Department of Transportation

Harborview Road PD&E Re-evaluation

Limits of Project: From Melbourne Street to I-75

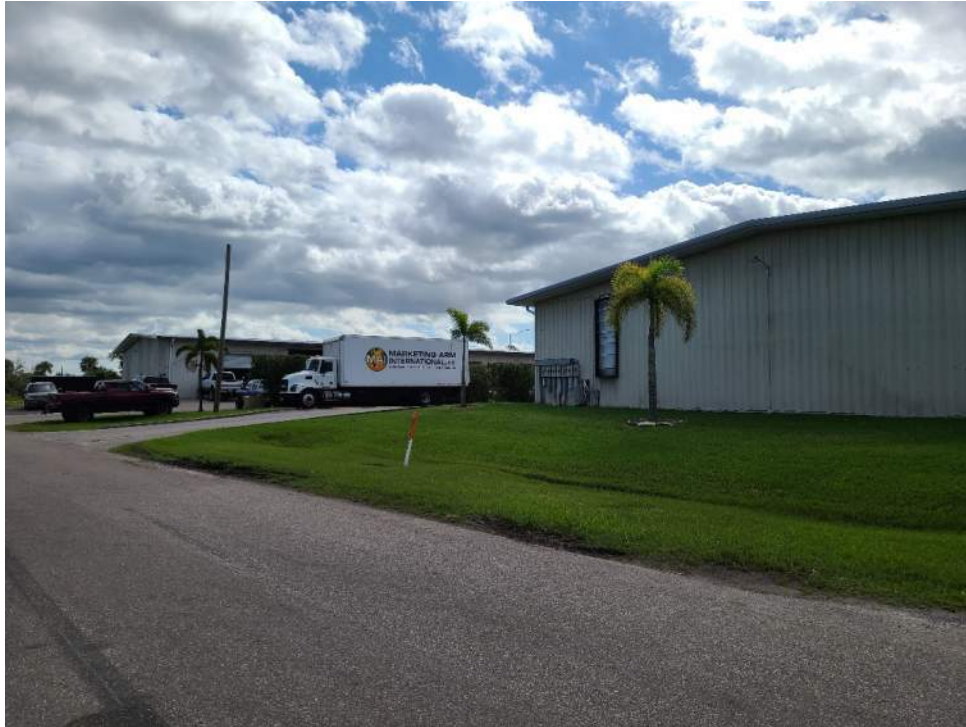
Site 1 – Marketing Arm International
Janice Avenue looking southeast

PD&E Site No.	Site Name	PD&E Risk Rating	Re-evaluation Risk Rating	Comments
1	Marketing Arm International 23395 Janice Ave., #16	No	No	The PD&E CSER notes that no discharges have been reported at this site. This site was not identified in EDM's search of regulatory databases. No new discharges have been reported since 2018. No subsequent regulatory information was identified. During the site reconnaissance, the site was observed as Marketing Arm Inc. and Charlotte Harbor Custom Upholstery. Given the lack of contamination concerns, no change is recommended to the risk rating and therefore it remains No.
2	Former Bailey's Towing 23400 Janice Ave., Port Charlotte	No	No	The PD&E CSER notes that no releases have been reported at this site. No new discharges have been reported since 2018. No updated regulatory information was identified. During the site reconnaissance, the site was observed as a Road Ranger station with some parked vehicles and heavy machinery approximately 320 feet from Harborview Road ROW. No change is recommended to the risk rating. Therefore, the risk rating remains No.

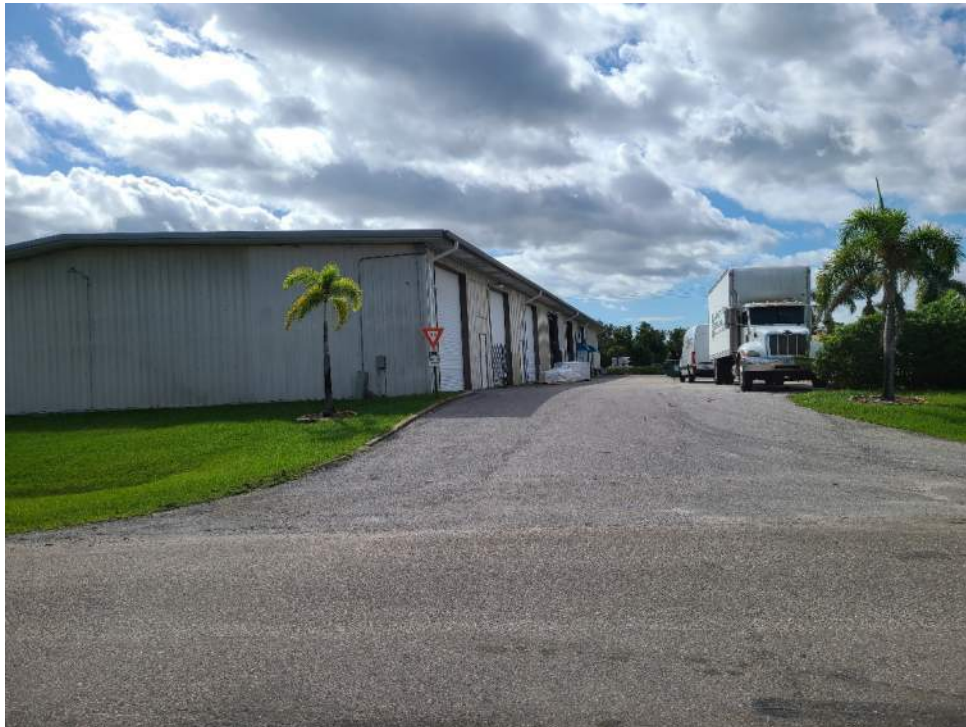
Site 1 – Marketing Arm International
Janice Avenue looking south

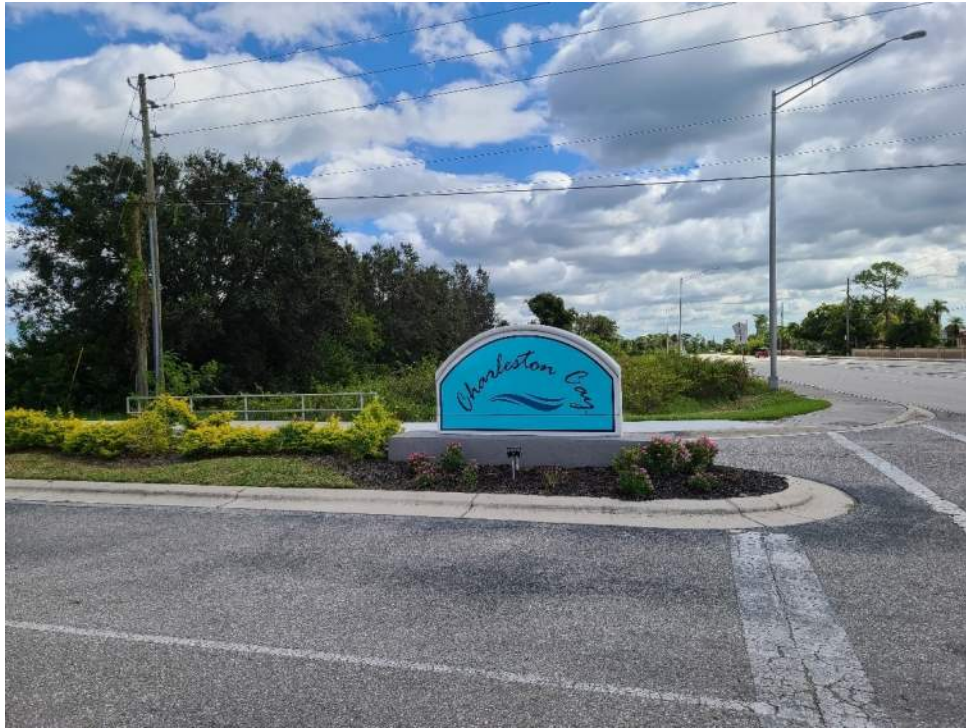
Site 3 – Charleston Cay Apartments
Harborview Road looking east

3	Charleston Cay Apartments NE of intersection of Melbourne Street and Harborview Road	No	No	The PD&E CSER notes that no releases have been reported at this site. No new discharges have been reported since 2018. No updated regulatory information was identified. During the site reconnaissance, the site was observed as an apartment complex. No change is recommended to the risk rating. Therefore, the risk rating remains No.
4	Bethanie 7th Day Adventist Church 24300 Harborview Road	No	No	The PD&E CSER notes that no releases have been reported at this site. No new discharges have been reported since 2018. No updated regulatory information was identified. During the site reconnaissance, the site was observed as Bethanie 7 th Day Adventist Church. No change is recommended to the risk rating. Therefore, the risk rating remains No.
5	Charlotte County Pest Management 25550 Harborview Road, Suite 2	No	No	The PD&E CSER notes that no releases have been reported at this site. No new discharges have been reported since 2018. The FDEP's Storage Tanks & Contamination Monitoring database lists one 10,000-gallon pesticide underground storage tank (UST) and one 750-gallon diesel aboveground storage tank (AST) in use at this facility. The 10,000-gallon pesticide UST is listed as Non-regulated/ <i>de minimis</i> . The 750-gallon diesel AST has an active status and is listed for emergency generator use. Files in the FDEP OCULUS database (Appendix B) include a Routine Storage Tank Inspection Form dated September 12, 2022 that found the site "In Compliance" with no discharges reported. During the site reconnaissance, the site was observed as Charlotte County Pest Management/Utilities Department. The facility was vacant due to exterior damage caused by Hurricane Ian. Inspection of the site was not possible due to a security gate. Given a lack of a reported discharge and recent documentation finding the facility "In Compliance," no change is recommended to the risk rating and therefore it remains No.

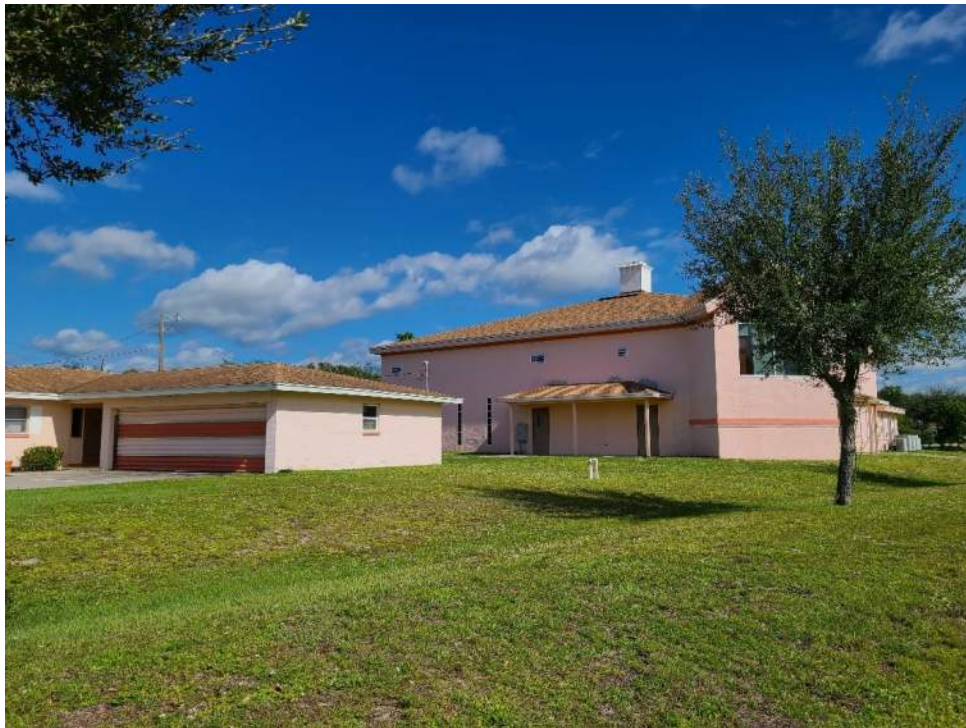
Site 4 – Bethanie 7th Day Adventist Church
Harborview Road looking northeast

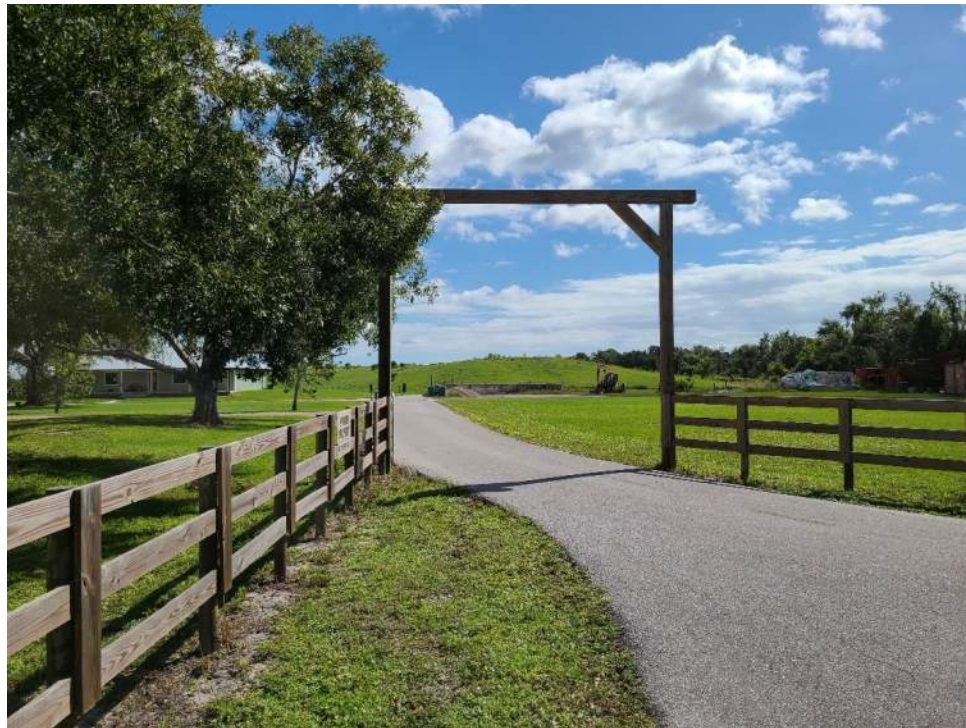
Site 6 – Former Raulerson Yard Trash Compost Site Rowland Drive looking east

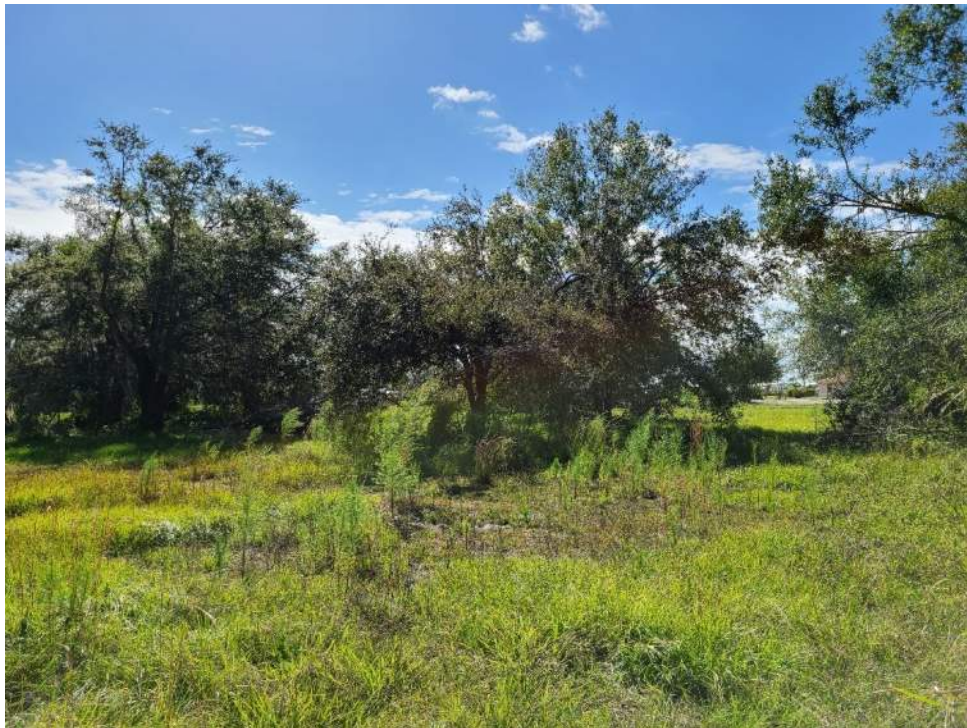
Site 7 – Former Groves
Harborview Road looking south

7*	Former Groves	N/A	Low	This site was not previously identified in the PD&E CSER dated October 2018. Review of the FDOT's aerial photographs from 1975 to 1995 (Appendix D) depict groves adjoining the ROW. The location of the former groves was interpreted from the historical aerial photographs and estimated on Sheet No. 1 (Appendix A). Groves were not identified in the regulatory report since they are not regulated. Although grove cultivation in itself does not confirm the presence of contamination, many of the activities associated with grove cultivation can result in hazardous materials or petroleum product contamination of the soil and/or groundwater. These activities include vehicle/equipment maintenance and fueling, pesticide, herbicide and fertilizer formulation and application, and freeze prevention via grove heaters. The maintenance of grove vehicles including tractors, harvesting equipment, pesticide sprayers, and motors used in the groves for pumping water or powering grove blowers was commonly performed near a central barn or storage area. In times prior to the current level of environmental awareness, the maintenance of equipment commonly involved draining oil, transmission fluid, or fuel directly onto the ground. No mix/load areas, diesel powered irrigation pumps, central grove barns, or storage areas were observed on-site or during historical aerial review. During the site reconnaissance, this site was observed as a grassy field. This site was assigned a risk rating of Low.

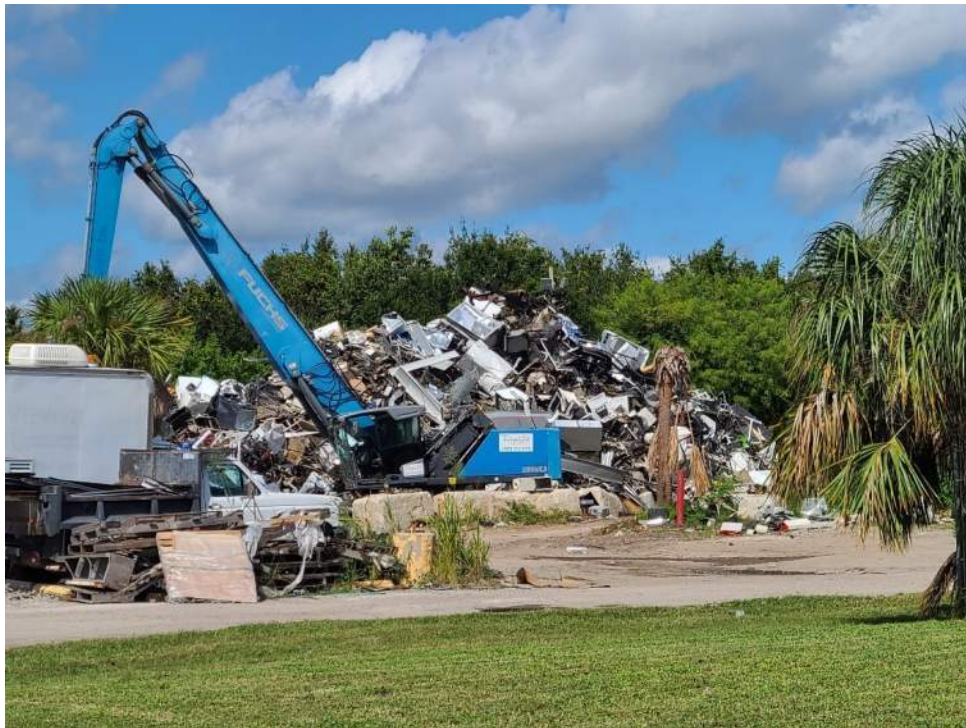
Site 9 – Allied Recycling Port Charlotte
James Street looking west

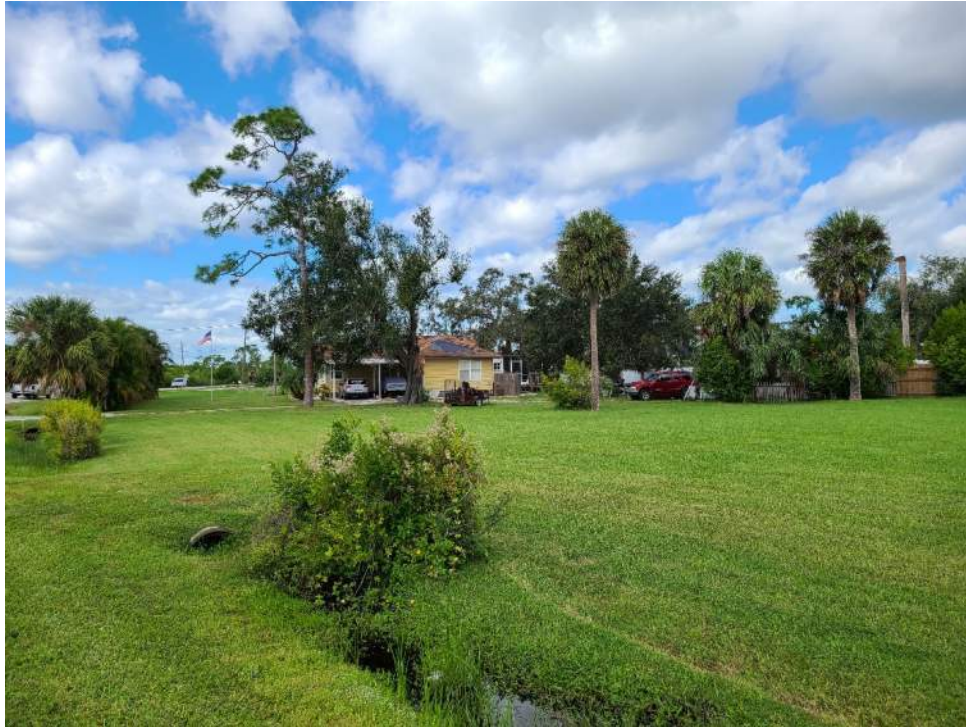
SMF 1-2B
Looking northwest

*	SMF 1-2	N/A	No	SMF 1-2 was not previously identified in the PD&E CSER dated October 2018. No regulatory information was identified for SMF 1-2. During the site reconnaissance, SMF 1-2 was observed as three residential homes. No contamination concerns were observed. Given a lack of contamination concerns associated with SMF 1-2, it was assigned a risk rating of No.

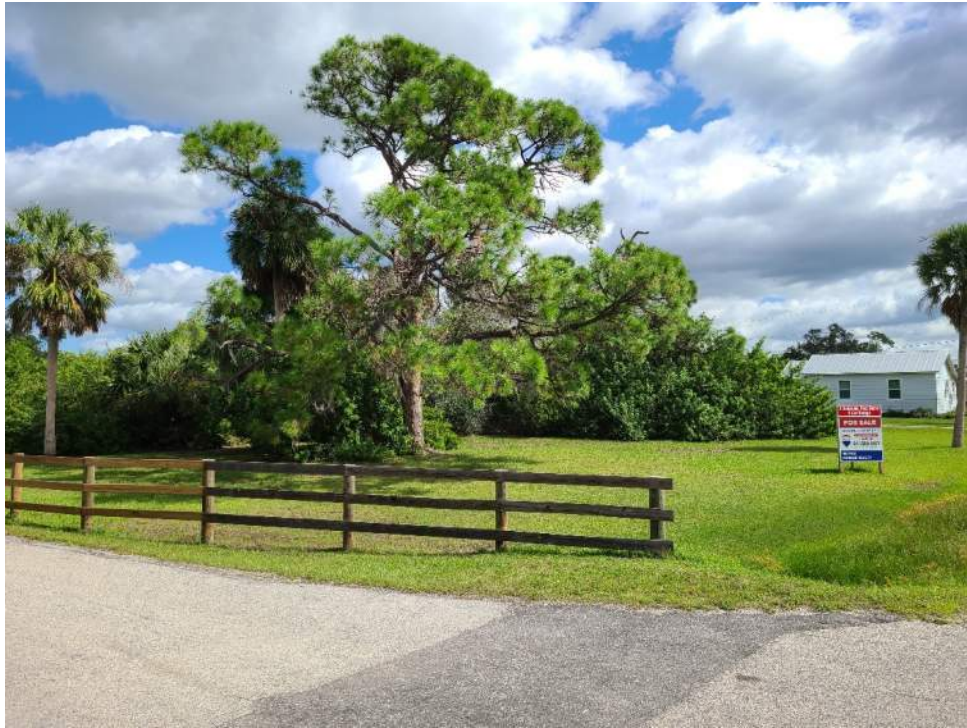
SMF 1-2D
Looking northwest

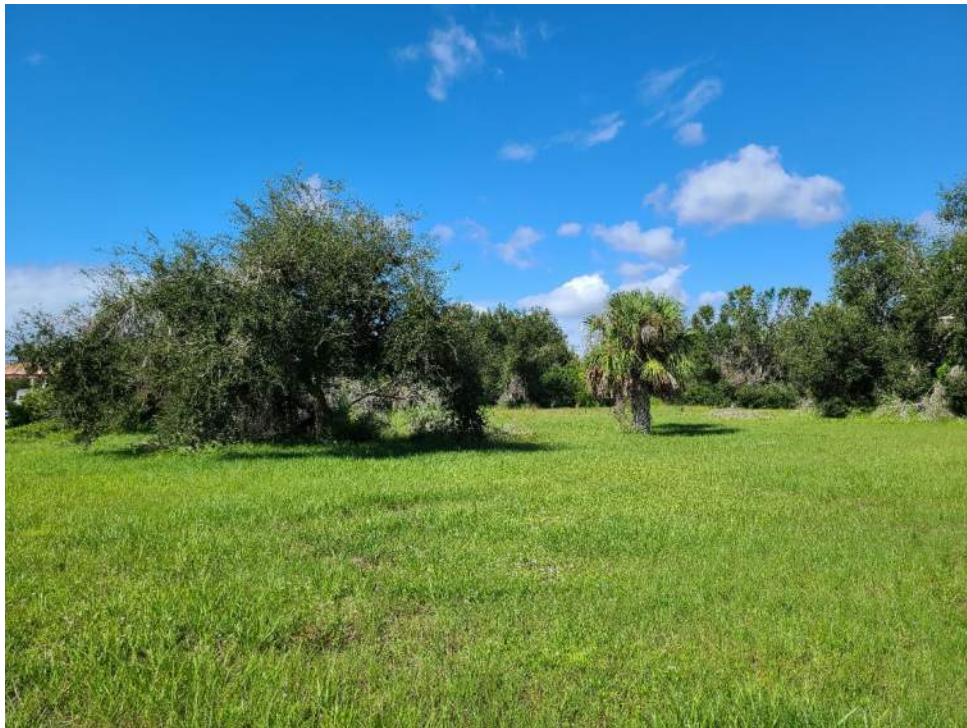
SMF 3
Looking west

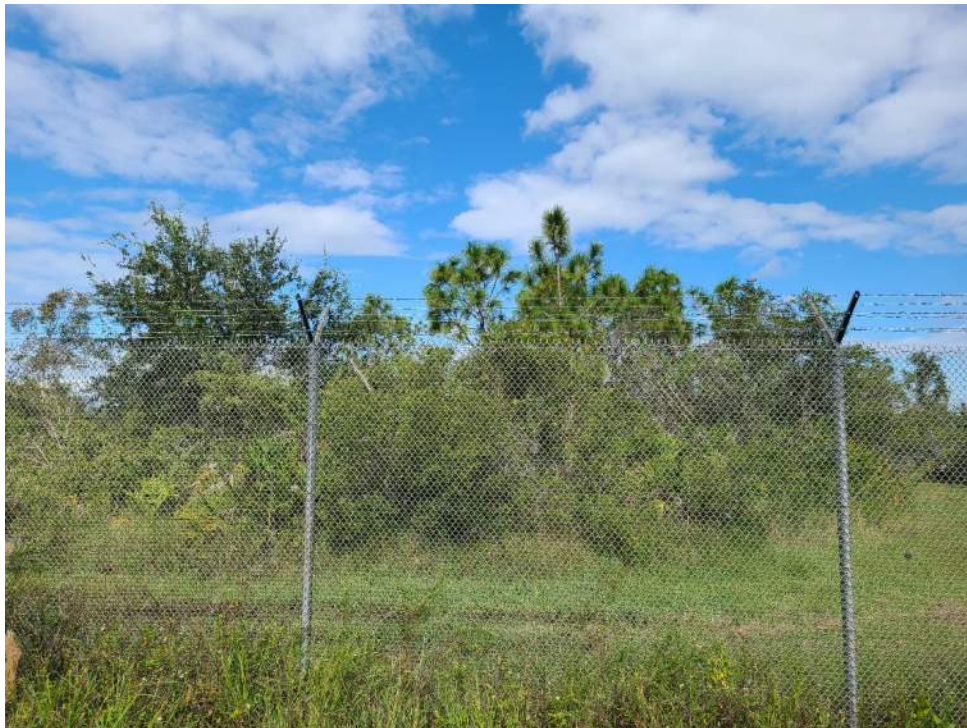
SMF 5-6
Looking northwest

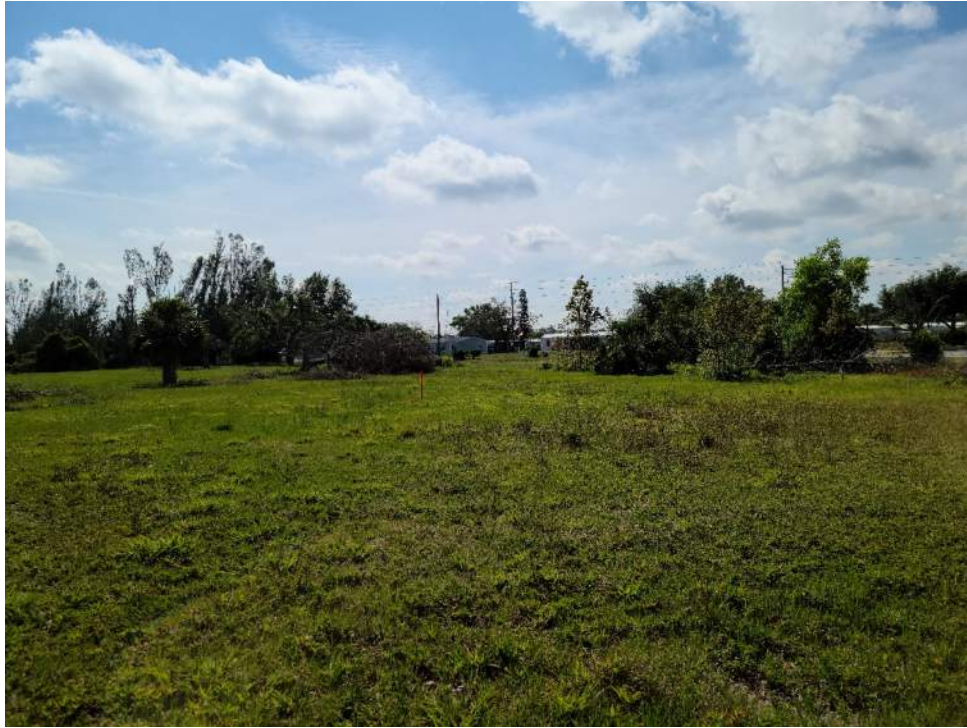
Site 7 – Former groves
Near central portion of project looking northwest

Site 7 – Former groves
Near central portion of project looking east

Site 7 – Former groves
Near central portion of project looking southeast

- **Pond 3C** was risk rated Medium due to **Site #3: Former Row Crops/groves** located within its boundaries and will be considered for Level II testing. The Level II services can include hazardous material surveys, soil borings, monitor well installation, soil and groundwater sampling, and laboratory testing. Further evaluation and Level II testing should be performed in consultation with the District Contamination Impact Coordinator.

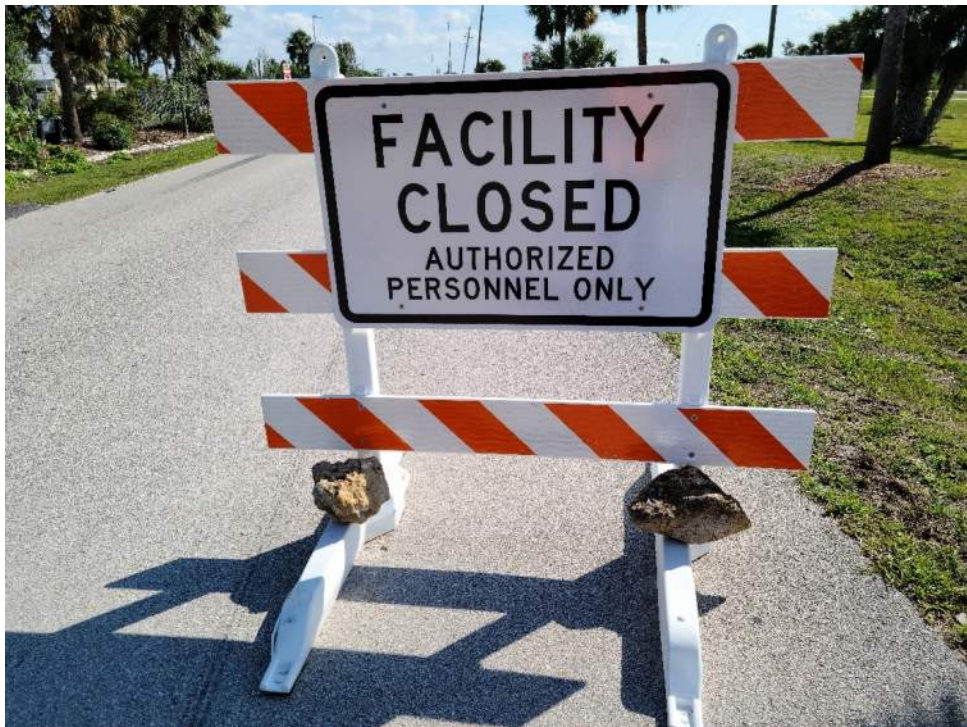
Site 5 – Charlotte County Pest-Management
Harborview road near eastern project boundary, looking northeast

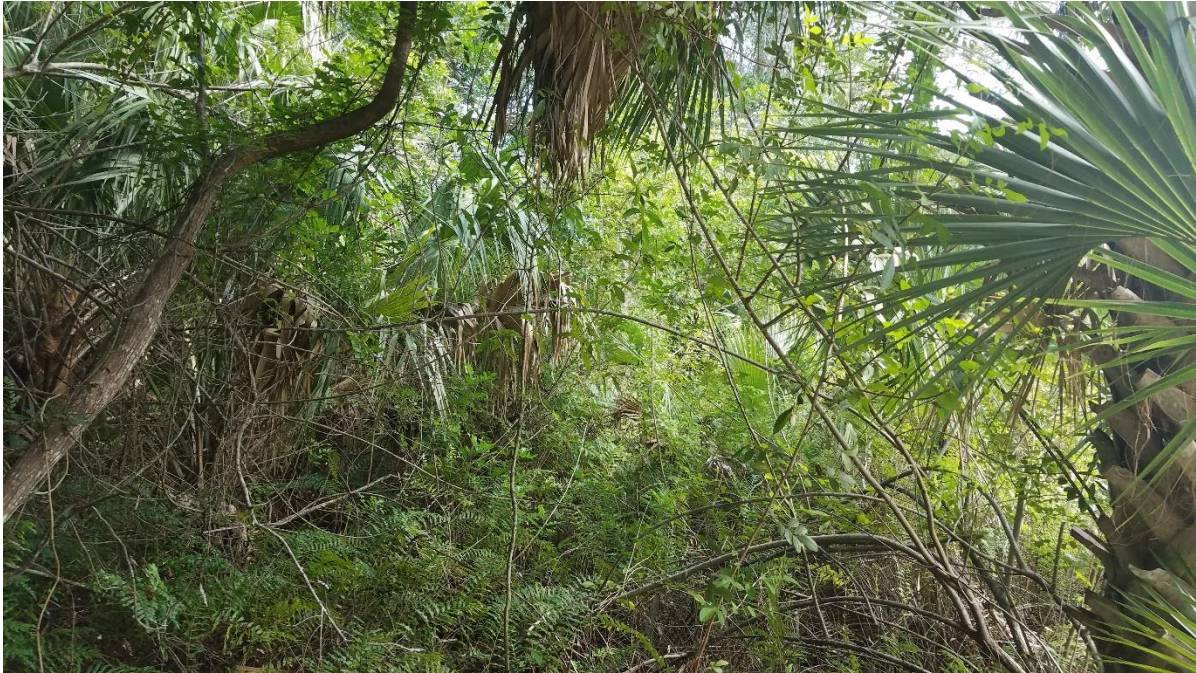
Pond 1A: southeast area looking west

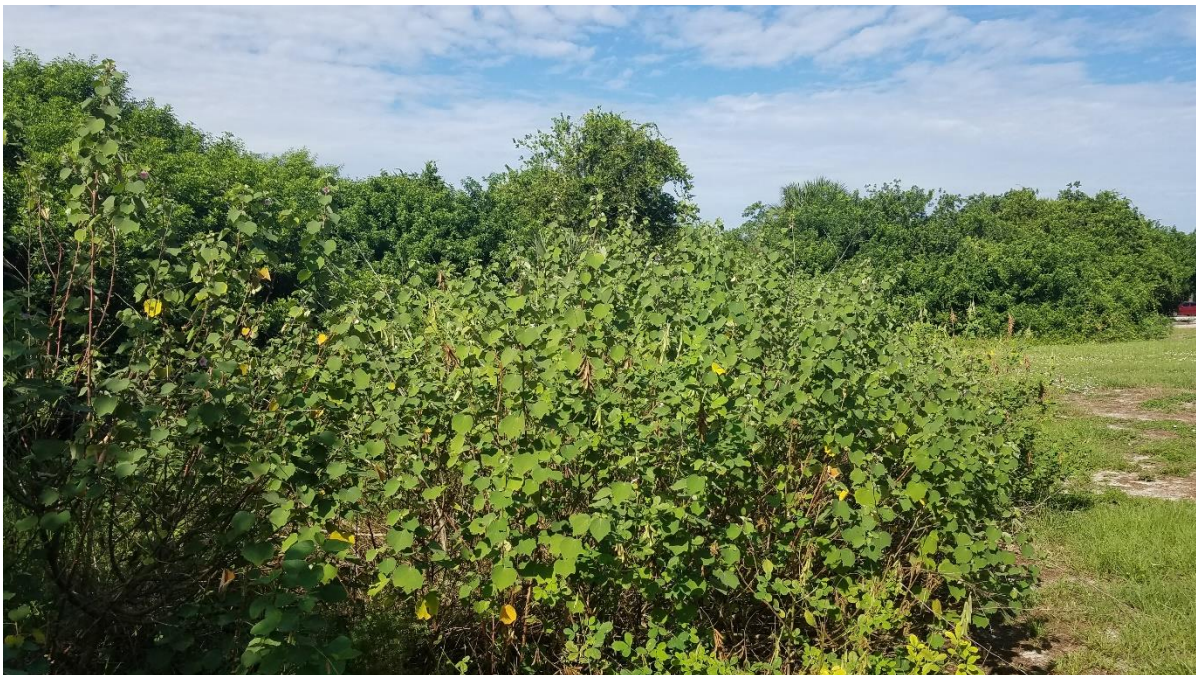
Pond 1B: north area looking southwest

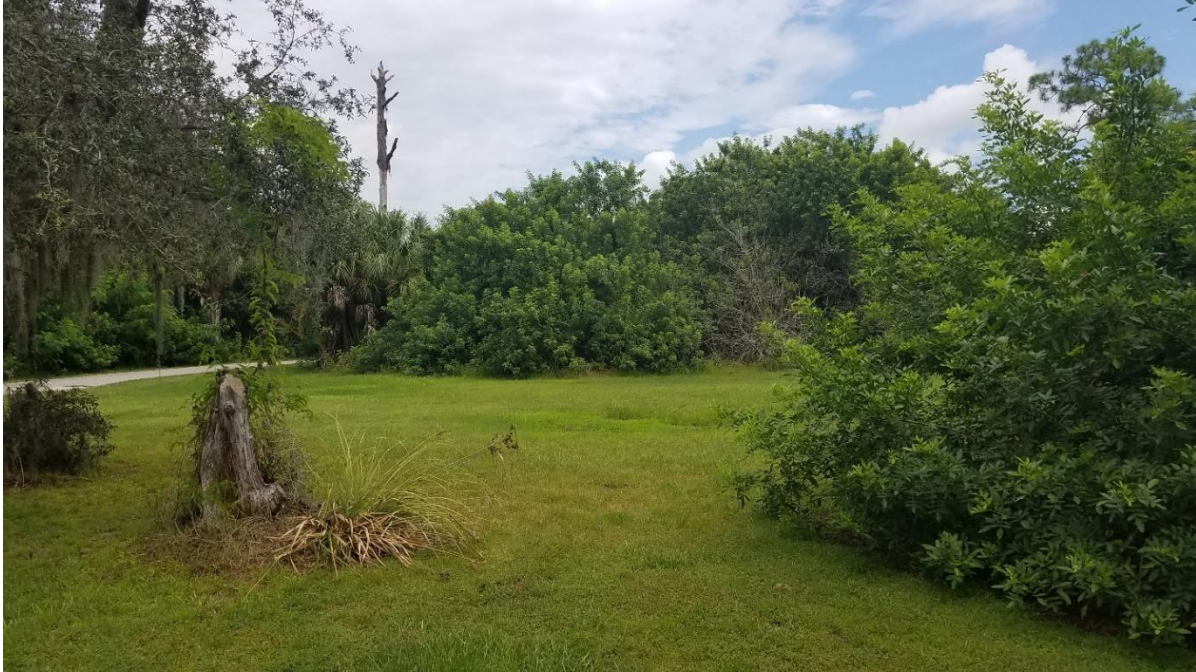
Pond 2B: central area looking north

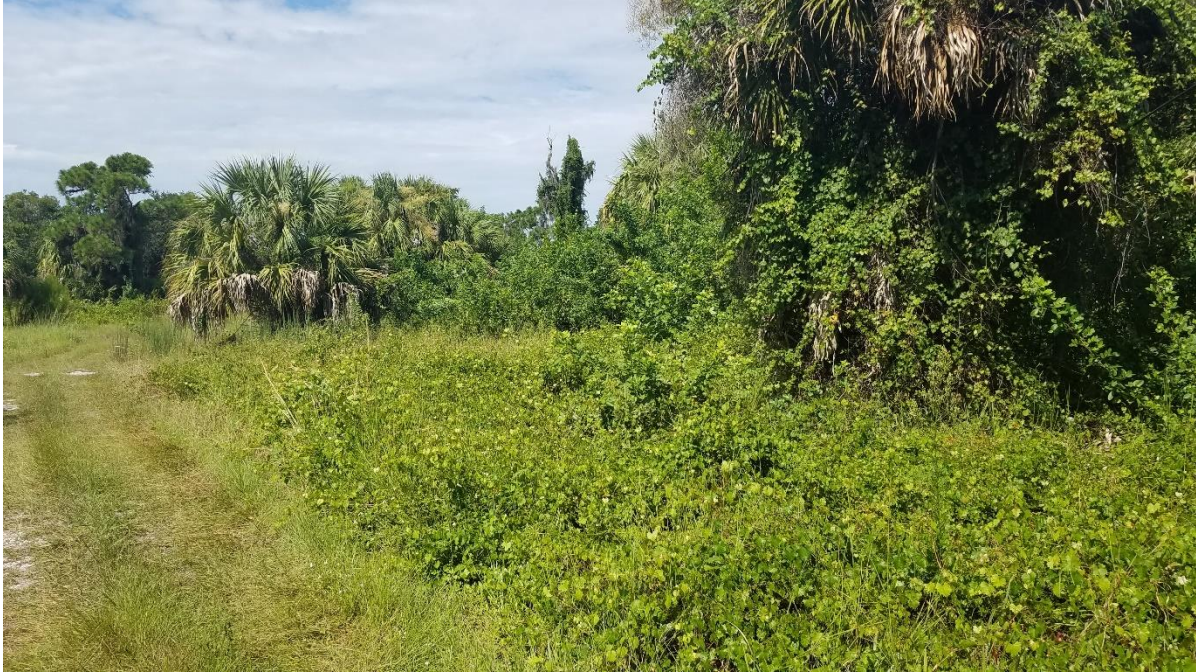
Pond 3A: central area looking northwest

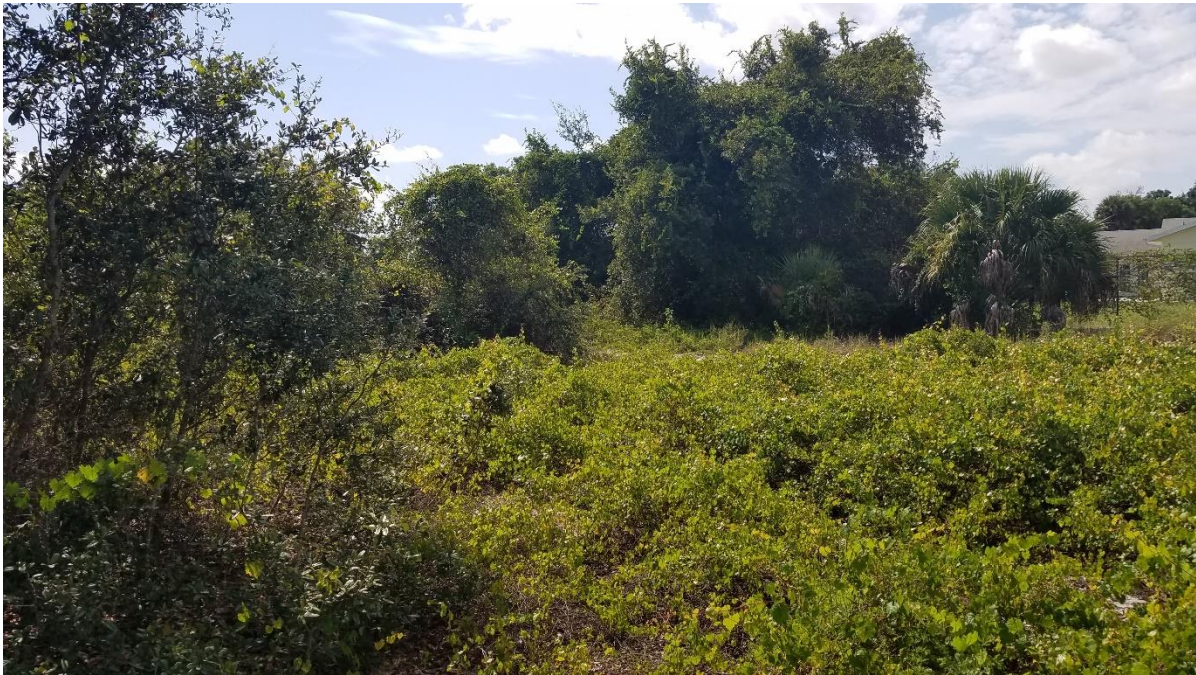
Pond 3B: northern area looking south

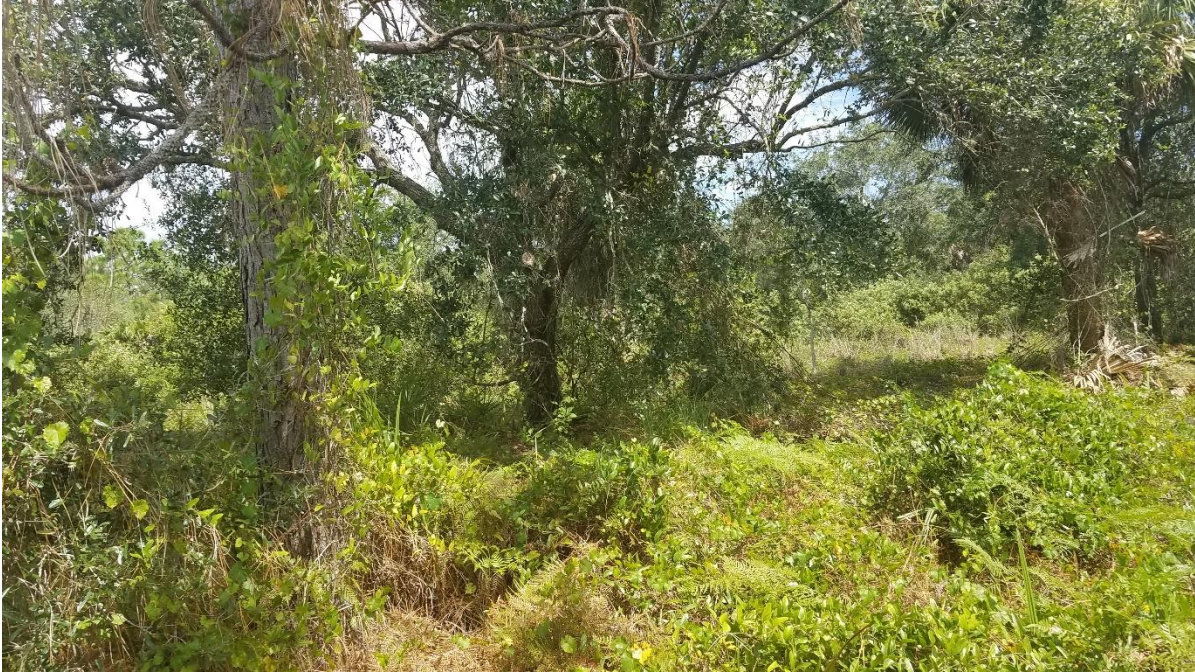
Pond 4B: central area looking north

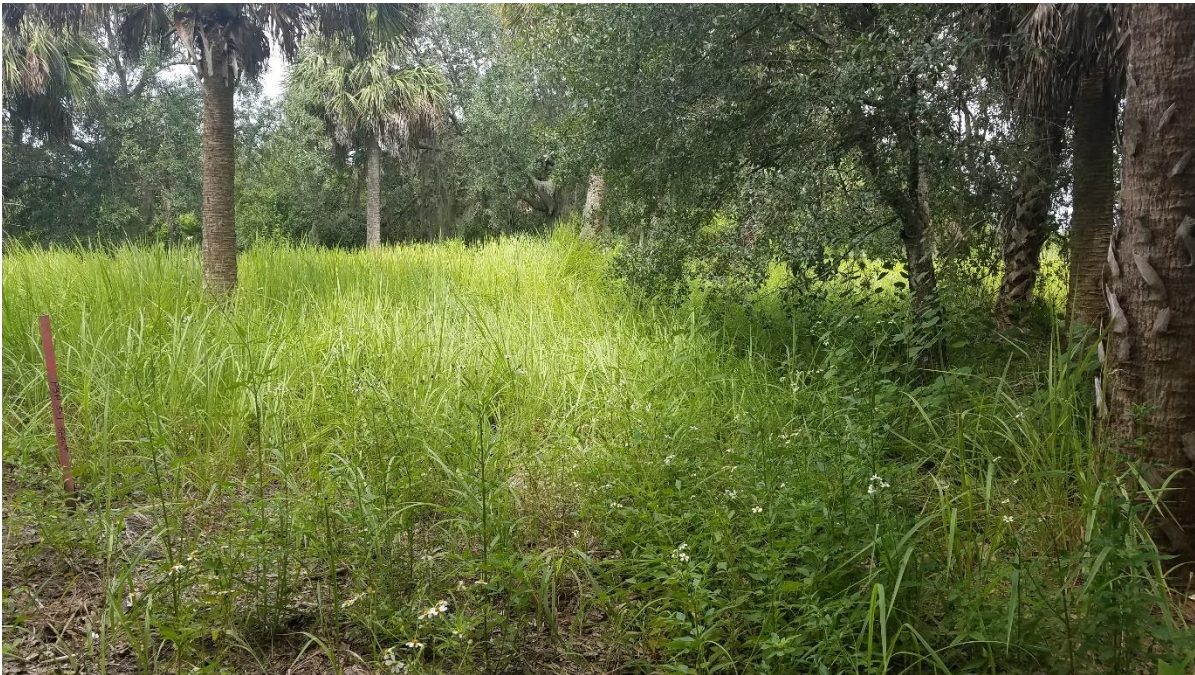
Pond 5A: central area looking west

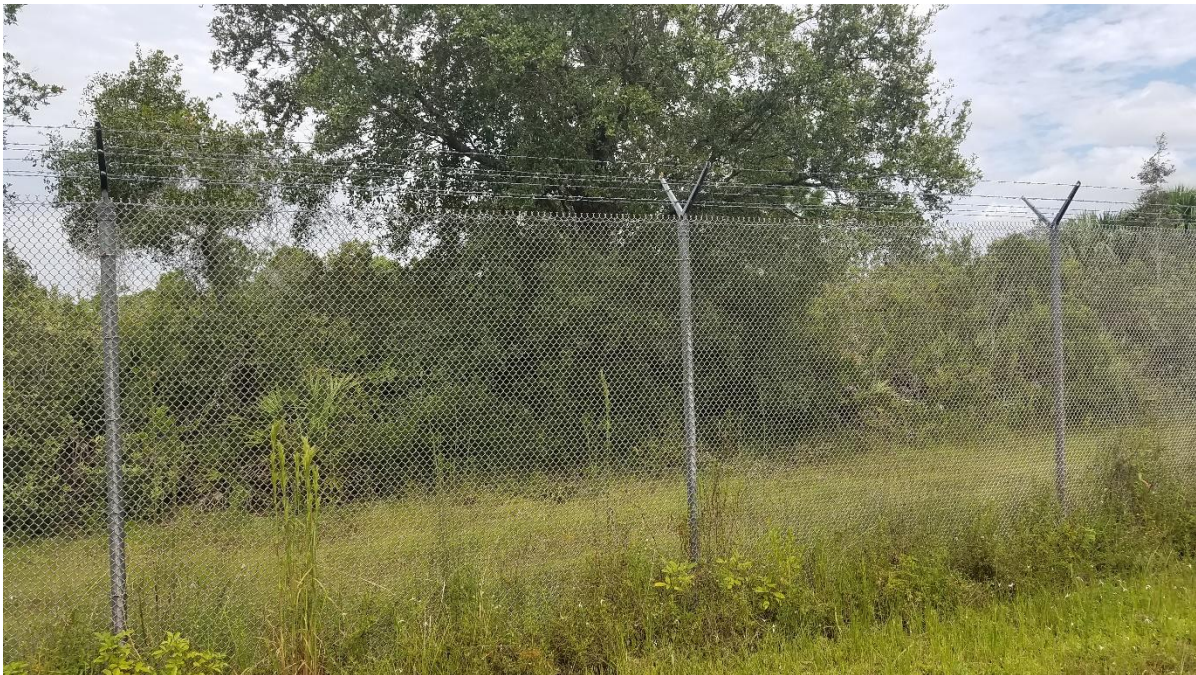
Pond 5C: southern boundary looking north

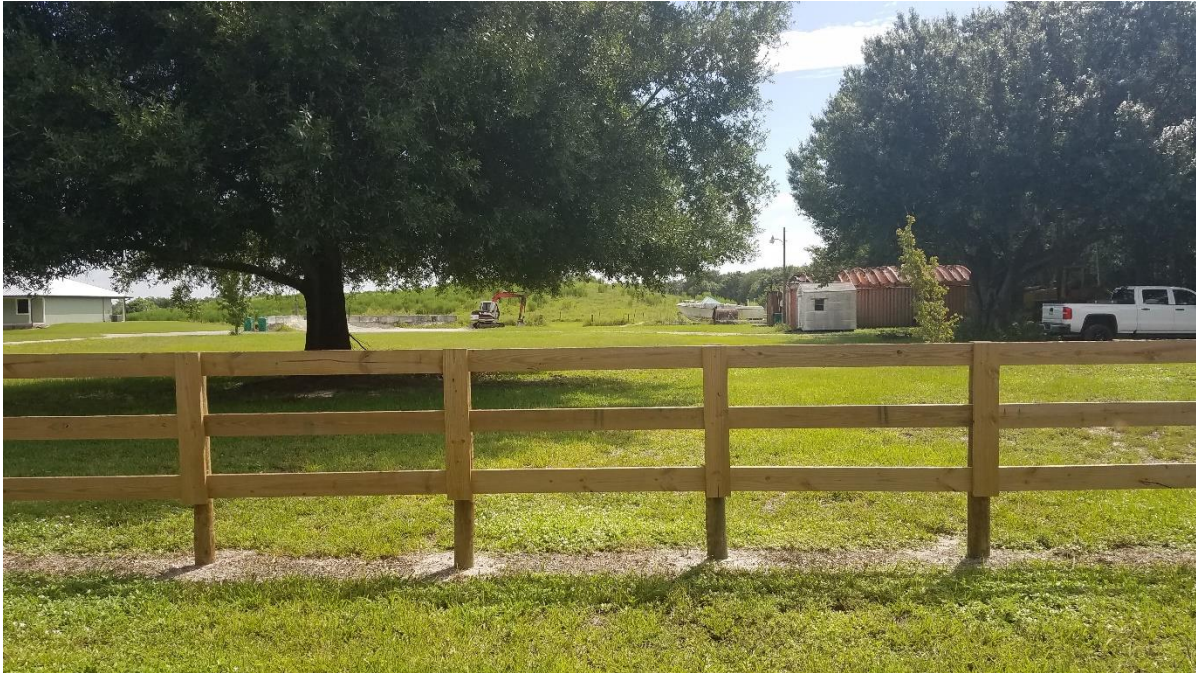
Site 1: Raulerson C&D Facility – offsite west looking east
